# Investigation Report

Published: December 2022

On November 27, 2019, a series of explosions occurred at the TPC Group (TPC) Port Neches Operations (PNO) facility, located in Port Neches, Texas, after highly flammable butadiene released from the process unit. The explosions caused a process tower to propel through the air and land within the facility, other process towers to fall within the unit, extensive facility damage, and fires that burned for more than a month within the facility. The butadiene unit was destroyed, forcing the facility to cease butadiene production operations indefinitely. As of the date of this report, the butadiene production operations remain shut down. Two TPC PNO employees and a contractor reported minor injuries, and according to media reports, at least five local residents reported injuries. Officials in Jefferson County, Texas declared the county to be in a state of disaster and issued a mandatory four-mile radius evacuation order that affected people in the cities of Port Neches, Groves, Nederland, and a portion of Port Arthur. The explosion also led to reduced usage of the Sabine-Neches Waterway, the nation's third largest waterway by cargo volume

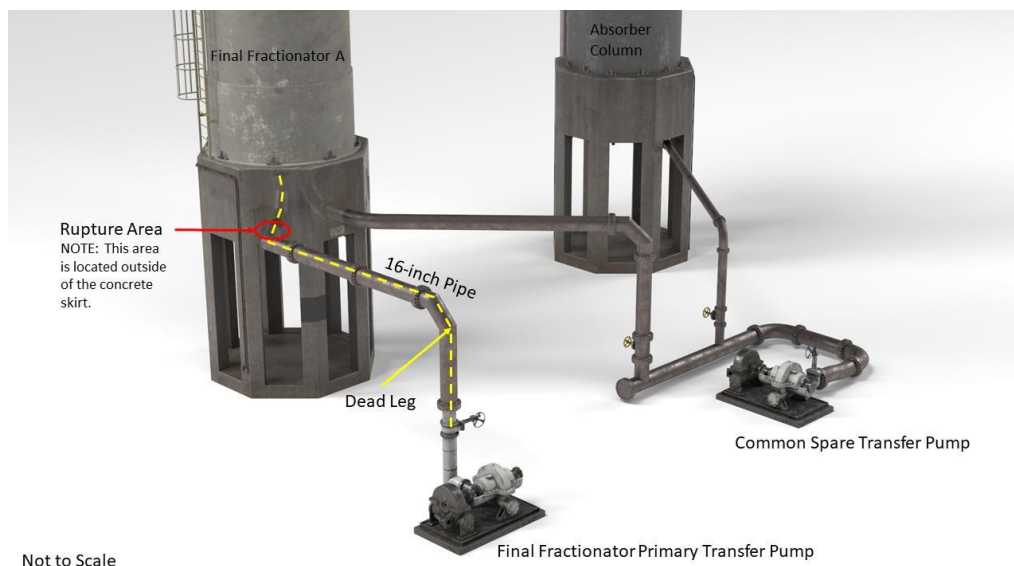
During this 114-day period, the process piping between Final Fractionator A and the manual isolation valve upstream of the Primary Pump was a dead leg, as the pump could not initiate flow through the line. The portion of dead leg piping was 16 inches in diameter and approximately 35 feet long (**Figure 9**). During this 114-day period, TPC PNO continued to experience popcorn polymer formation and plugging in the unit (see Section 4.3). The U.S. Chemical Safety and Hazard Investigation Board (CSB) did not find that anyone at the TPC PNO facility realized the potential popcorn polymer and rupture hazard in the dead leg that was created when the Primary Pump became nonoperational.

**Figure 9.** Schematic showing dead leg location when Primary Pump was nonoperational. (Credit: CSB)

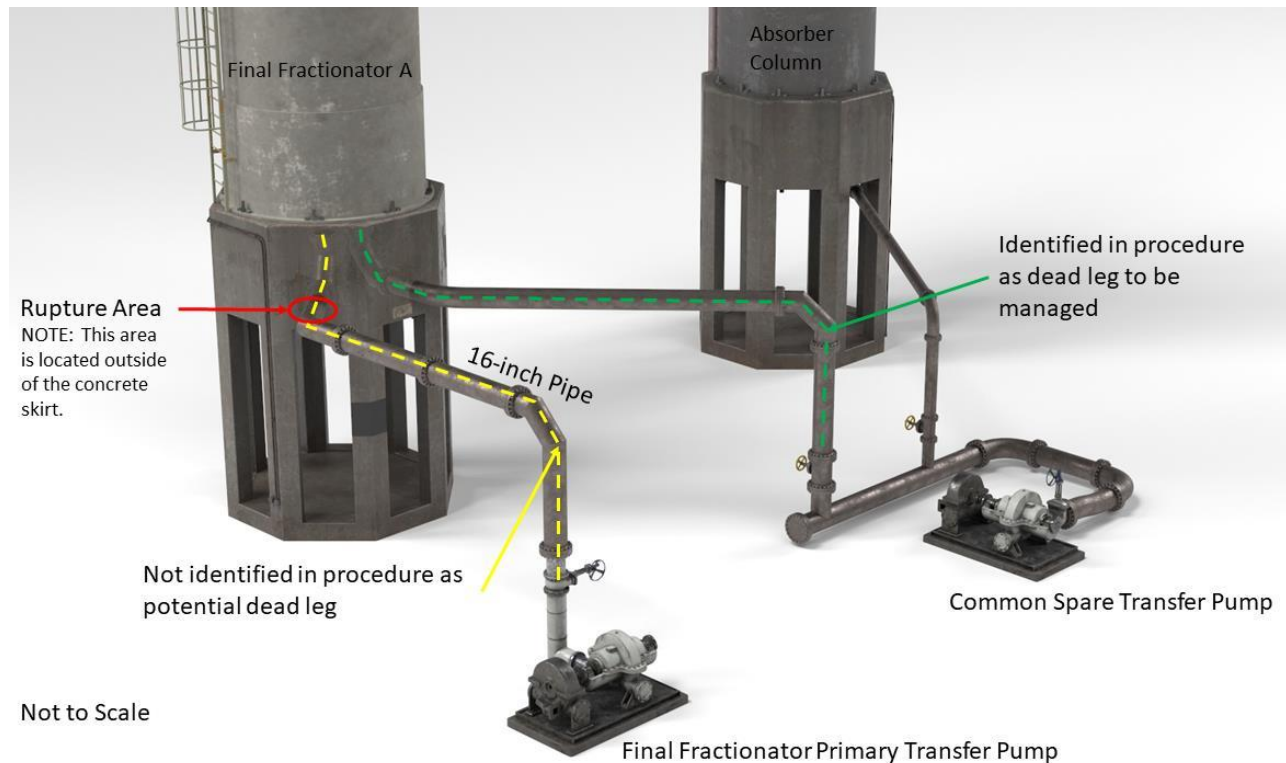
**Figure 19.** Primary Pump dead leg not identified in TPC PNO procedure. (Credit: CSB)

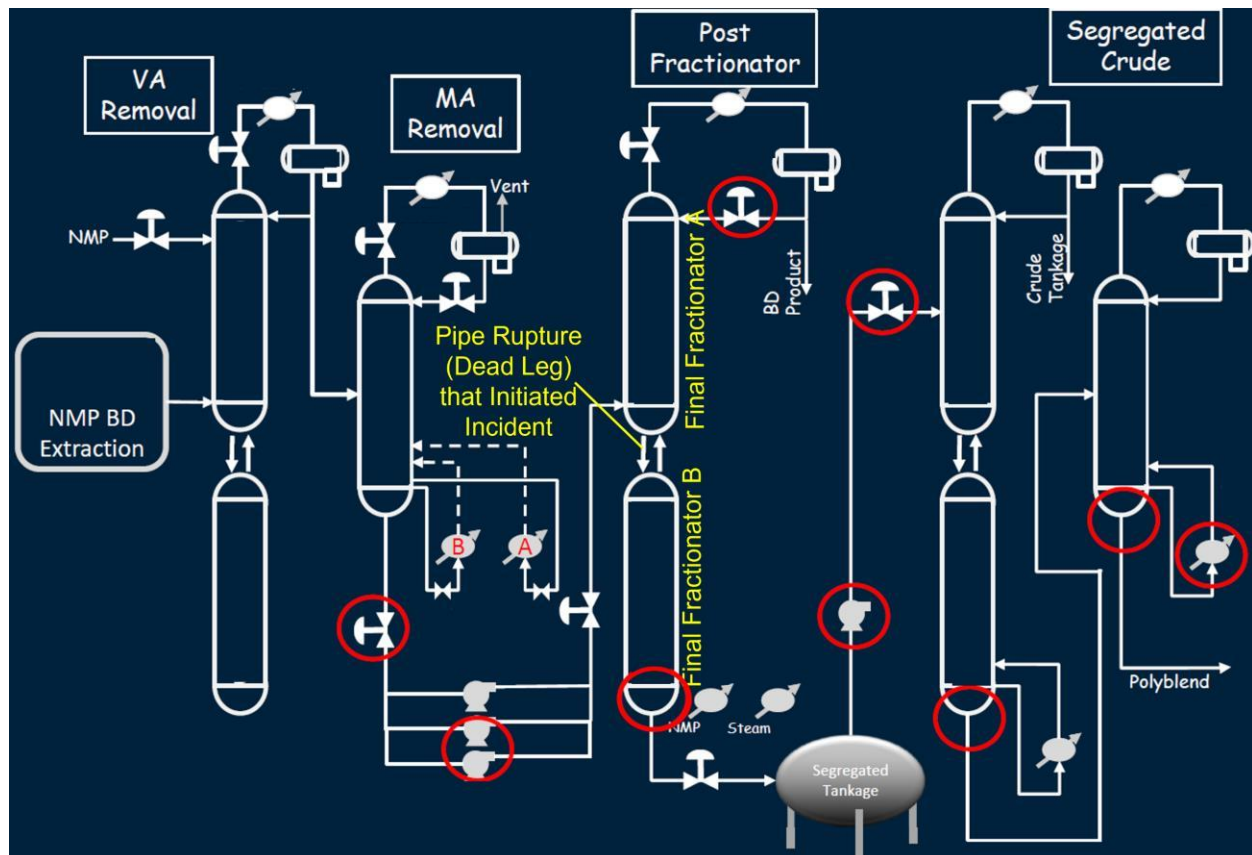
TPC PNO continued to experience popcorn polymer and equipment plugging in the butadiene process throughout the remainder of 2019. Circled in red in **Figure 34** below are locations where the TPC PNO facility had experienced popcorn polymer blockage in equipment between June and October 2019.<sup>a</sup>

**Figure 34.** Locations of popcorn polymer blockages or fouling between June and October 2019. (Credit: TPC with text added by CSB)
