U.S. Chemical Safety and Hazard Investigation Board

Three Catastrophic Hydrogen Fluoride Incidents at Honeywell Geismar

Geismar, Louisiana | No. 2023-02-I-LA

Investigation Report

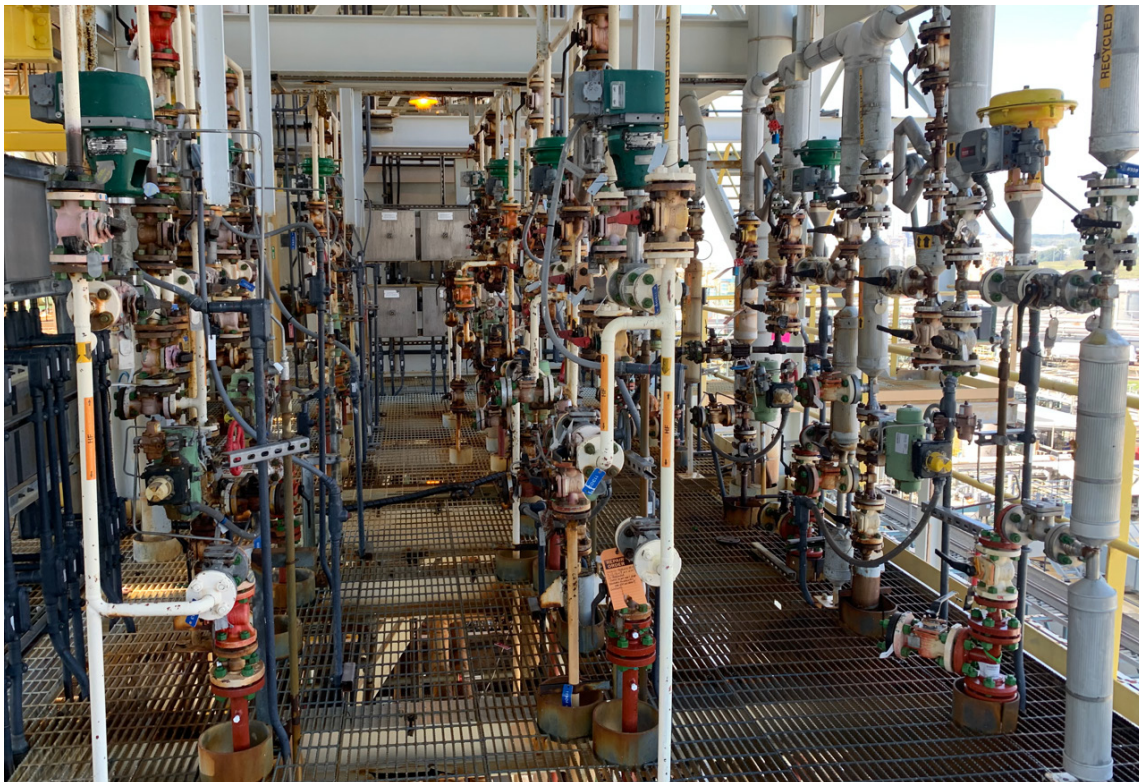
Figure 3. Photo of the D reactor Fresh HF (left), Recovered HF (center), and Recycle HF (right) feed stations.^a (Credit: CSB)

^a Figure 3 shows the locations of both the 2021 and 2024 incidents. The 2021 incident occurred on the D reactor recycled HF feed station, shown on the right of Figure 3. The 2024 incident occurred on the D reactor fresh HF feed station, shown on the left of Figure 3.

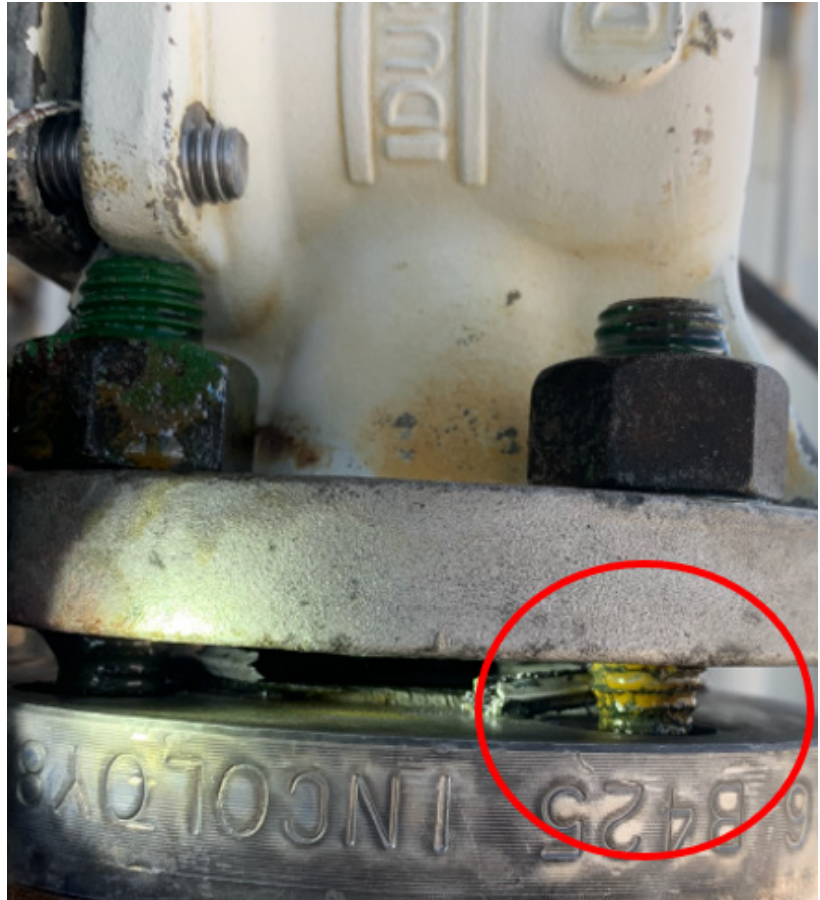
Before moving to check the manual block valve, Field Operator 1 smelled HF coming from behind him. He turned and saw a wisping leak from one of the flanged connections of a bypass valve at the D reactor recycle HF feed station. Field Operator 1 then radioed for assistance. Field Operators 2 and 3 acknowledged over the radio,

Figure 7. Photo of the flange assembly as found after the incident, showing the stud corrosion observed by the field operators prior to the release. (Credit: Honeywell, annotated by CSB)

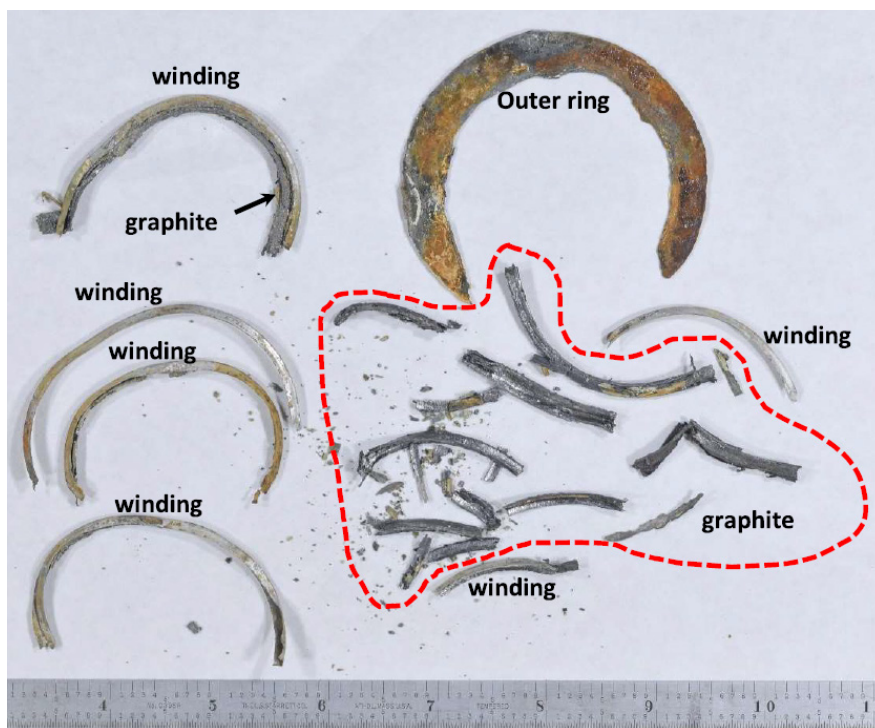
The CSB determined that the cause of the HF release was the failure of a flanged piping connection. The gasket within the connection had deteriorated from stress corrosion cracking, and the flange assembly was likely loosened because its fastening studs were thinned from wet HF acid corrosion, resulting in the release.

The release was caused by the failure of a spiral wound gasket.^c The gasket was constructed with 304 stainless steel windings and graphite filler, which, according to Honeywell, was appropriate for the process material and conditions. A photo of the remnants of the failed gasket is shown in **Figure 9**.

Figure 9. Photo of the failed spiral wound gasket remnants. (Credit: Honeywell via Stress Engineering Services, annotated by SES)

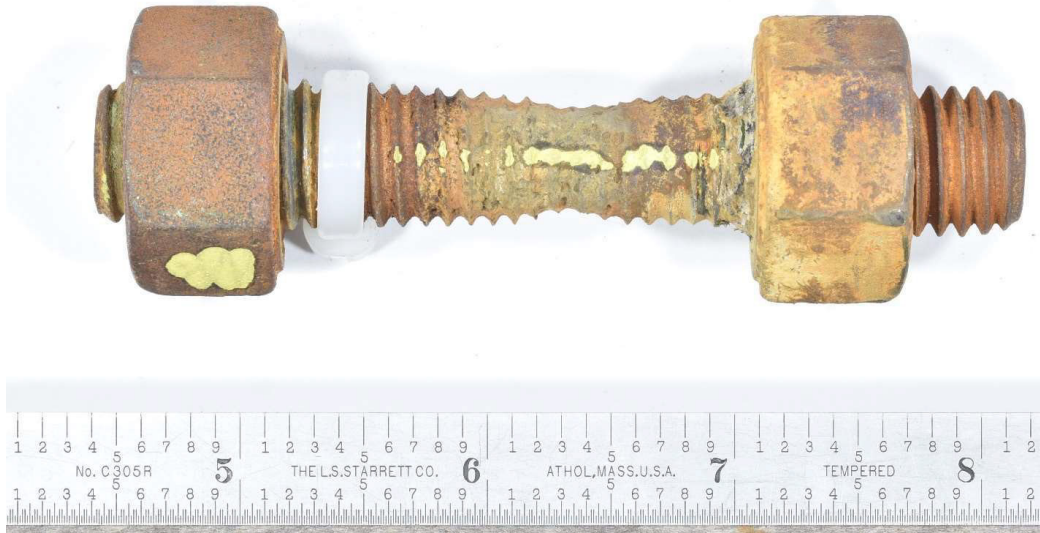
The fastening studs were constructed of A193 Grade B7M and had a nominal diameter of 0.50 inches. After the incident, Honeywell contracted Stress Engineering Services (“SES”) to conduct metallurgical examination of the flange assembly, including the gasket and fasteners. SES measured diameter loss between 0.020 and 0.060 inches among the fastening studs installed in the incident flange. A picture of one of the corroded fastening studs is shown in **Figure 10**.

Figure 10. Post-incident examination photo of a corroded stud installed in the incident flange. (Credit: SES)

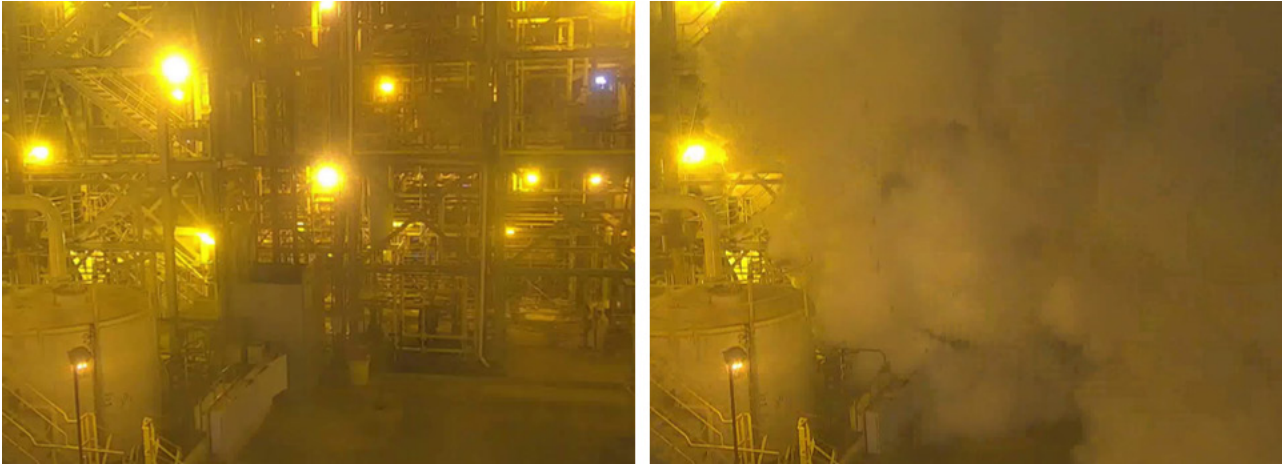
At 7:03 p.m. on January 23, 2023, Honeywell Geismar began restarting the 245 unit after the site experienced an unrelated utility outage. Operations personnel established feed to the distillation column at 7:16 p.m. At 8:12 p.m., the reboiler shell suddenly and catastrophically ruptured when the reboiler shell thinned to the point at which it could no longer contain the operating pressure (**Figure 17**).

Figure 17. Surveillance images immediately before (left) and four seconds after (right) the reboiler rupture. (Credit: Honeywell)

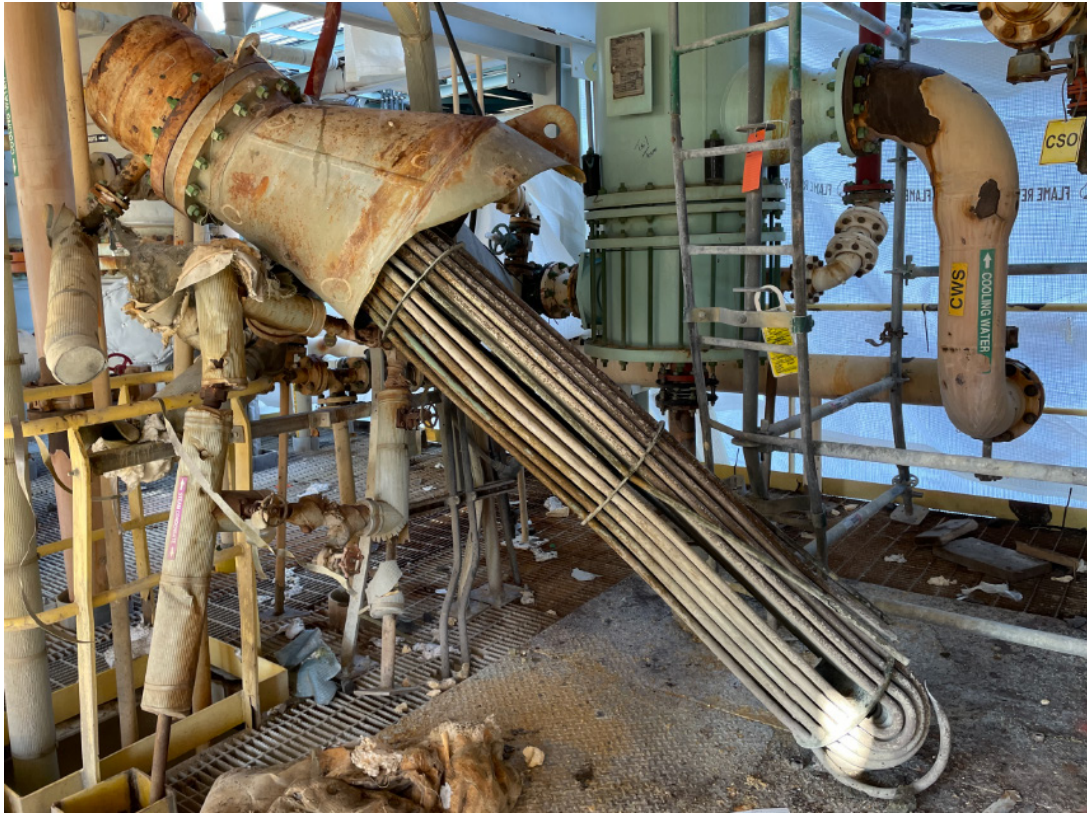
The CSB determined that the cause of the accidental release of toxic HF and chlorine was the catastrophic failure of a reboiler. The reboiler had thinned due to HF corrosion of its carbon steel shell to the point that it could no longer contain its normal operating pressure.

The reboiler shell ruptured into at least nine fragments, which were propelled up to 35 feet away. The largest fragment contained the tube side head, the complete tube bundle, and the conical section of the shell. This fragment is pictured below in **Figure 18**. The debris from the explosion was largely contained by the nearby piping and equipment collocated on the same platform as the reboiler.

Figure 18. Post-incident image showing the remnants of the reboiler. (Credit: Honeywell)

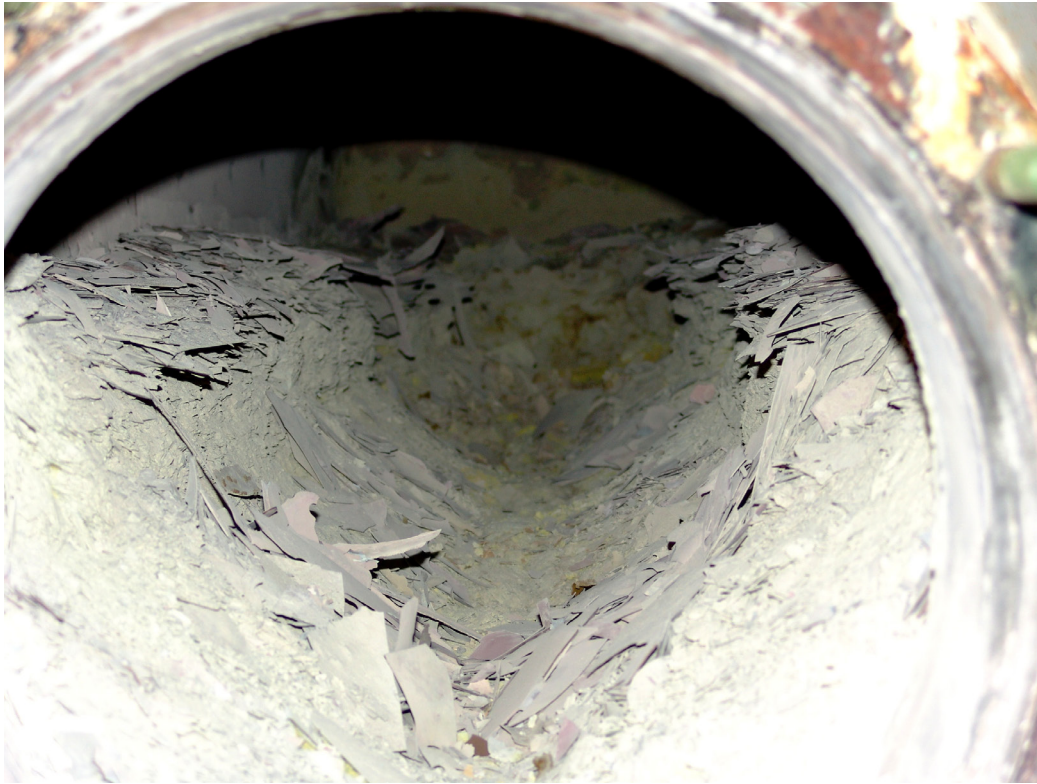
In May 2005, Honeywell conducted an internal inspection of the reboiler shell and found it filled with corrosion solids and debris, pictured below in **Figure 19**.

Figure 19. Picture of the inside of the reboiler shell, taken during a May 2005 internal inspection. (Credit: Honeywell)

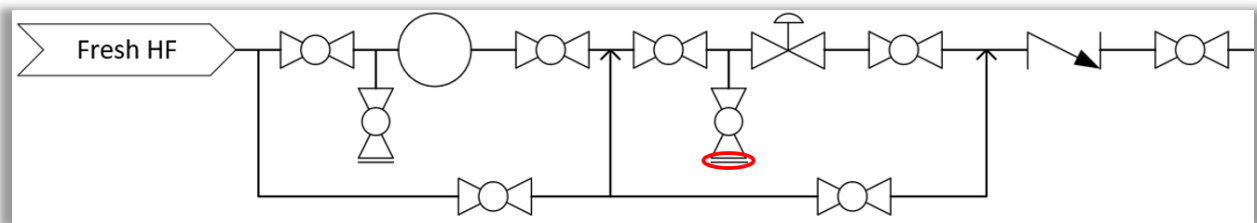
Figure 29. Simplified drawing of the fresh HF feed station. The release location is circled in red. (Credit: CSB)

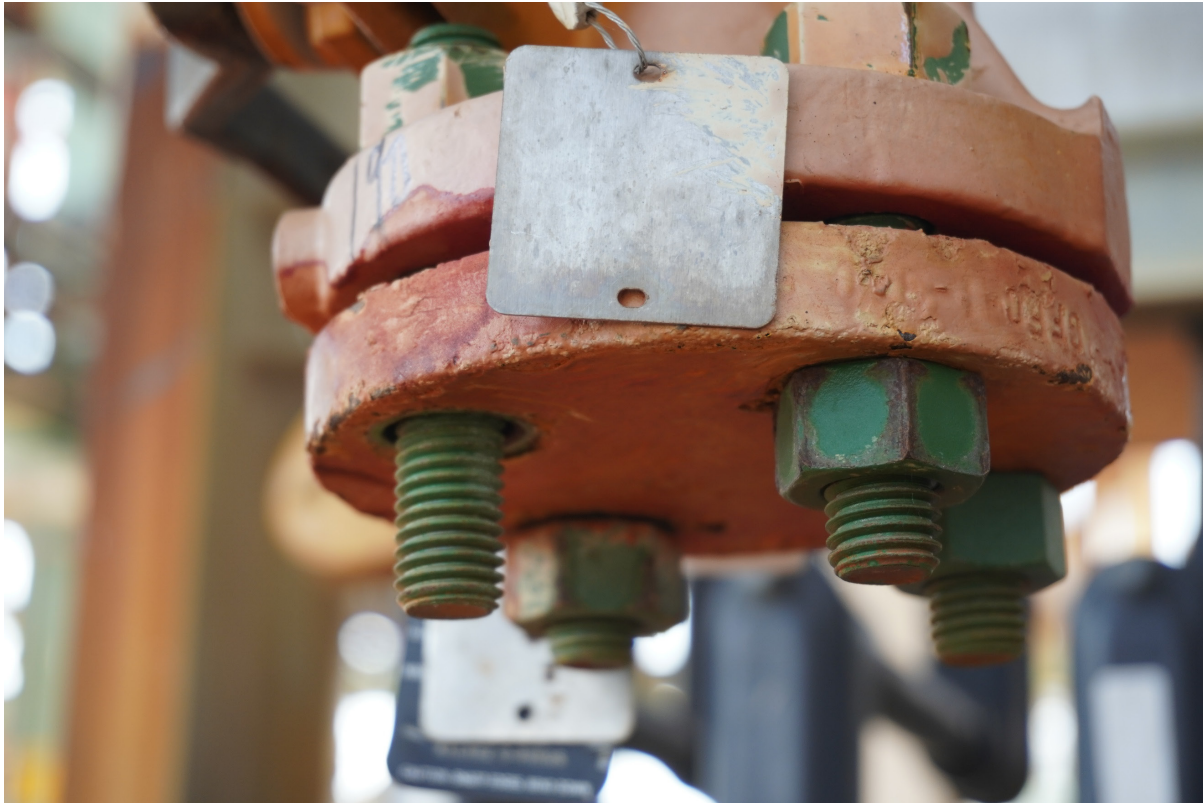
The CSB determined that the cause of the accidental HF release was the partial removal of a blind flange from a valve that contained pressurized HF during a maintenance activity. Honeywell did not effectively remove all HF from the valve before turning it over to contract workers for maintenance.

As the two workers proceeded through the work, one of them loosened the blind flange^a on one of the two bleed valves, as depicted in **Figure 29** and pictured in **Figure 30**:

Figure 30. Blind flange as found after the incident.^a One nut was removed (foreground left) and another (background left) was loosened to within two to three threads. (Credit: CSB)

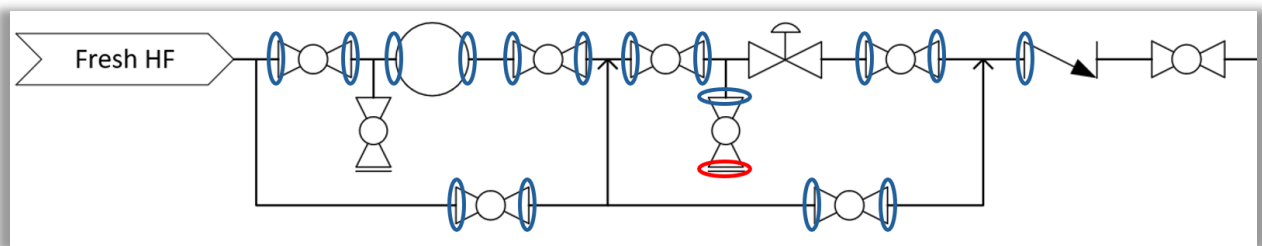
Figure 31. Partial excerpt of the incident job scope. In-scope flanges and gaskets are circled in blue. The blind flange from which the HF released was not in scope and is circled in red. (Credit: CSB)
