U.S. Chemical Safety and  
Hazard Investigation Board

# Chemical Decomposition, Fires, and Toxic Gas Release at KIK Consumer Products / Bio-Lab Conyers Facility

Conyers, Georgia | Incident Date: September 29, 2024 | No. 2024-04-I-GA

## Investigation Report

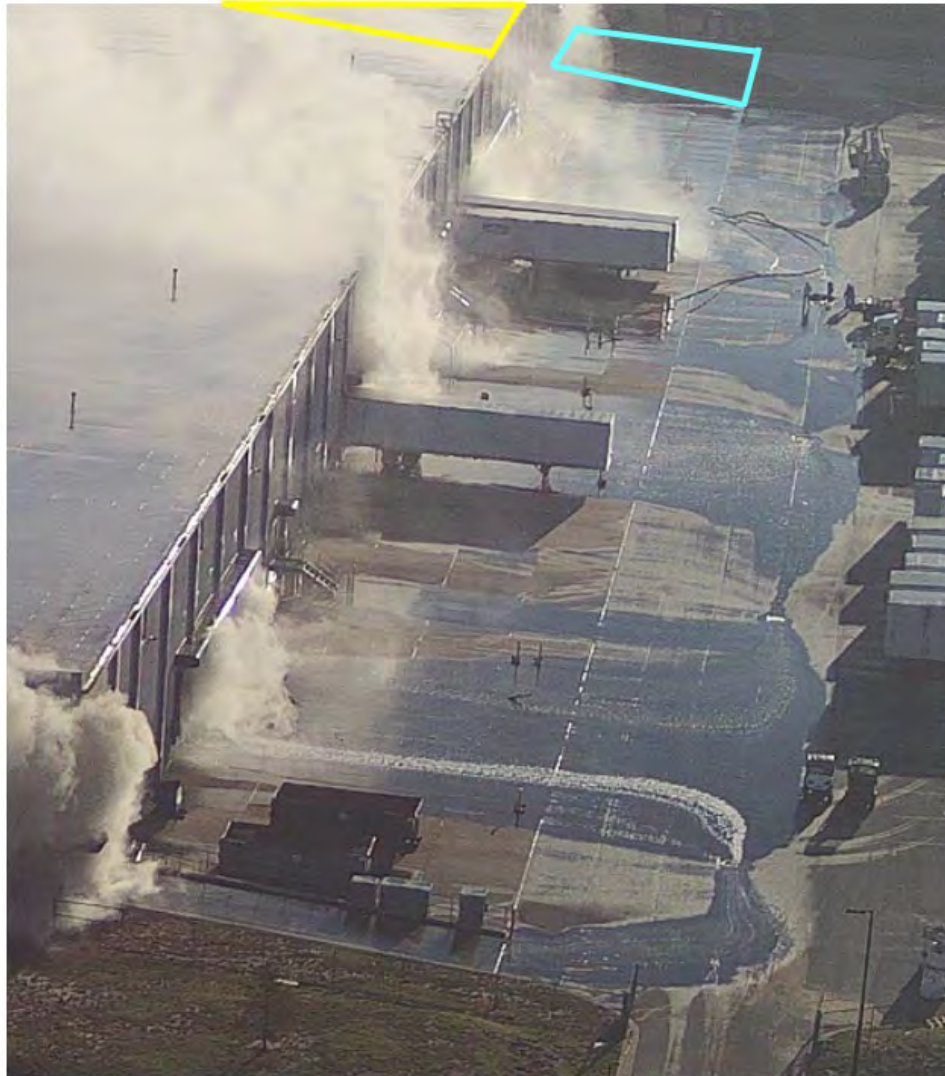
**Figure 18.** Water flow from the Bio-Lab Plant 12 Storage Warehouse’s interior through dock doors at 8:41 a.m., with the bunker area outlined in yellow and its exterior ramp outlined in aqua. (Credit: RCFR, annotated by CSB)<sup>a</sup>

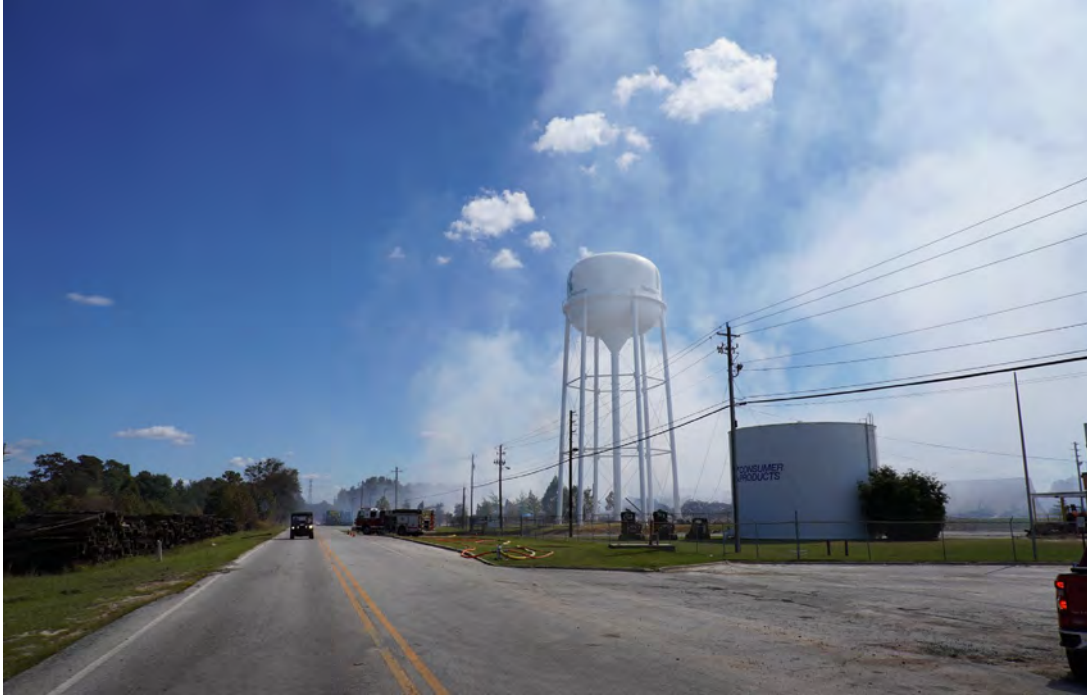
**Figure 26.** Ongoing off-gassing observed from the site during cleanup operations on October 2, 2024, several days after the incident. (Credit: CSB)

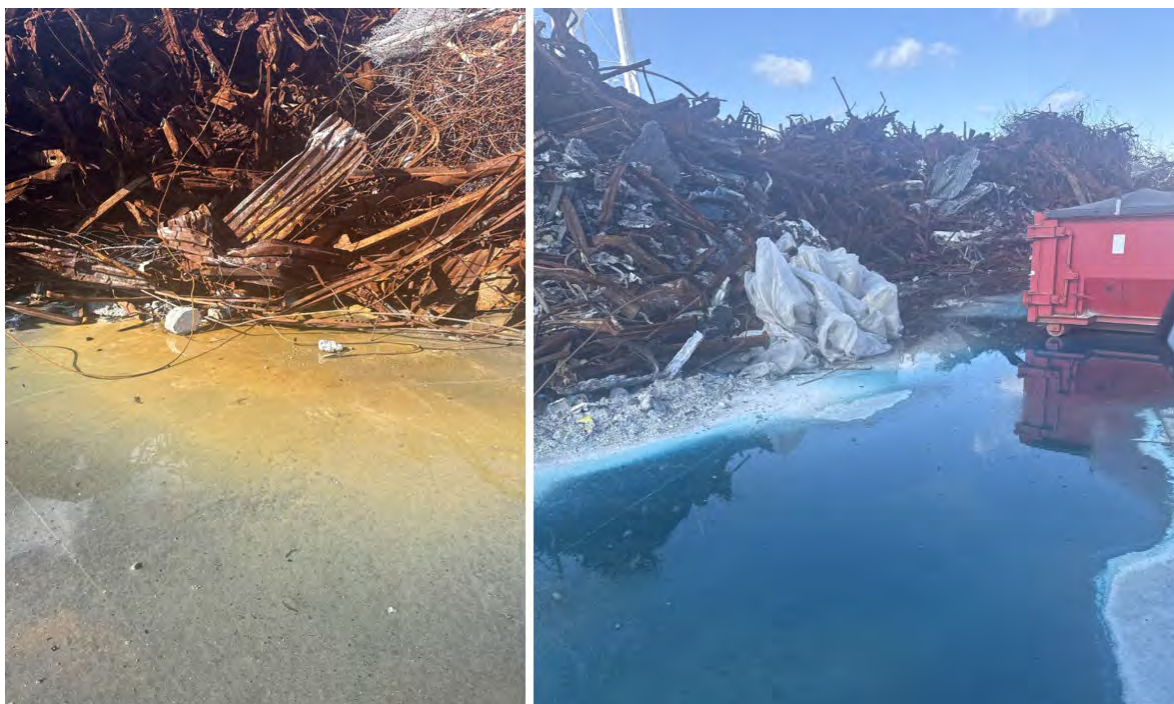
**Figure 28.** Surface water runoff of metals from rusting structural debris (left) and residual chemicals (right) on the former warehouse’s concrete slab. (Credit: KIK)<sup>b</sup>

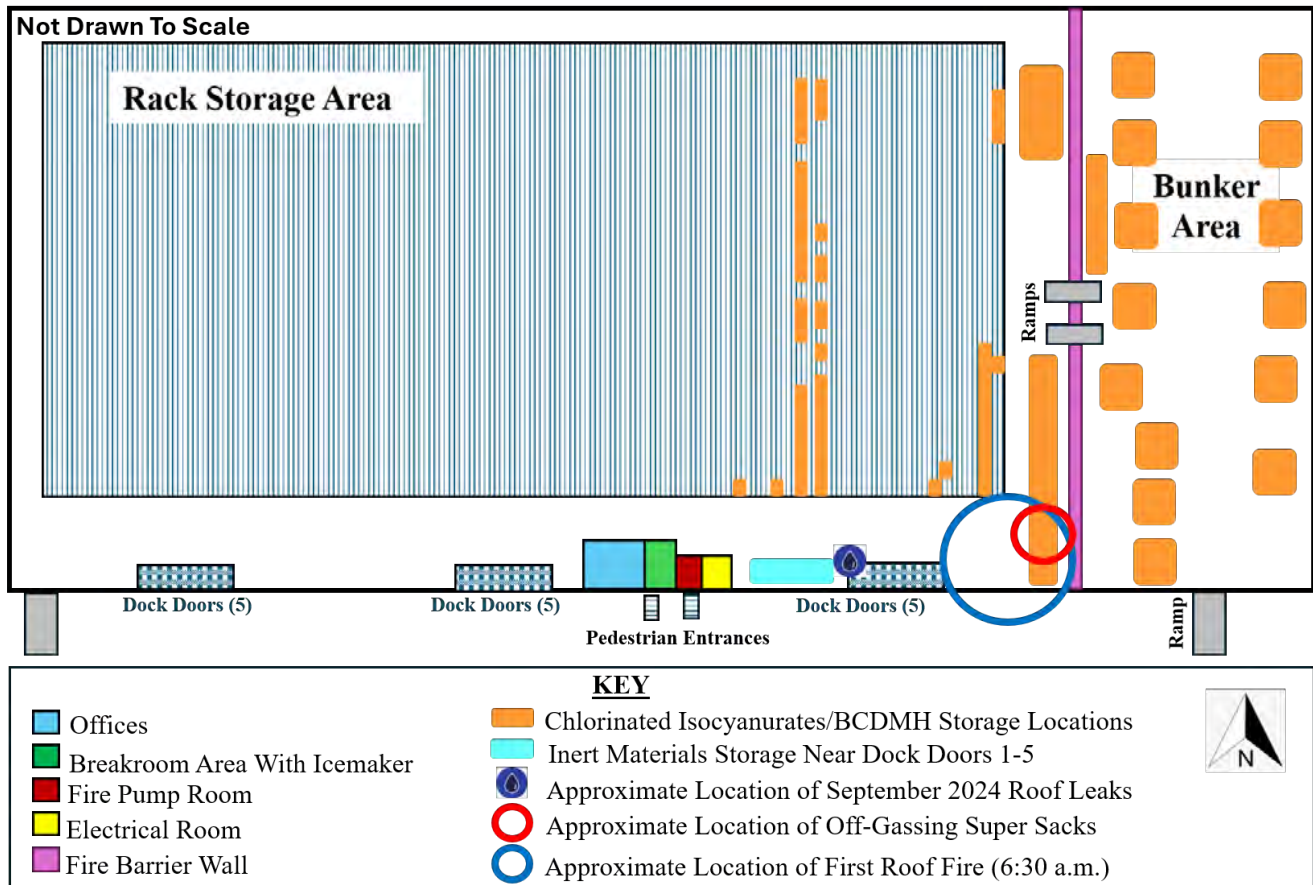
**Figure 31.** Location of roof leaks discovered in the Plant 12 Storage Warehouse on September 15, 26, and 27, 2024. (Credit: CSB)

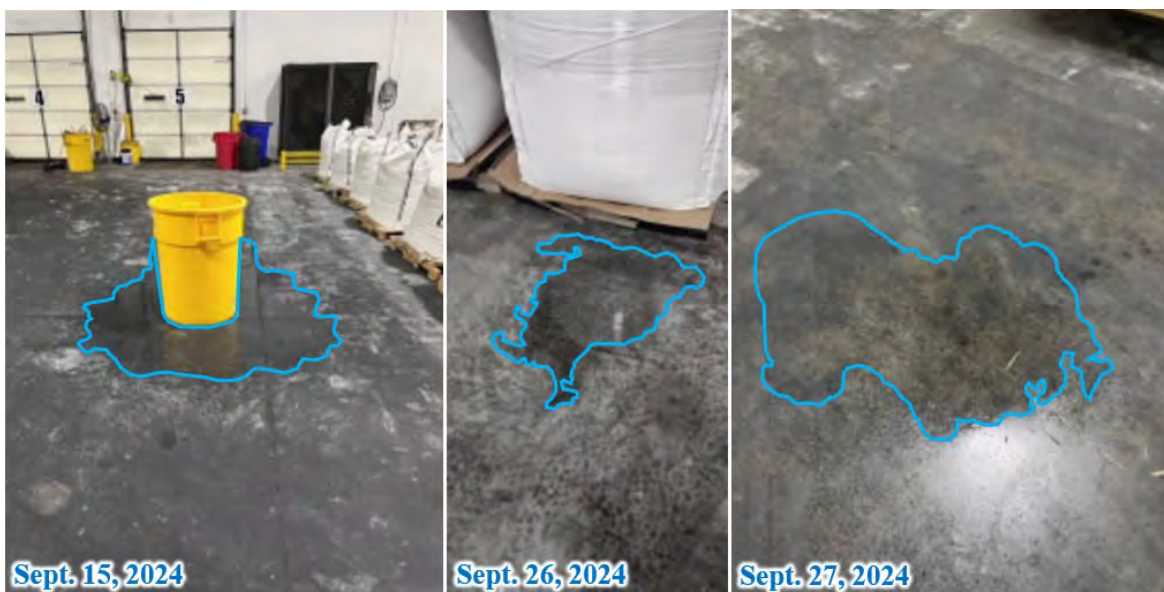
**Figure 32.** Roof leaks discovered in the Plant 12 Storage Warehouse on September 15, 26, and 27, 2024, with each puddle extent outlined in blue. (Credit: KIK, annotated by CSB)

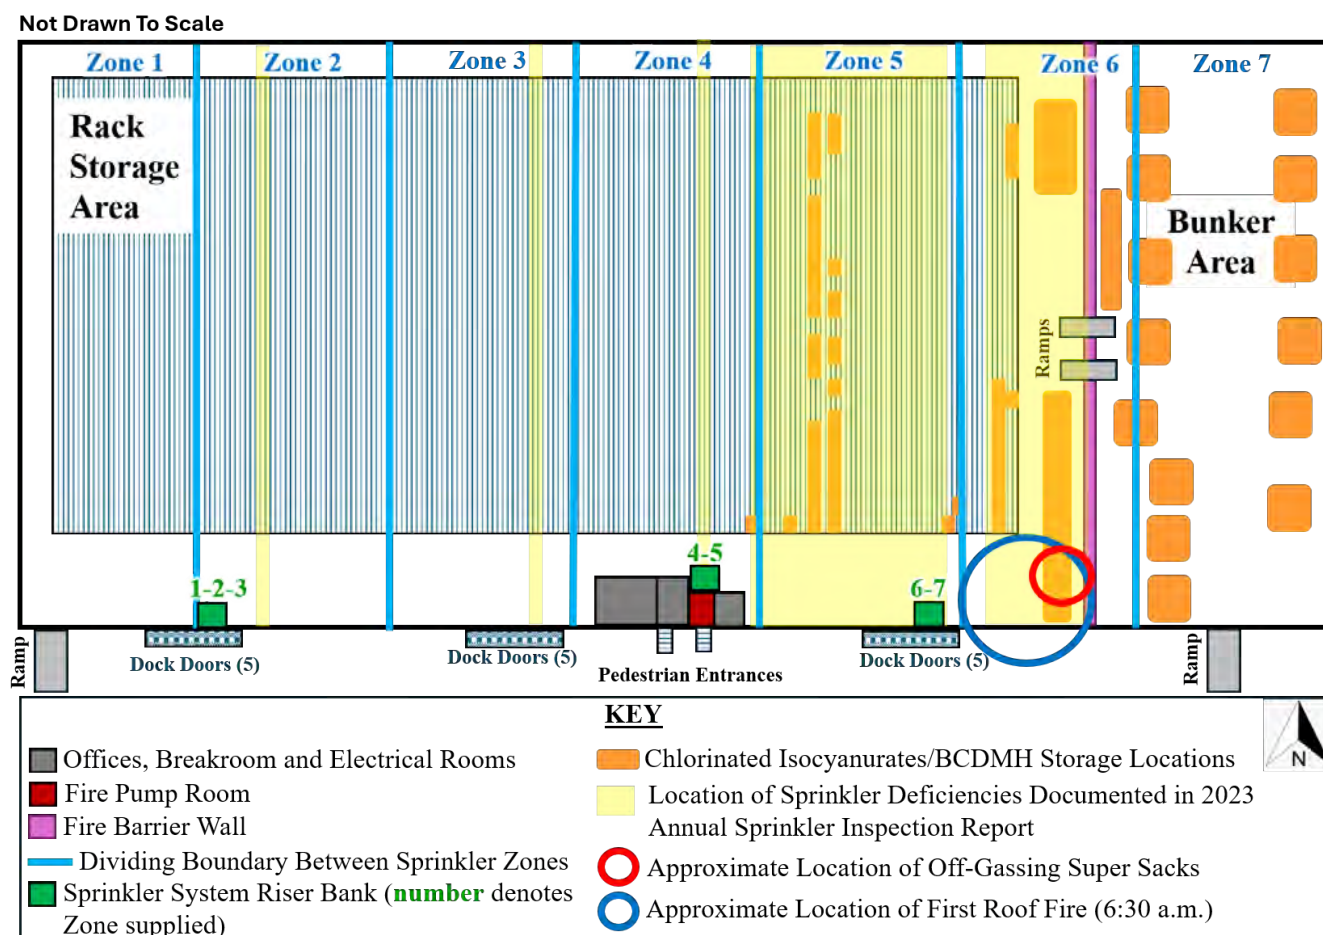
Figure 37. Fire protection zone locations and illustration of 2023 sprinkler deficiencies. (Credit: CSB)

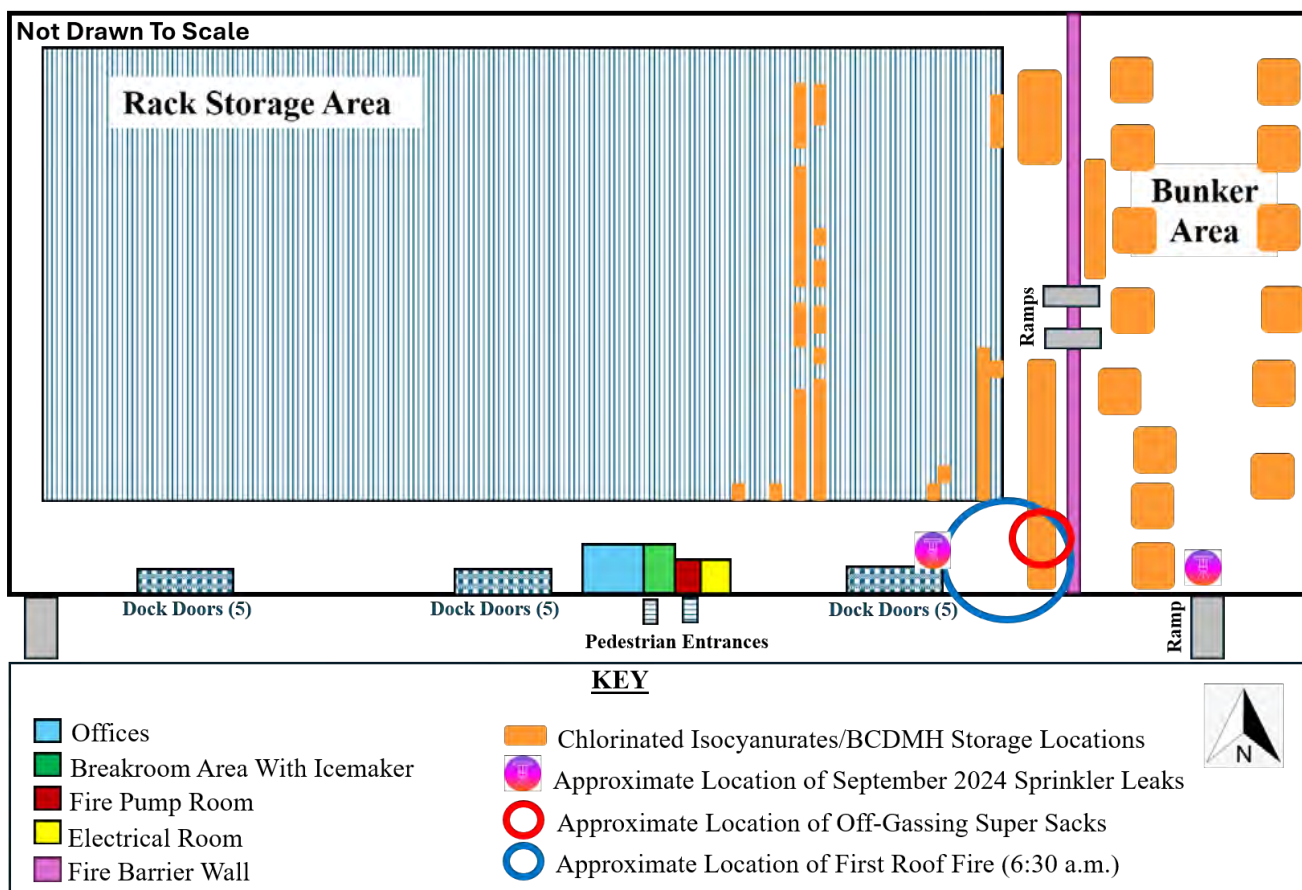
**Figure 39.** Location of sprinkler system leaks in the warehouse on September 17 and 19, 2024. (Credit: CSB)
