## Investigation Report

Published: June 12, 2019

On January 22, 2018, a blowout and rig fire occurred at Pryor Trust 0718 gas well number 1H-9, located in Pittsburg County, Oklahoma. The fire killed five workers, who were inside the driller's cabin on the rig floor. They died from thermal burn injuries and smoke and soot inhalation. The blowout occurred about three-and-a-half hours after removing drill pipe ("tripping") out of the well.

# Gas Well Blowout and Fire at Pryor Trust Well 1H-9

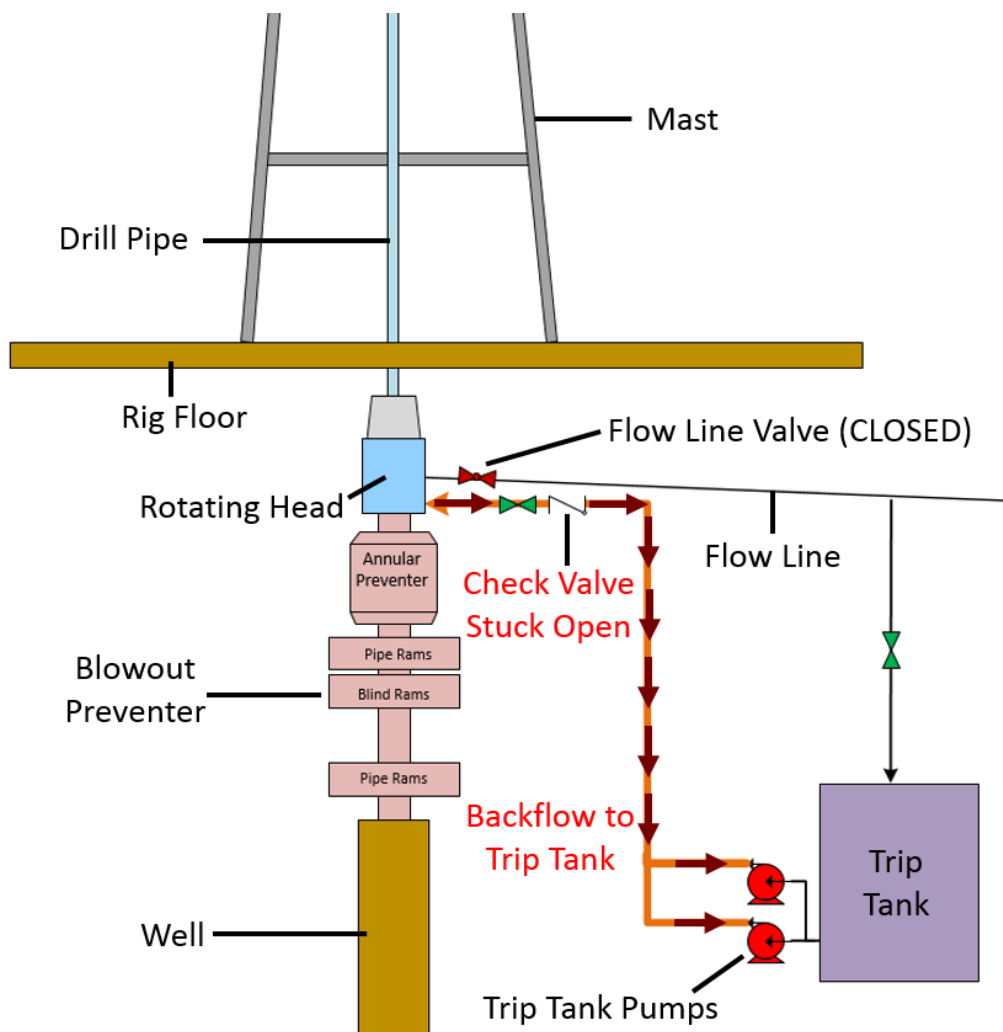
Figure 14. Pressurized mud backflowed through trip tank discharge piping, stuck-open check valve, and centrifugal pumps into trip tank.

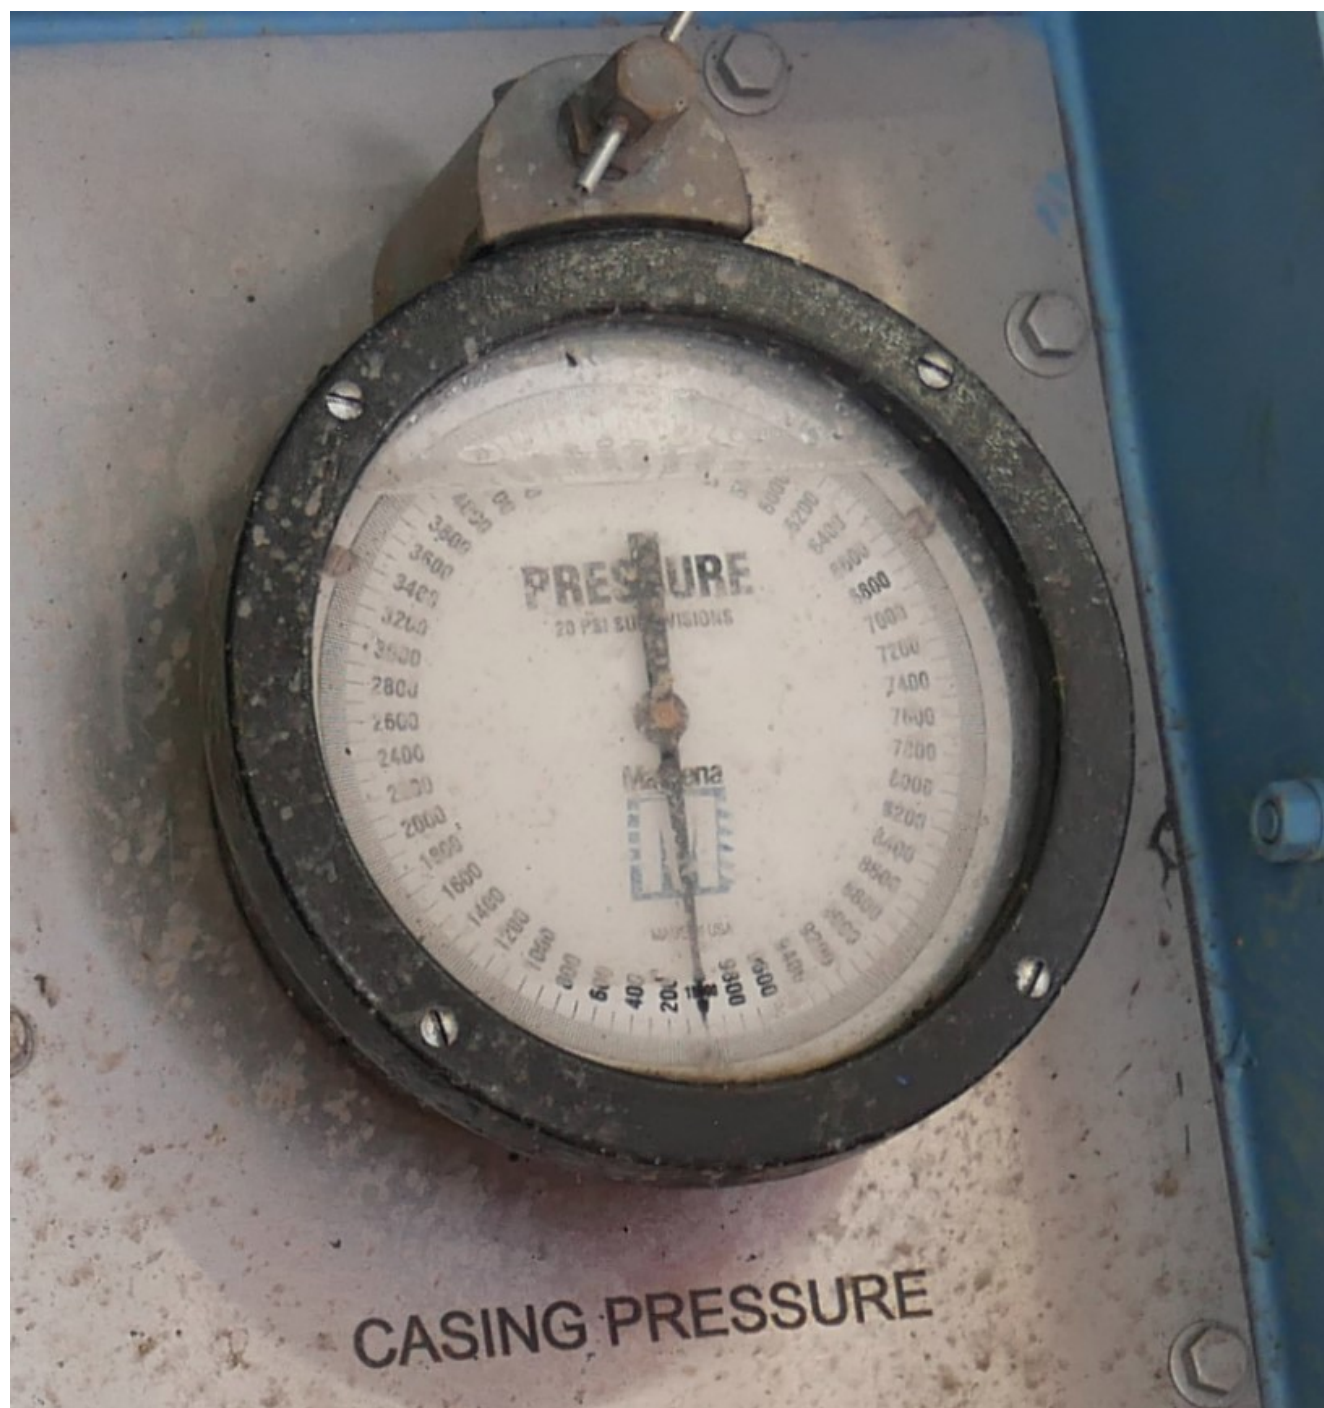
Figure 16. Photo of casing pressure gauge on an exemplar Patterson drilling rig. The pressure gauge could indicate pressures up to 10,000 psi. Low pressures might have been difficult to read on the Rig 219 pressure gauge, or the pressure gauge might not have worked properly at low pressures. The valve on the choke system (“HCR valve”) that needed to be opened to measure annular pressure might have been closed during pressure readings, or the line might have been plugged.

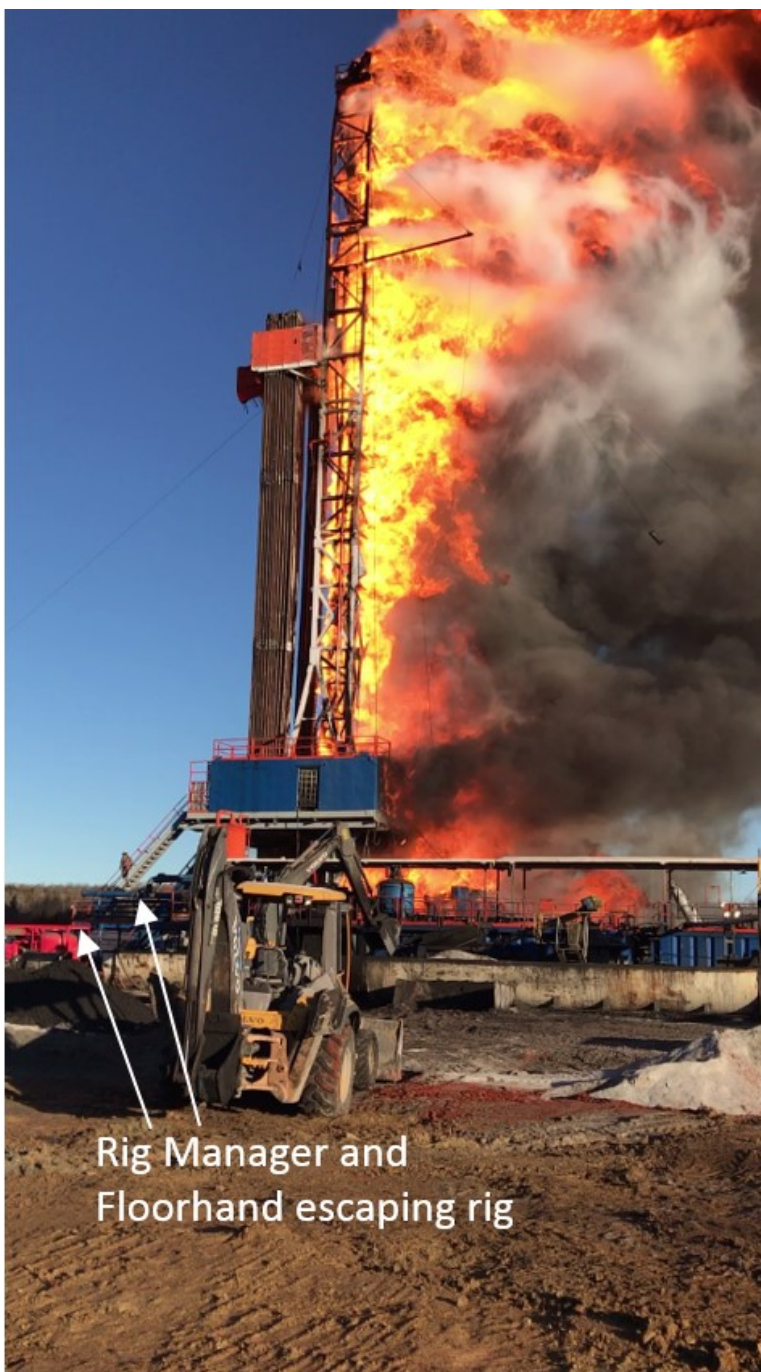
*Figure 43. Still from video captured at 8:36 am, shortly after blowout started. The rig manager and floorhand can be seen escaping the rig. At this point, the fire has engulfed the driller's cabin (far side of photo).*

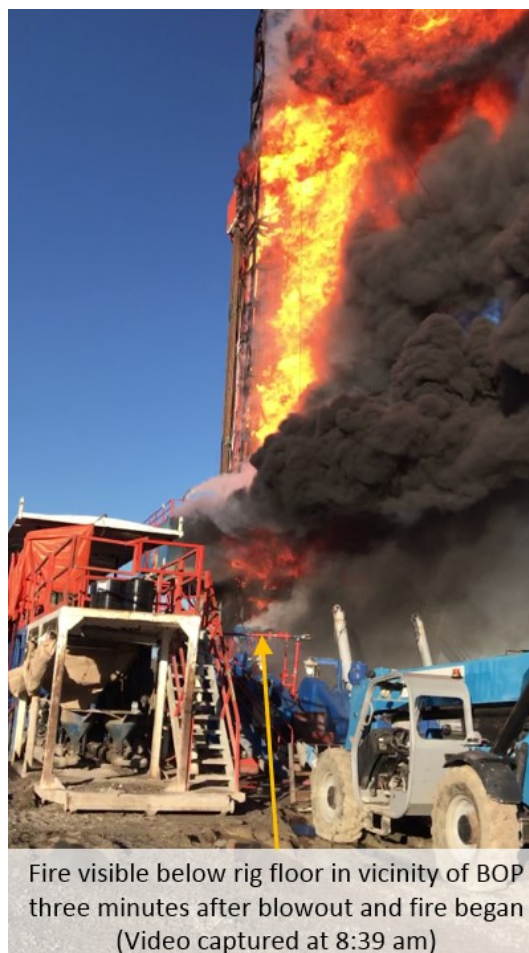
Figure 51. Video still of Patterson Rig 219 fire, taken 3 minutes after blowout began.
