# CASE STUDY

## Heat exchanger rupture and ammonia release in Houston, Texas (One Killed, Six Injured)

2008-06-I-TX  
January 2011

Houston, TX

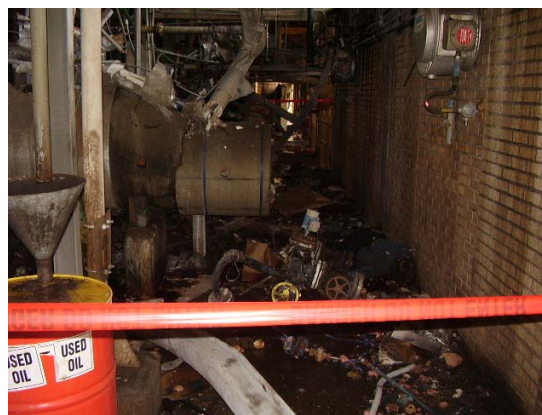
Figure 1. Area of fatality

Several hours later, after plant operations had resumed, a supervisor assessing damage in the immediate incident area discovered the body of a Goodyear employee located under debris in a dimly lit area (Figure 1).

At about 1:20 p.m., an operations supervisor assessing the damage to the incident area discovered the victim buried in rubble in a dimly lit area and contacted City of Houston medical responders.

*Companies should conduct worker headcount drills that implement their emergency response plans on a facility-wide basis. Company procedures must account for breakdowns in automated worker tracking systems to ensure that all workers inside a facility can be quickly accounted for in an emergency. Drills that simulate such malfunctions should be conducted to verify that all lines of responsibility and alternate verification techniques will account for workers in a real situation.*
