Improving Public and Worker Safety at Oil Refineries

Draft Report of the Interagency Working Group on Refinery Safety Governor Jerry Brown

July 2013

CHEVRON RICHMOND REFINERY FIRE

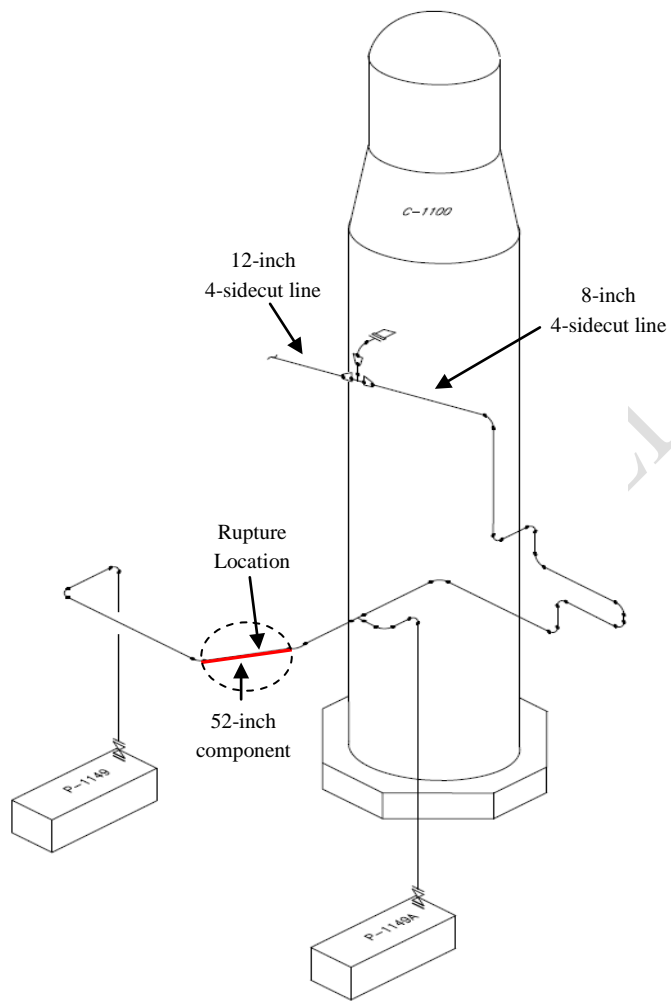
Figure 6. 4-sidecut line configuration and rupture location

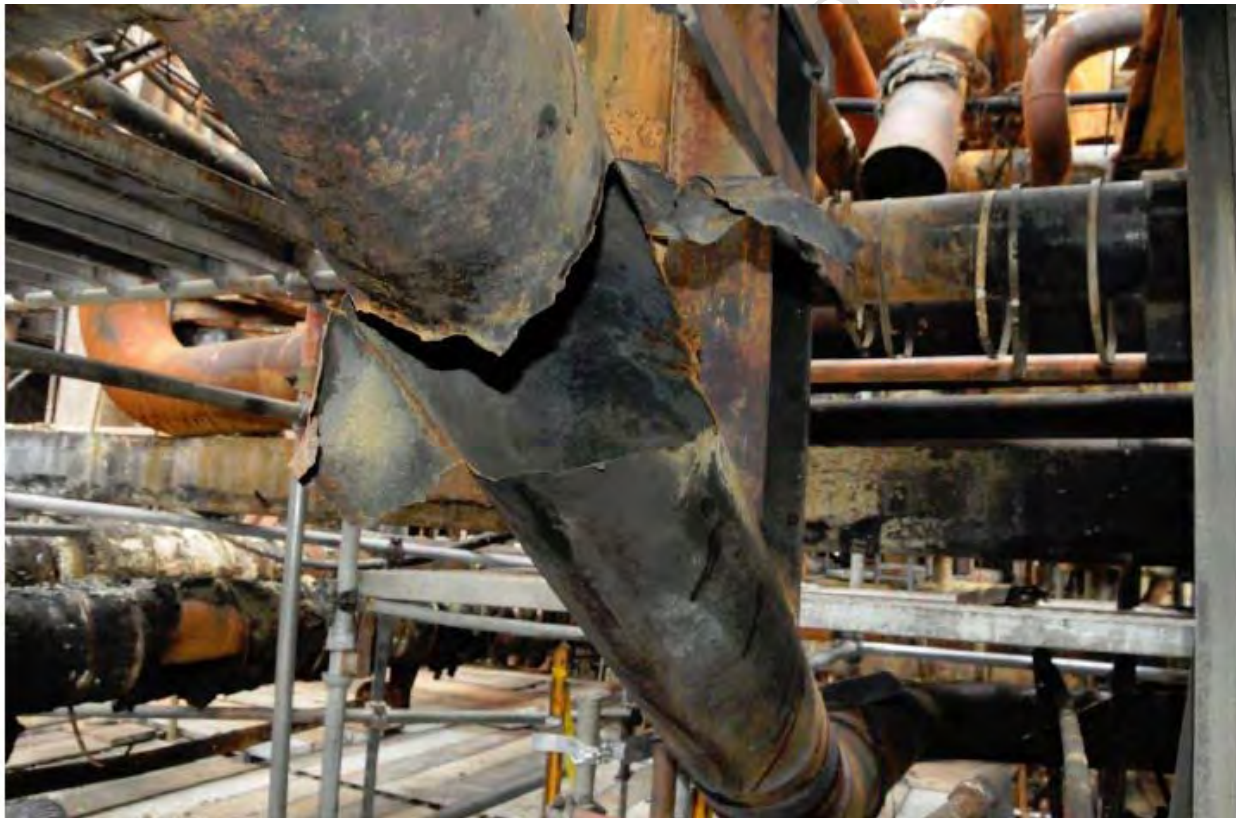
4. The CSB commissioned Anamet, Inc., a materials engineering and laboratory testing company, to conduct testing of the 4-sidecut pipe, including the failed 52-inch component. The testing concluded that the rupture was due to pipe wall thinning caused by sulfidation corrosion,³ which is discussed below.
5. Anamet's metallurgical analysis found that the 52-inch component where the rupture occurred had experienced extreme thinning; the average wall thickness near the rupture location was approximately 40 percent thinner than a dimeⁱ (the thinnest American coin). Between 1976 and 2012, the 52-inch piping component had lost, on average, 90 percent of its original wall thickness in the area near the rupture. The piping had an initial nominal wall thickness of 0.322-inchⁱⁱ when it was installed in 1976.

Figure 7. Photo of rupture on 4-sidecut 52-inch component

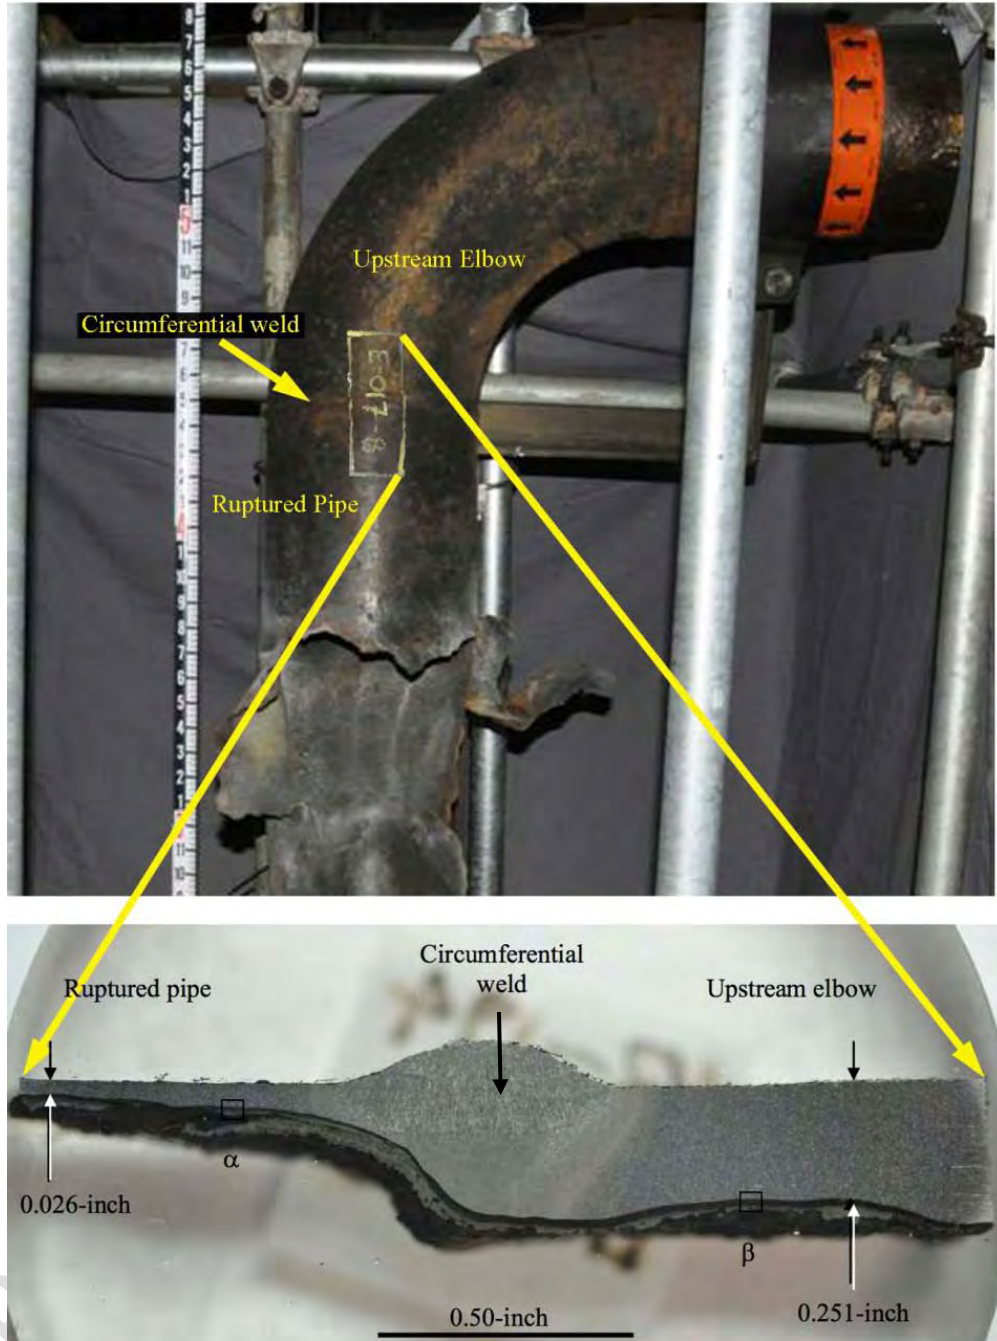
Figure 9. 4-sidecut piping sample (E-017-8) analyzed by Anamet Labs showing the relative thickness of low silicon piping on the left and the high silicon piping on the right. The ruptured pipe component (left) contained 0.01 % silicon and the upstream elbow component (right) contained 0.16 % silicon.¹⁹ The initial nominal thickness of this piping was 0.322-inch.

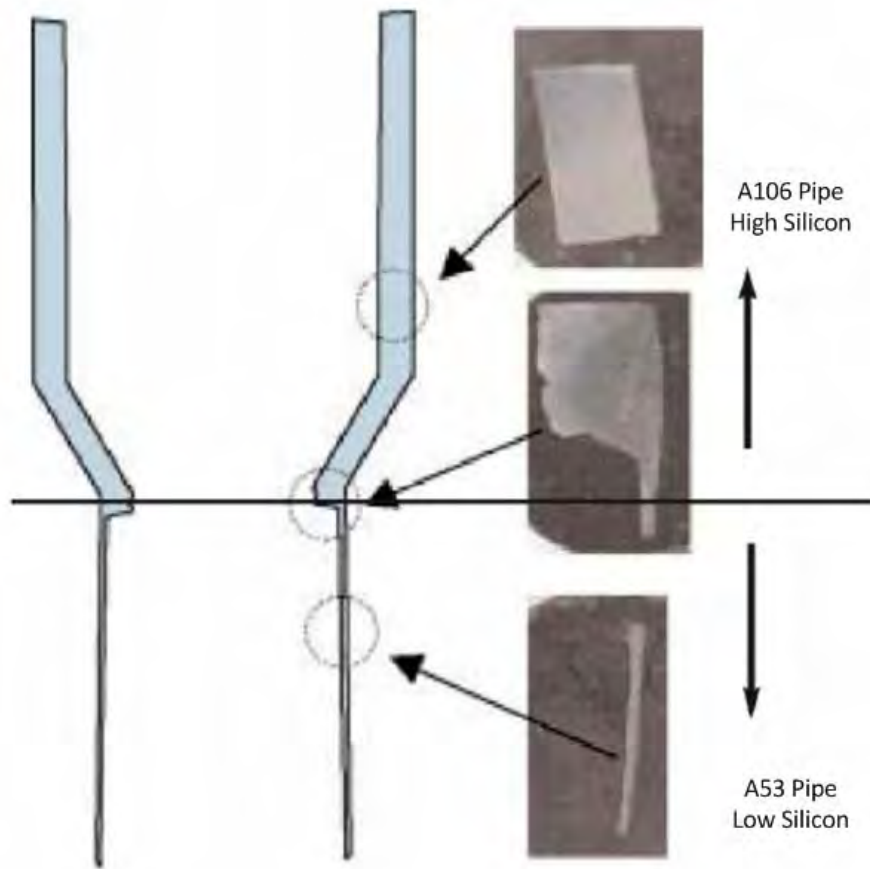
Figure 12. Schematic of failed piping from the Chevron Salt Lake Refinery. Similar to the Chevron Richmond Refinery incident, the failed piping contained low amounts of silicon and corroded significantly faster than adjacent piping components.

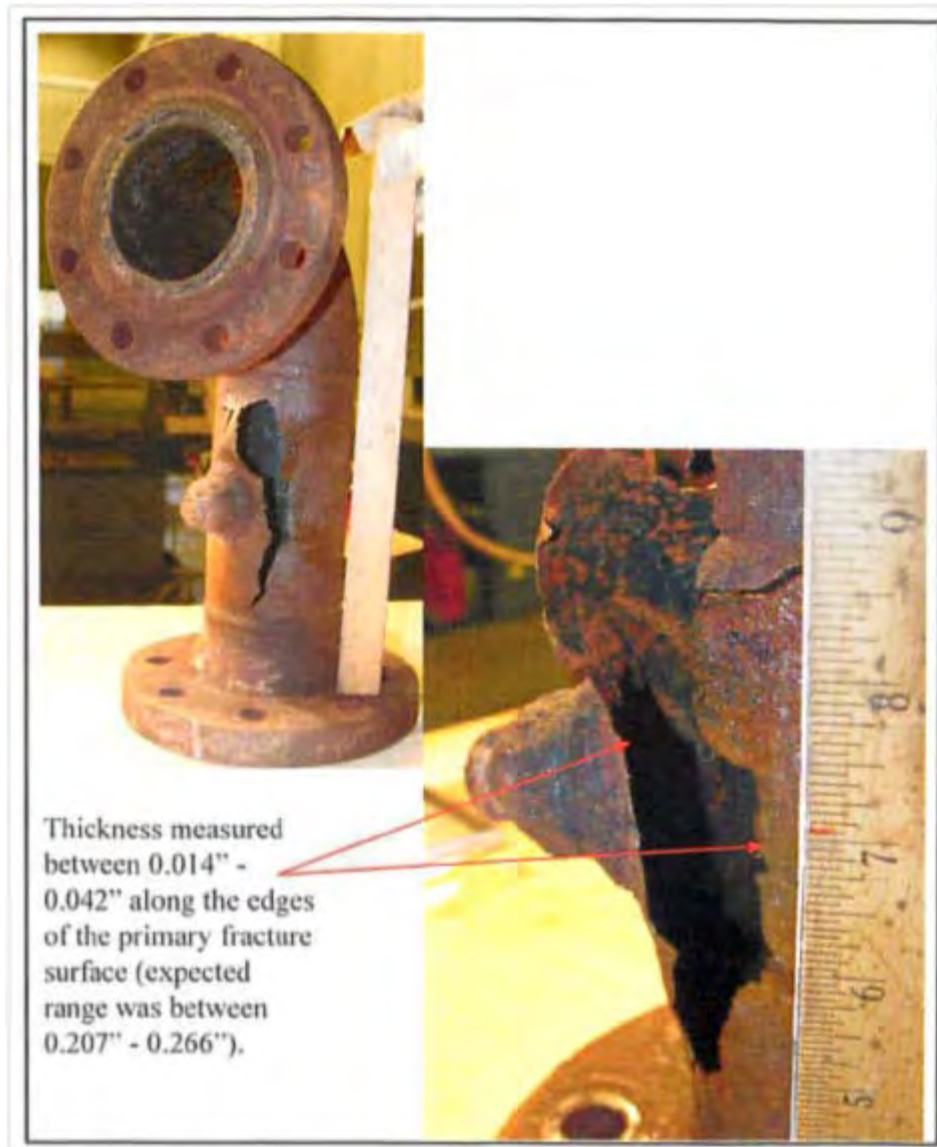
28. In January 2007, a failure due to sulfidation corrosion caused a serious fire in the Chevron Richmond Refinery crude unit resulting in a CWS Level 3 alert, initiating a shelter-in-place for the surrounding community. A carbon steel piping spoolⁱ failed catastrophically during operation (Figure 13). The carbon steel piping contained a low percentage of silicon (<0.005 wt. %). The process fluid ignited, injuring a nearby worker. Chevron informed Contra Costa County in a letter that the metallurgy had been upgraded following this incident as an inherently safer solution. However, the CSB learned that this upgrade was limited to only the immediate piping spool that failed. The inherently safer, more corrosion resistant metallurgy was not implemented more broadly in crude unit high temperature service as a result of this incident.

Figure 13. Failed piping component that resulted in the 2007 Richmond crude unit fire. This carbon steel piping was found to contain less than 0.005 percent silicon.

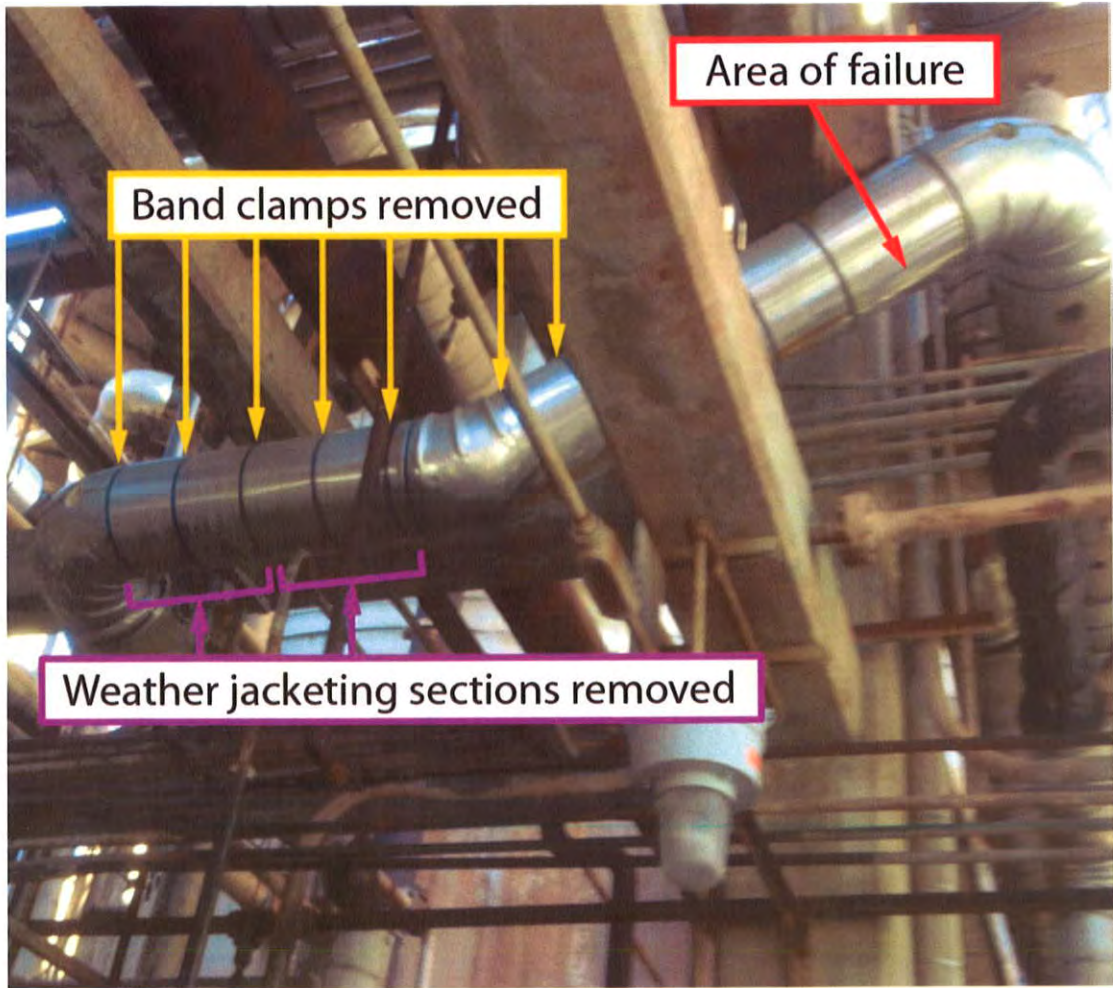
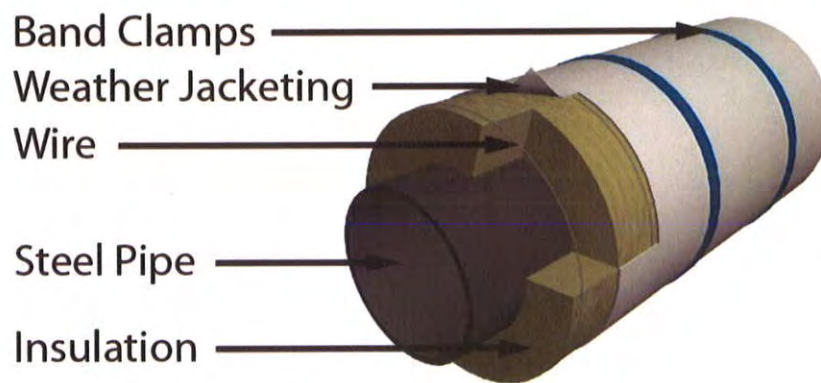
Figure 5. The steel pipe was encapsulated by insulation held in place by wire, which was covered by aluminum weather jacketing held in place with band clamps (bottom). The firefighters cut several band clamps (marked with yellow arrows) with pliers and removed two sections of the weather jacketing from the piping (marked with purple brackets).

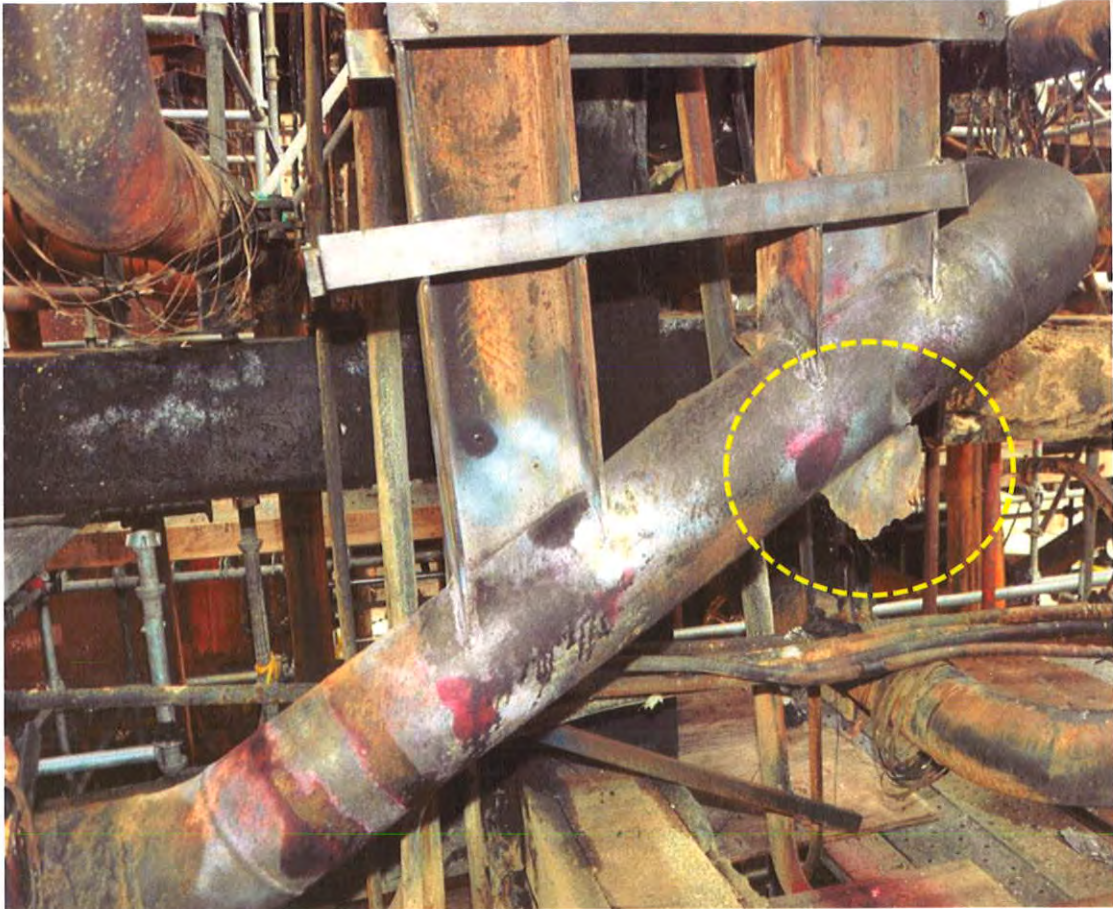
The ruptured pipe is shown in Figure 7 and Figure 8.

Figure 7. Photograph of the ruptured pipe component during inspection prior to removal. Area of the rupture is circled in yellow. (This photograph shows the same sloped portion of the pipe component shown in Figure 5.)

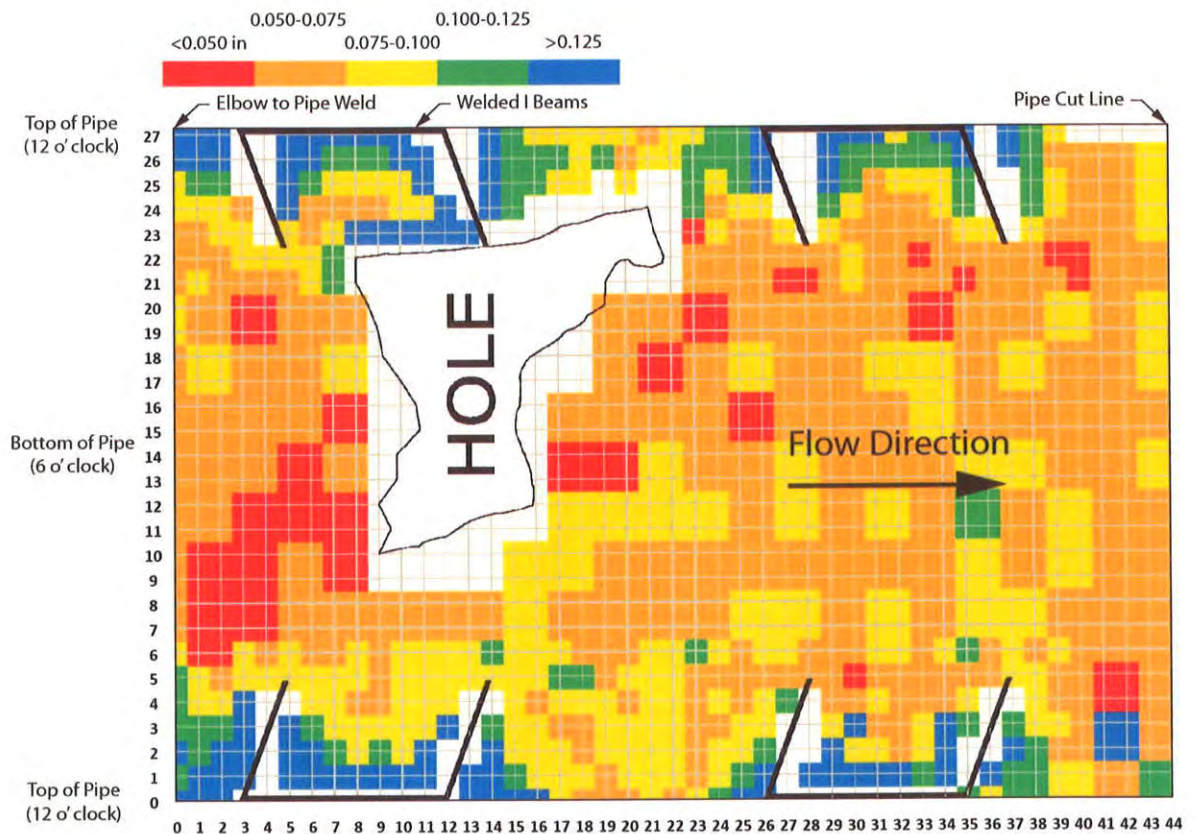
Figure 9. Thickness measurement results from the ruptured pipe component. Virtually the entire 27-inch circumference and 44-inch length of the ruptured pipe component had thinned to less than 0.10 inches, consistent with sulfidation corrosion. The graphic represents the pipe as sliced longitudinally at the top of the pipe (12 o'clock) and rolled out flat. The areas in white could not be measured.

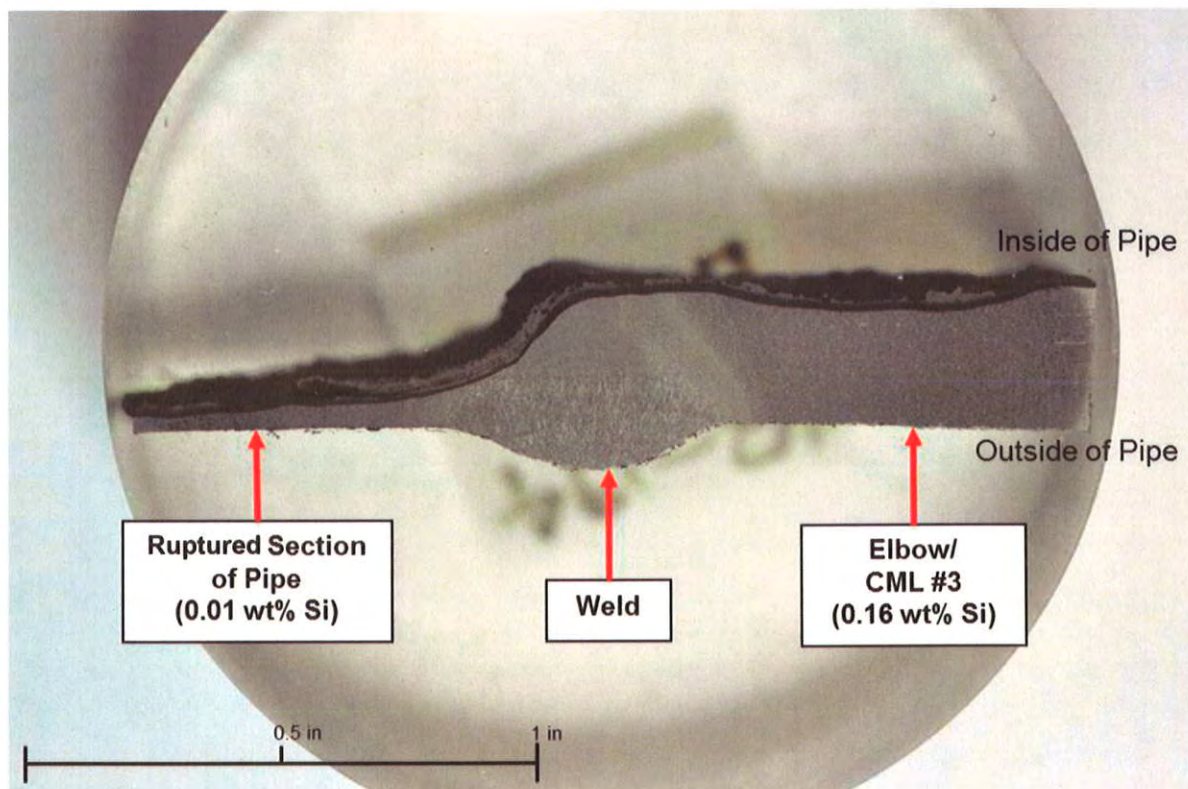
Figure 11 shows a cross section of the ruptured pipe, the adjacent elbow, and the weld between the two. Figure 12 shows the location where the sectioned sample was removed from the ruptured pipe. The ruptured component is clearly thinner than the adjacent elbow. The results of the chemical analysis indicate that the ruptured pipe component had a silicon content of approximately 0.01 wt% and the adjacent elbow had a silicon content of 0.16 wt%. As noted earlier, carbon steel with less than 0.10 wt% silicon content can exhibit higher sulfidation corrosion rates than carbon steel with higher levels of silicon. The impact of these differing corrosion rates is discussed in Section 4.

Figure 11. Cross section through the weld of the subject pipe showing thicknesses of the ruptured section (left) and the adjacent elbow, where CML #3 is located.
