## **FINAL INVESTIGATION REPORT**

### **CARIBBEAN PETROLEUM TANK TERMINAL EXPLOSION AND MULTIPLE TANK FIRES**

#### **CARIBBEAN PETROLEUM CORPORATION (CAPECO)**

REPORT NO. 2010.02.I.PR

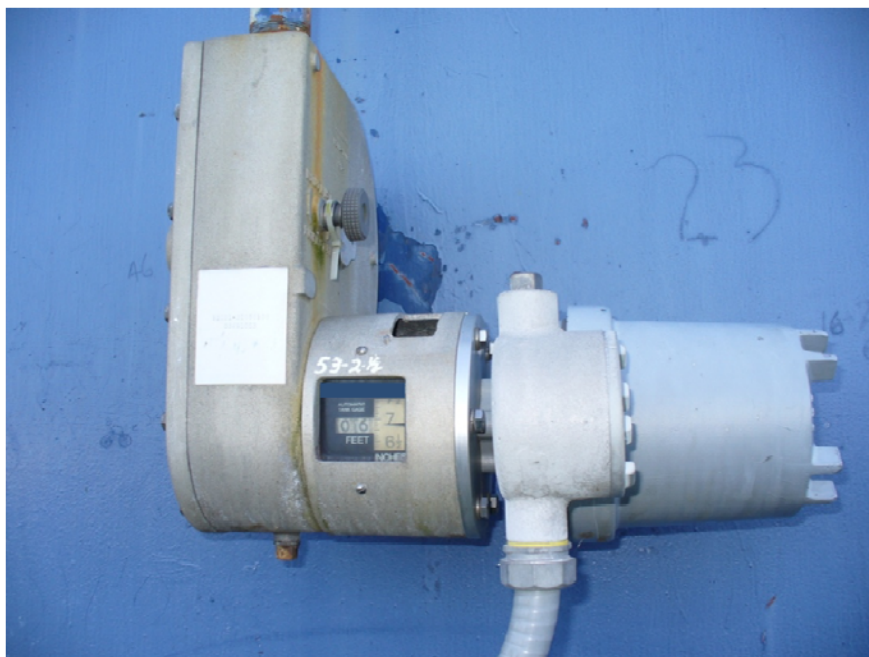
Figure 4: Side gauge: mounted on the side on a tank and displaying the amount of liquid in the tank

At the 11 p.m. walk-around, the tank farm operator observed the gauge on Tank 409 during his hourly check. The operator called the level into the supervisor who calculated once again that the tank should be full at 1 a.m.; however, between the 11 p.m. and 12 a.m. check, Tank 409 began to overflow. At the 12 a.m. check, operations staff noticed a fog on the ground and on the road along Tanks 504, 411 and 409. Fuel gushed from the vents, creating a spray of gasoline that formed a vapor cloud and pooled in the secondary containment dike.

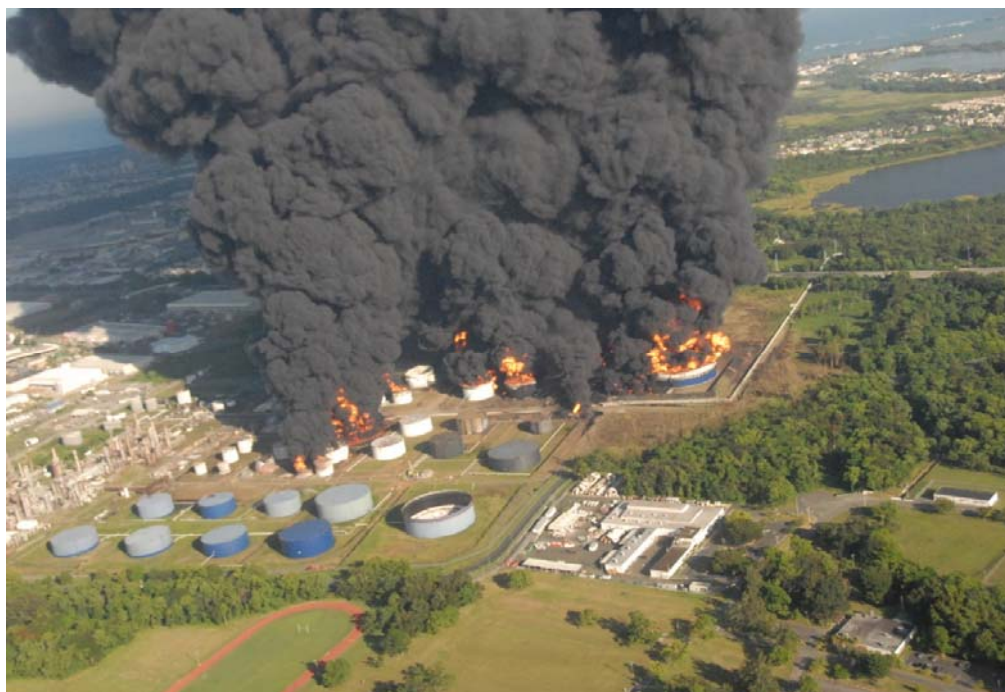
After the explosion, fuel in the damaged tanks burned for over two days while emergency responders fought to control the fire and prevent other tanks from igniting. The large fire demanded emergency personnel and resources from across the Commonwealth of Puerto Rico and the US mainland. Local fire departments with assistance from an industrial firefighting company took 66 hours to extinguish the fire after the explosion. As a result, 17 of the 48 tanks burned. (See Figures 5 and 6.)

Figure 5: CAPECO multiple tank farm fire, October 23, 2009.

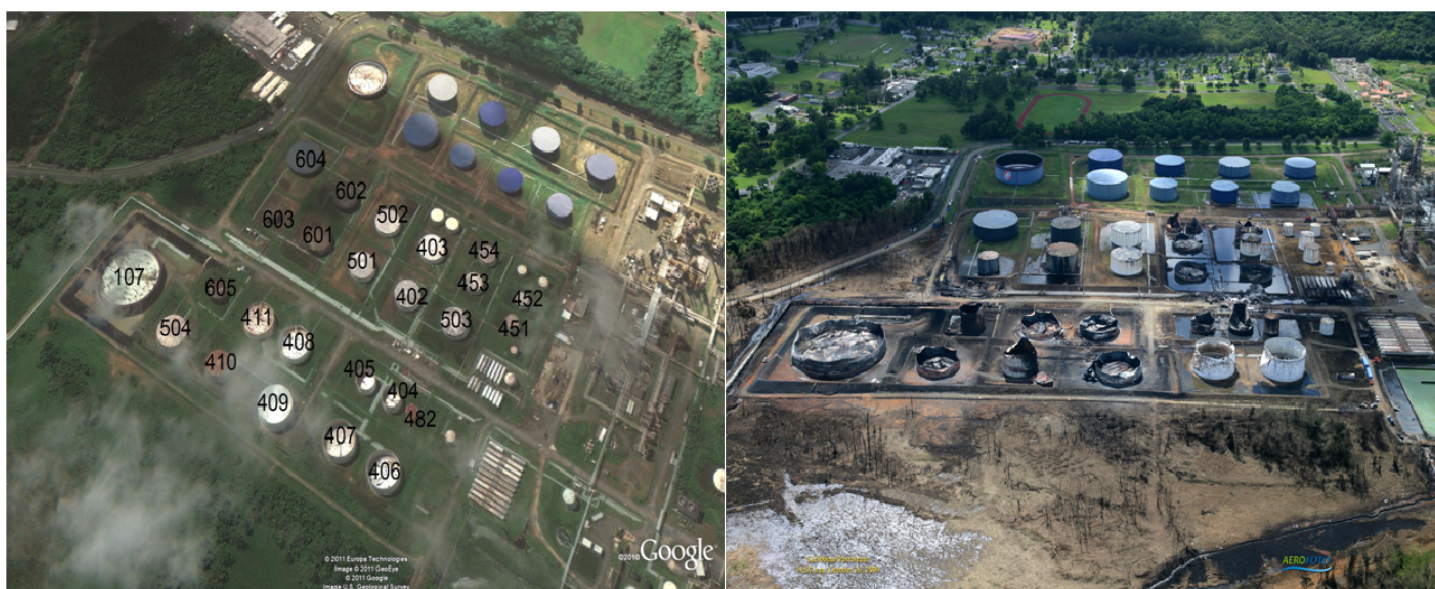
Figure 6: Impact of the explosion and multiple tank fires after the October 23, 2009 incident

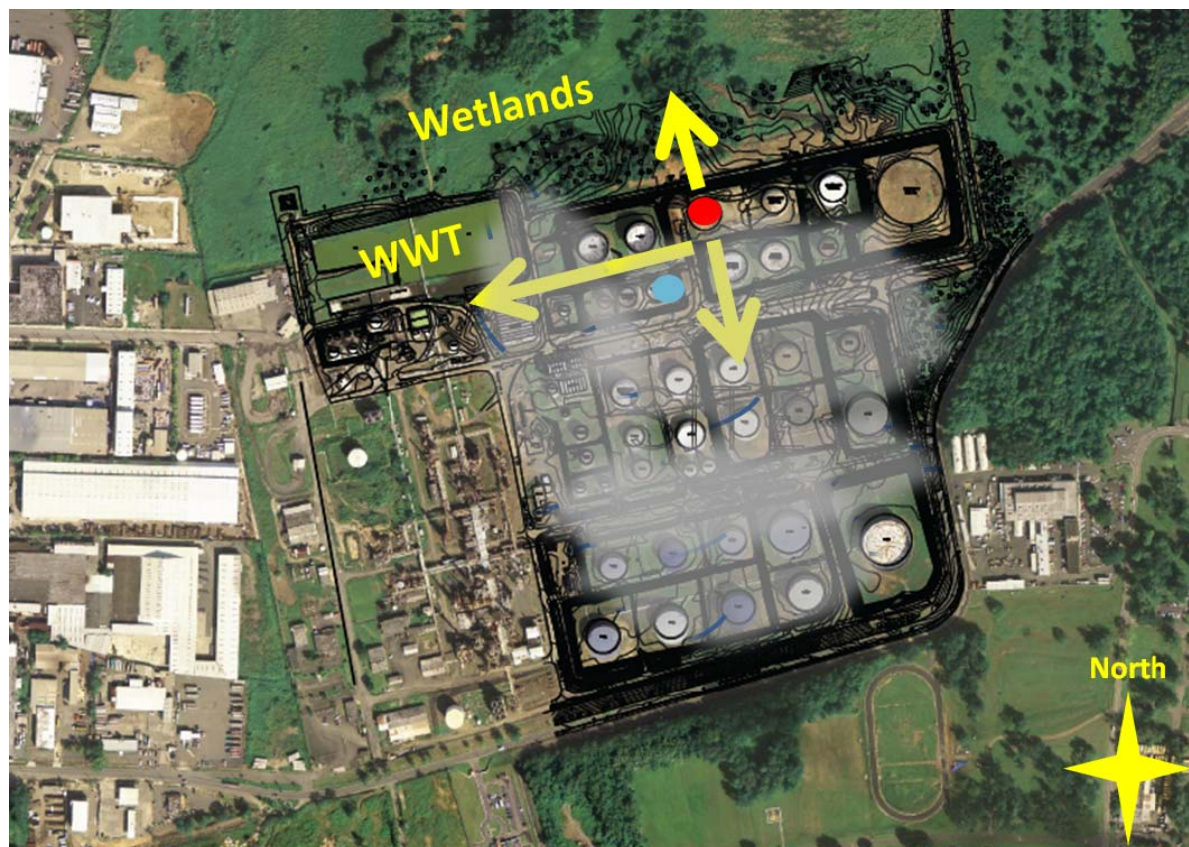
Figure 7. Topographic Survey of CAPECO Tank Farm showing the gasoline vapor cloud migration from higher elevation (Tank 409-Red and Tank 411-Blue) toward low-lying areas by the WWT plant, the south eastern end of the refinery and wetlands to the north. The cloud indicates the approximate area where the vapor cloud migrated based on surveillance footage.

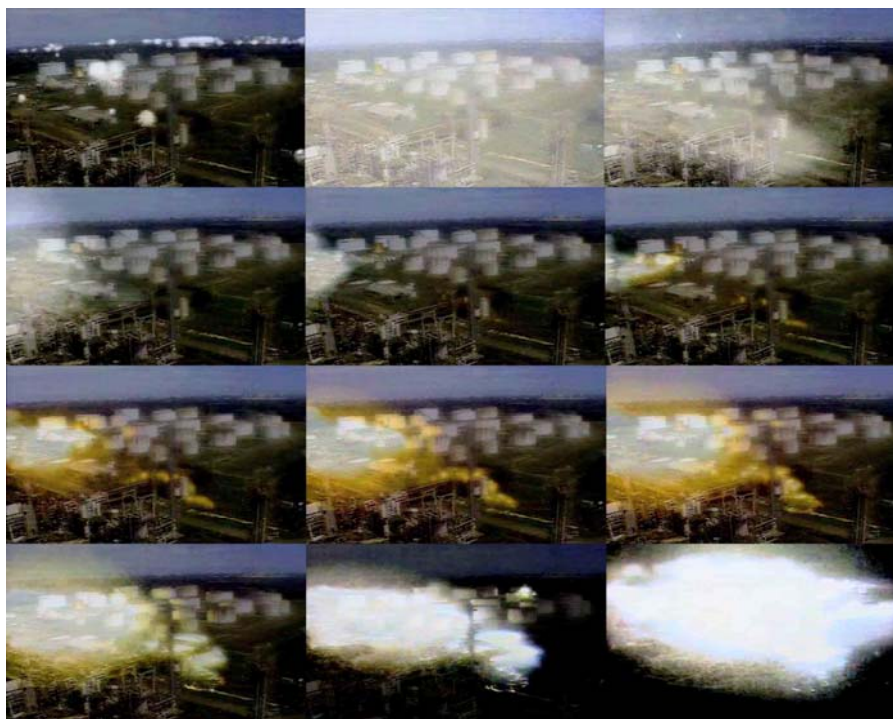
At 12:23 a.m., on October 23, 2009, security cameras at CAPECO and neighboring facilities recorded the ignition of the vapor cloud in the WWT area. About seven seconds after ignition, the vapor cloud exploded, creating a pressure wave that damaged hundreds of homes and businesses up to 1.25 miles from the site. The fire propagated through the vapor cloud and ignited multiple subsequent tank explosions registering 2.9 on the Richter scale.<sup>19</sup>

Figure 8: CAPECO surveillance footage of flame propagation during October 23, 2009 CAPECO explosion

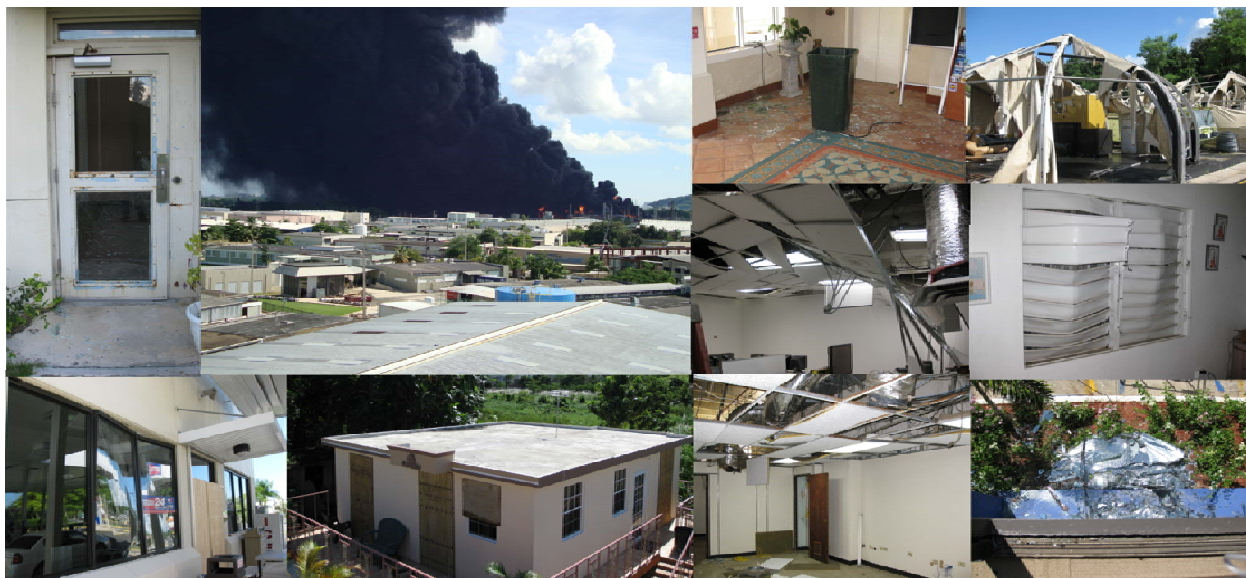
Fort Buchanan experienced the most severe damage—suffering an estimated \$5 million in repair costs. Community impact assessments<sup>38</sup> found most of the structural damage occurred in the Puente Blanco neighborhood where PREMA and the Department of Housing (DOH) found damage to 232 of the 266 homes assessed; 139 were repaired and 6 were demolished by November 2009.<sup>39</sup> The Puente Blanco community also experienced environmental contamination to several surface water bodies, including federally protected wetlands and streams surrounding the CAPECO site. After assessing 289 homes damaged by the explosion in the Cataño community, the Small Business Administration (SBA)<sup>40</sup> designated 25 single-family homes as destroyed or severely damaged at or beyond 40% of their fair market value. (See Figure 10.)

Figure 10: Community damage surrounding the CAPECO facility

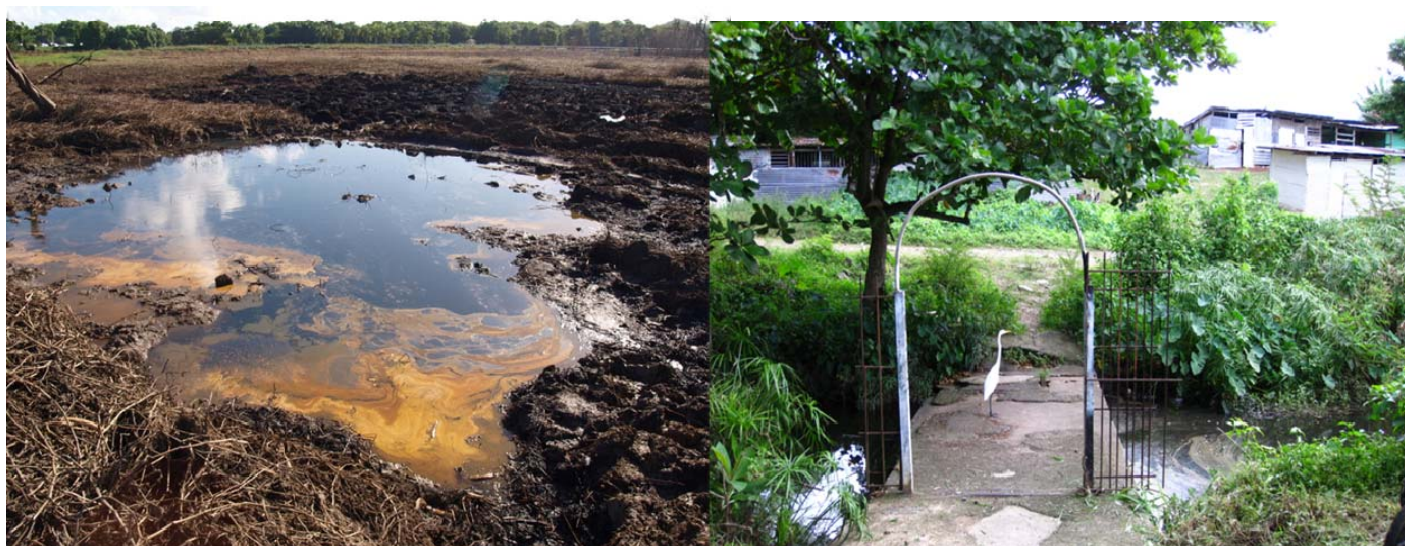
Figure 11: Oil Spill into nearby wetlands (photo from NOAA.gov) and in a local community drain after CAPECO explosion and tank fires

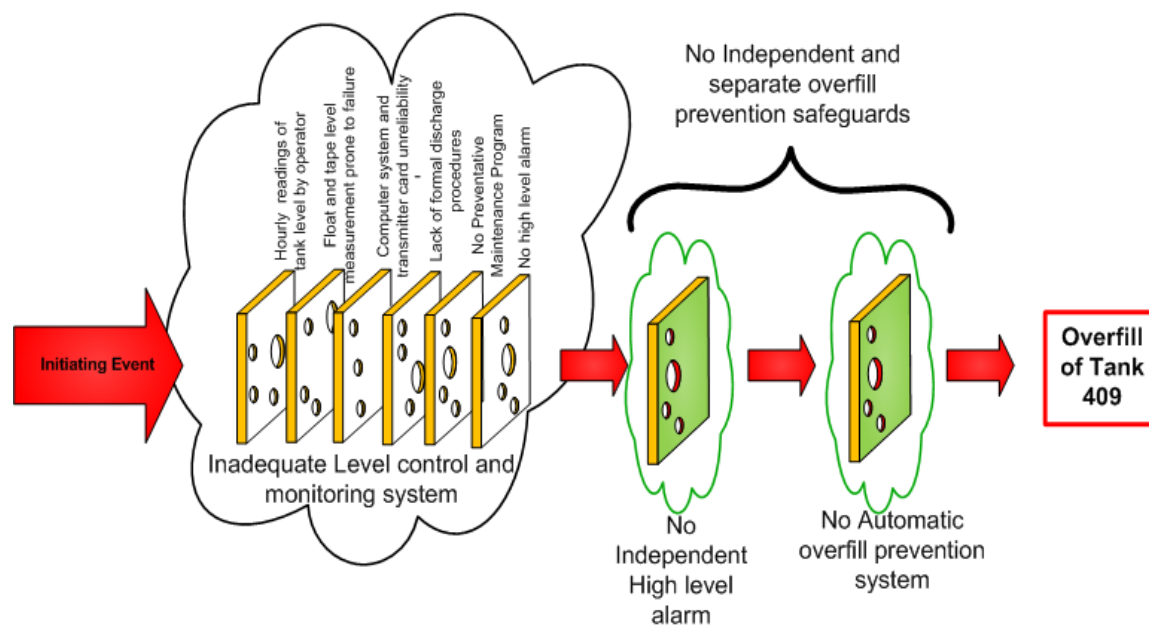
The CSB determined that numerous technical and systemic failures contributed to the explosion and multiple tank fires at the CAPECO tank terminal. The CSB found that multiple layers of protection failed within the level control and monitoring system at the same time in addition to a lack of independent safeguards. James Reason's Swiss Cheese Model best demonstrates these systemic failures that led to the accident.<sup>49</sup> Reason postulates that an accident results from the breakdown of the "interaction between latent failures<sup>50</sup> and a variety of local triggering events

Figure 12: Contributing to the October 2009 overfill incident at CAPECO were multiple failures of the level control and monitoring system in addition to a lack of safeguards like a high level alarm, an independent level alarm and an automatic overfill prevention system that allows for automatic shutdown or diversion.

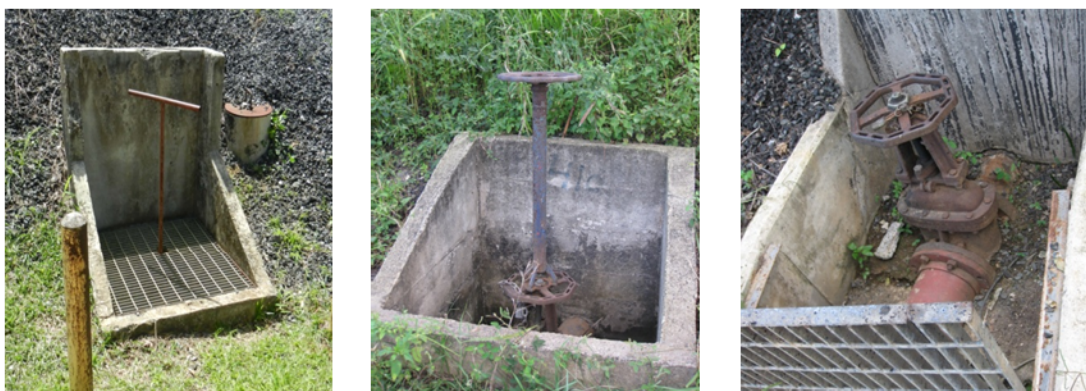
CAPECO's normal practices required operators to open and close valves during the day shifts. Operators customarily inspected whether the dike drain valves were open or closed from their vehicles as they drove by. The tank farm used both rising stem and fixed stem valves on the dike drains leading to the storm water retention pond in the WWT area. Rising stem valves allowed operators to easily observe the open or closed position while fixed stem valves do not provide a visual indication of the position. The fixed stem valve on the dike drain for Tank 409 made it difficult for tank farm operators to observe its position without physically turning it. (See Figure 15.) In some cases, the valve position could not be determined with a visual inspection because the rising stem valve position was hidden in the sump. (See Figure 15, center photo.) Furthermore, none of the dike valves shown in Figure 15 were consistent with RAGAGEP. Regulatory coverage under the EPA Risk Management Plan (RMP) or OSHA's Process Safety Management (PSM) Standard requires that CAPECO use the best available engineering practices to assess valve open/close status.

Figure 15: Various dike drain valves at CAPECO. Tank 409 dike drain valve (left): position of the valve is undeterminable without physically turning the valve. Rising stem valves (center, right). In some cases, the valve position is hidden in the sump (center).
