DuPont La Porte, Texas Chemical Facility Toxic Chemical Release

Interim Recommendations

Investigation: 2015-01-I-TX
Incident Date: November 15, 2014
Issue Date: September 30, 2015

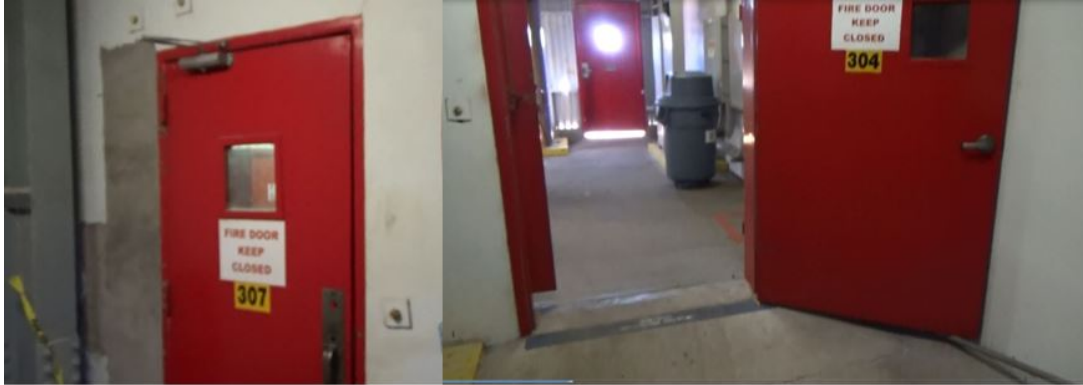
Figure 3. Doors within the manufacturing building on the 3rd floor that separate the east (wet end) and west (dry end) sides. Although intended by design to remain closed, these doors were propped open at times, as shown in the photograph of door 304 on the right.

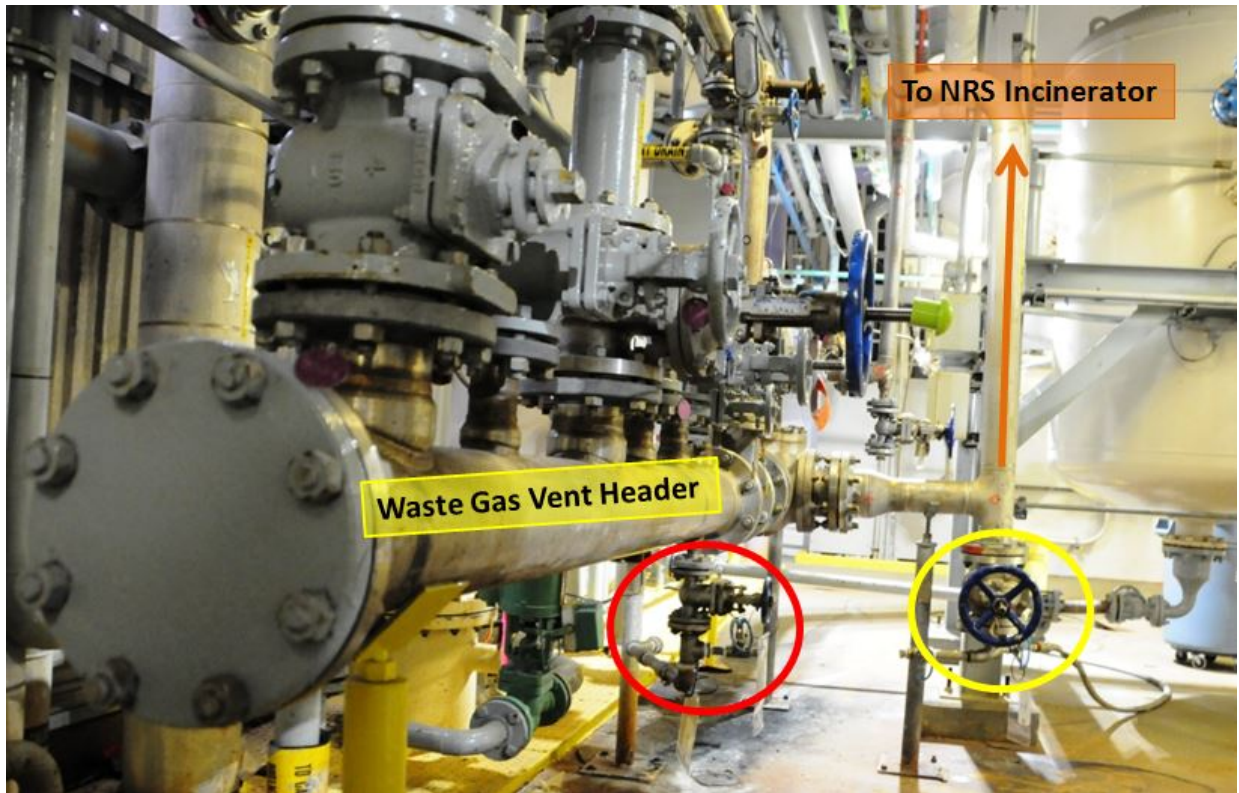
Figure 10. Waste gas vent header piping on the third floor of the manufacturing building. This portion, where several waste gas sources come together, is referred to as the waste gas vent header. Waste gas from this portion of the vent header travels up to reach the NRS Incinerator, a piping configuration that creates a low spot where liquid accumulates. To remove the liquid during waste gas vent header piping high pressure events, operators were instructed to open valves (yellow circle) and drain the system through a hose routed to a floor drain located near a safety shower. The floor drain is connected an open trench-type sump on the first floor. At the time of the incident, a second set of drain valves (red circle) were also opened directly to the floor inside the manufacturing building. This photo was taken while facing south. See Figure 11 for a view of the equipment while facing north.

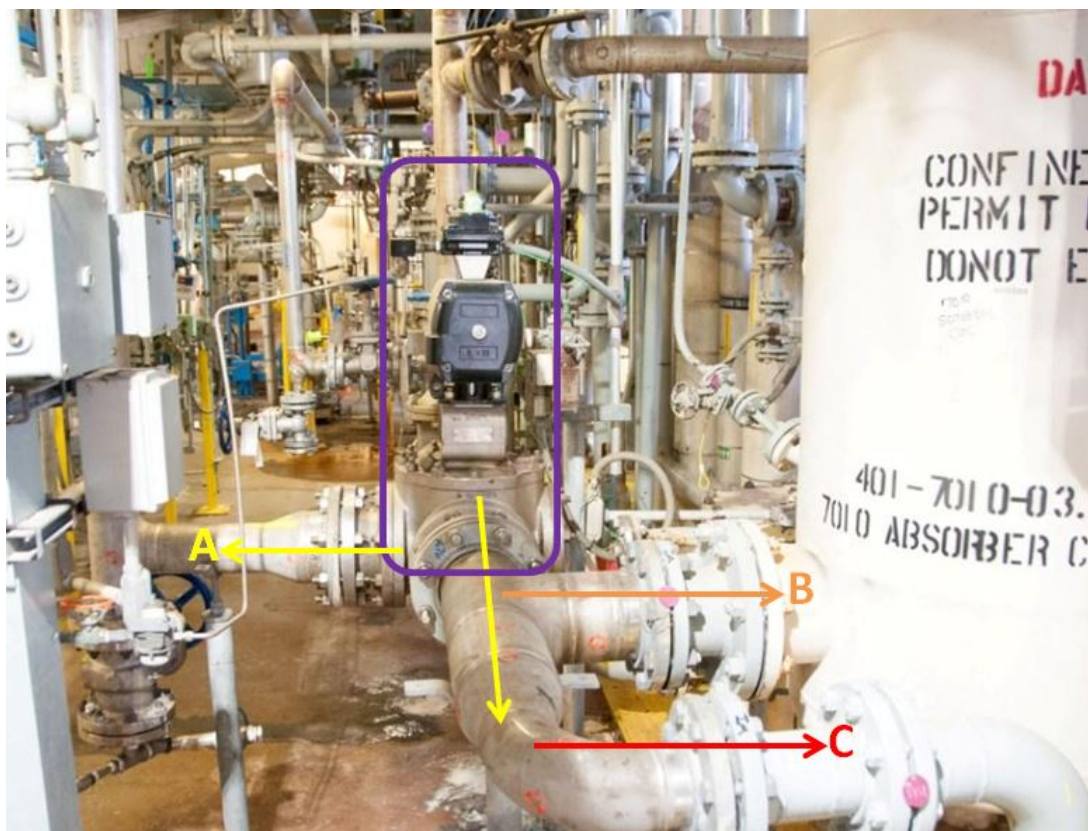
Figure 11. Waste gas vent header piping on the 3rd floor of the manufacturing building. This photograph was taken while facing north. Figure 10 shows the same waste gas vent header piping but taken while facing south. A 3-way valve (purple) is controlled to send the waste gas to either the NRS incinerator labeled “A” (yellow) or a caustic scrubber labeled “B” (orange). The caustic scrubber is designed with a vapor equalization line labeled “C” (red) that connects to the vapor space of the caustic receiver on the floor below (2nd floor). Prior to the installation of the NRS Incinerator, the 3-way valve did not exist and liquid that might accumulate in the waste gas vent header piping could freely drain into the caustic scrubber system.

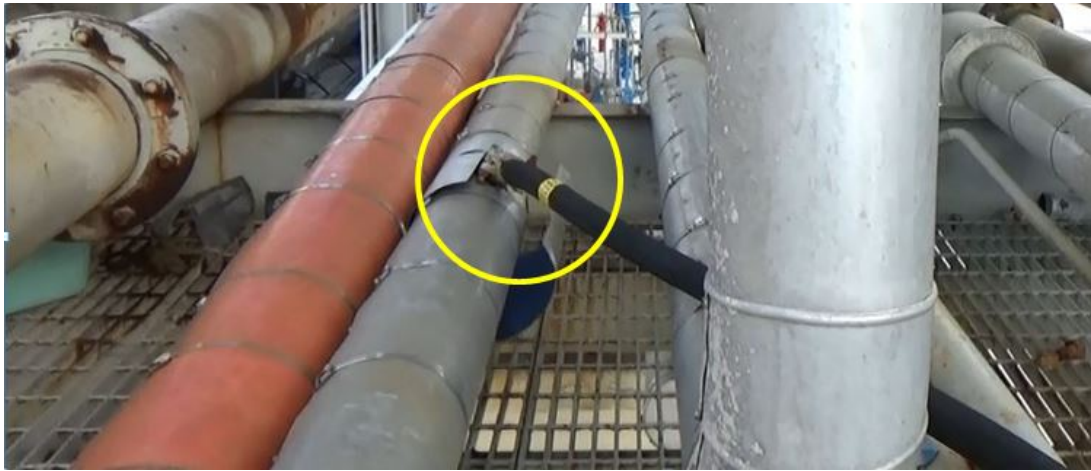
requested that operators put hot water on the outside of the methyl mercaptan feed piping, under the insulation, to warm the piping and its contents to dissociate the hydrate back to liquid methyl mercaptan and water (Figure 14).

Figure 14. Hot water hose positioned on the liquid methyl mercaptan feed piping to flow hot water between the piping and the insulation in an effort to heat the piping and dissociate the solid hydrate that formed after water inadvertently entered the mercaptan storage tank.

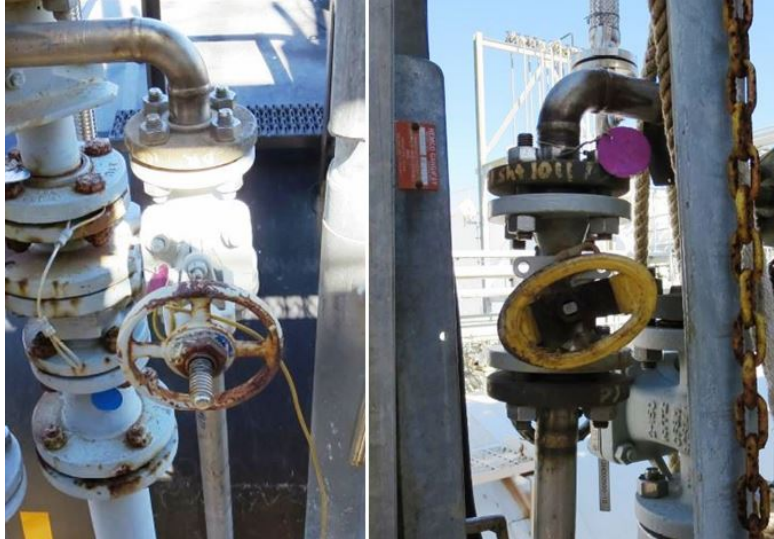
Figure 17. The fully open valve (left photo) and the cracked open valve (right photo) between the methyl mercaptan feed line and the waste gas vent header. These post-incident photos show the valve positions at the time of the incident.

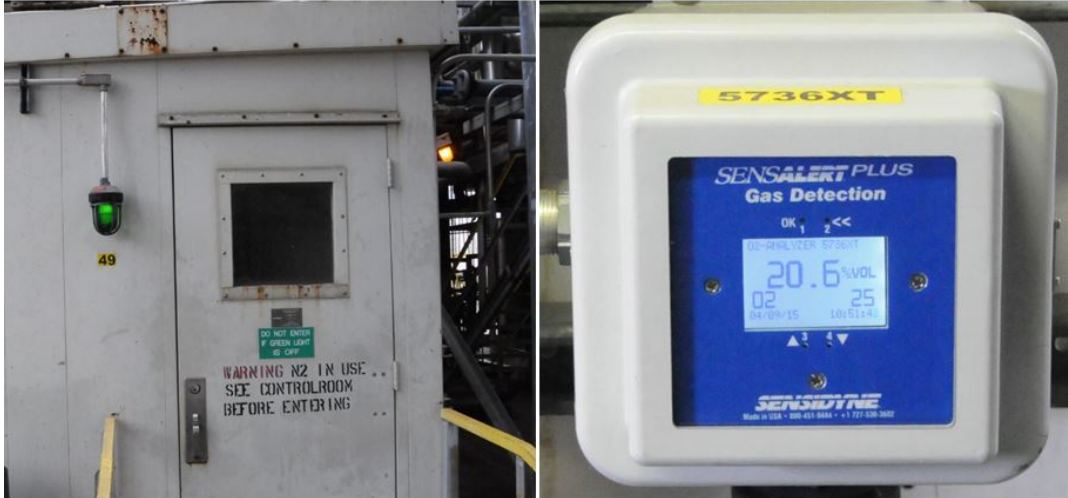
13. The (IBU) process analyzer houses²¹ are infrequently entered, but they are equipped with more robust asphyxiation safeguards (oxygen detectors and alarms) than the normally occupied manufacturing building. However, the manufacturing building—which lacks the same level of asphyxiation safeguards—has significantly larger inventories of hazardous chemicals, has unventilated areas, and is regularly occupied by workers.

Figure 23. Unlike the manufacturing building this DuPont analyzer house shown in the left photo is equipped with safeguards to ensure entrant safety. The oxygen analyzer shown in the right photo is inside the analyzer house continuously monitoring the analyzer house atmosphere. If a nitrogen leak occurs inside the analyzer house sufficient enough to cause the atmosphere inside to approach dangerous levels, an alarm sounds and the green light outside the door turns off to indicate it is not safe to enter. The manufacturing building lacks similar safeguards. The CSB has not been able to determine why DuPont applied more rigorous safeguards to the infrequently entered analyzer house than for the normally occupied manufacturing building.

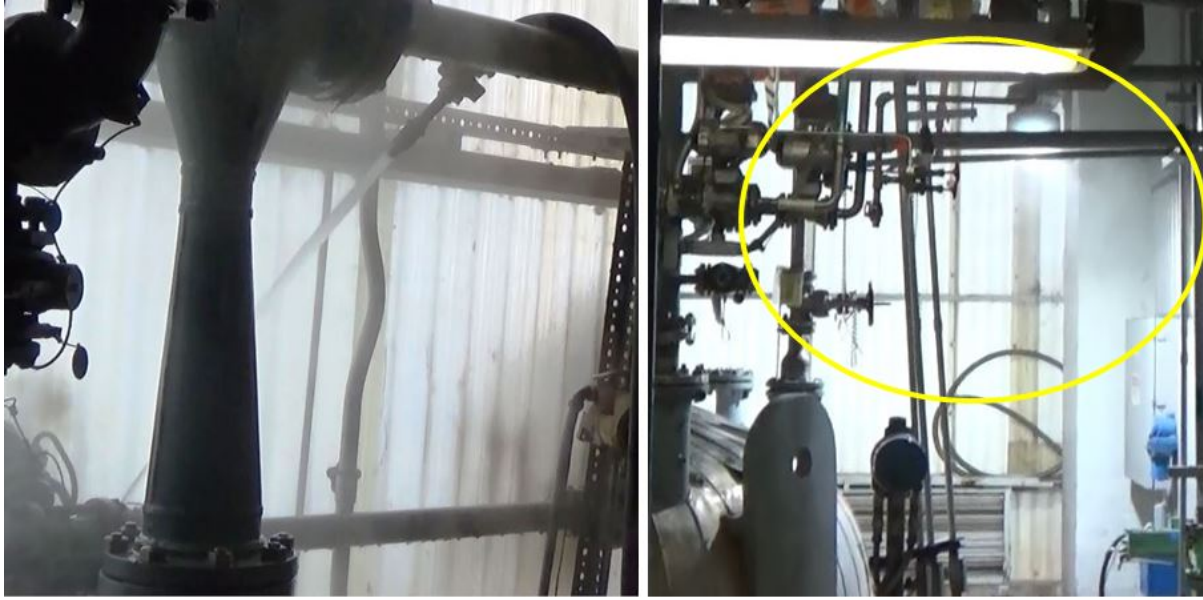
Figure 24. Ineffective ventilation on the second floor of the manufacturing building. These photos document an operational activity taking place on January 9, 2015. Operations had directed a hot water hose on a flow meter on the north east side of the second floor as seen in the photo on the left. The photo on the right shows the steam nearly motionless (yellow circle) on the south east side of the building also on the second floor. Although the wet end fan was running at the time, an open door (Figure 25) provided a less restrictive path for air to enter the building and thus very little dilution air ventilation was taking place to sweep potentially hazardous gases out of the south east corner of the room. Note – these photos are snippets from a video recording. The video recording does a much better job of demonstrating the poor ventilation within the yellow circle.

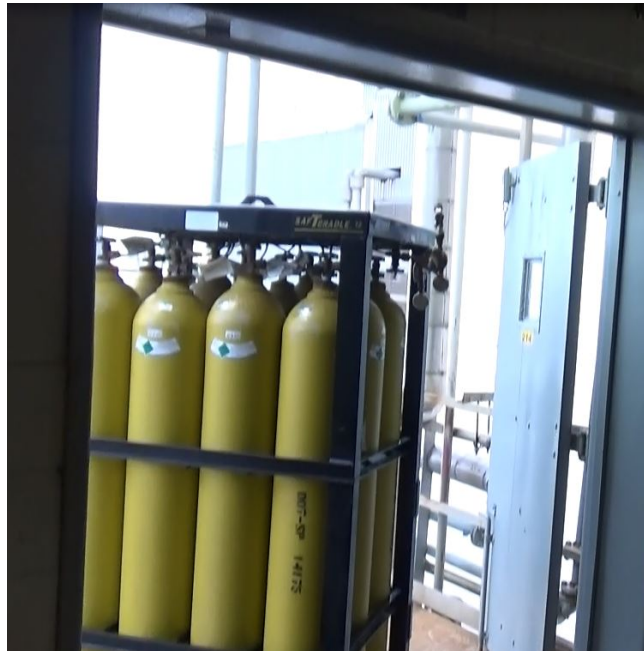
Figure 25. Photo of the open door on the south side of the second floor adversely impacting the dilution air ventilation flow across process equipment described in Figure 24.

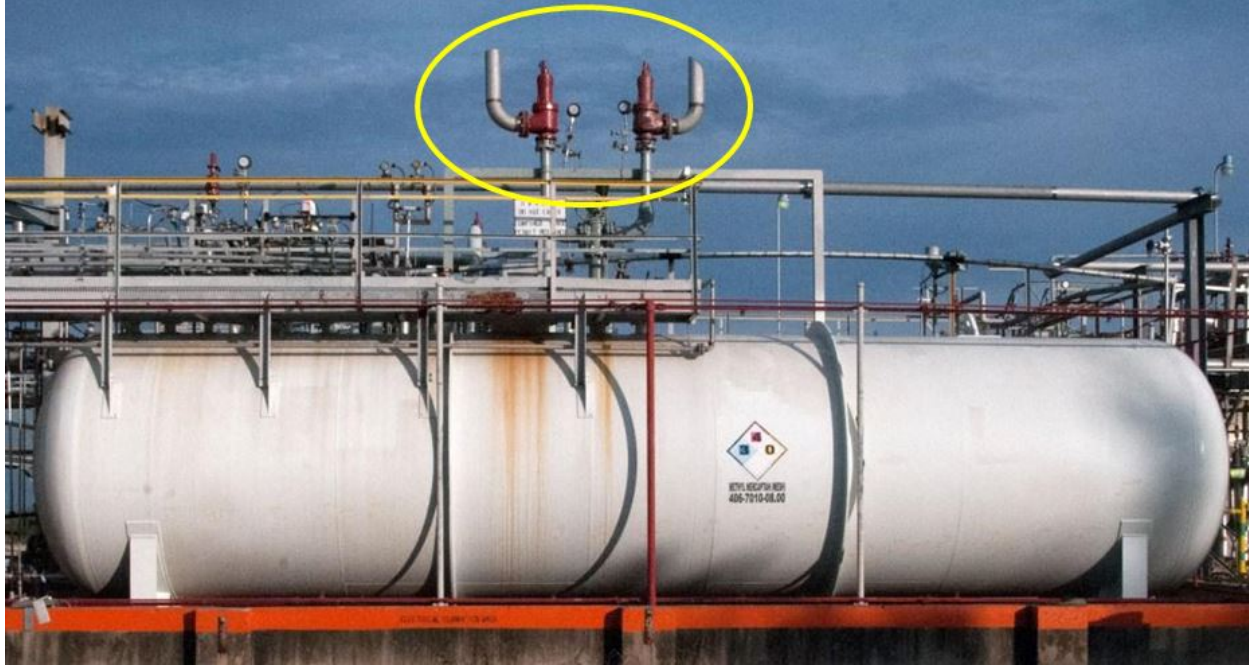
⁸⁹ A 2005 document indicates that the insulation installed on the methyl mercaptan storage tank in 2002 resulted in corrosion to the methyl mercaptan storage tank and further implied that the insulation would be repaired. There was no indication that simply removing the insulation was an option.

Figure 26. Methyl mercaptan storage tank showing atmospheric relief valves (yellow circle). At present, the storage tank is not insulated and there does not appear to be any mitigation to prevent off-site ERPG-3 concentrations as required by American Petroleum Institute and DuPont standards.

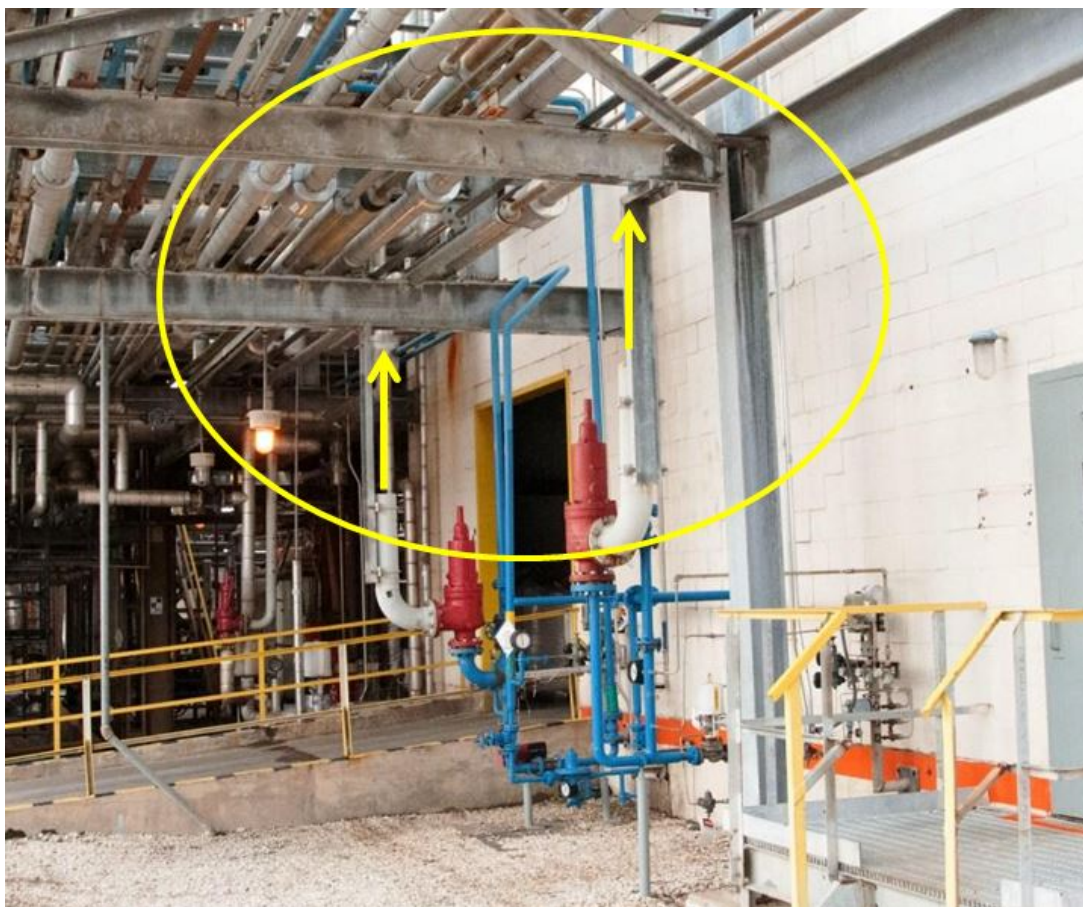
Figure 27. Nitrogen relief valves near south entrance of the manufacturing building. Dispersion from these atmospheric nitrogen relief valves is obstructed by an overhead pipe rack. This obstruction could result in a dangerous atmosphere to workers as they access or exit from the manufacturing building.

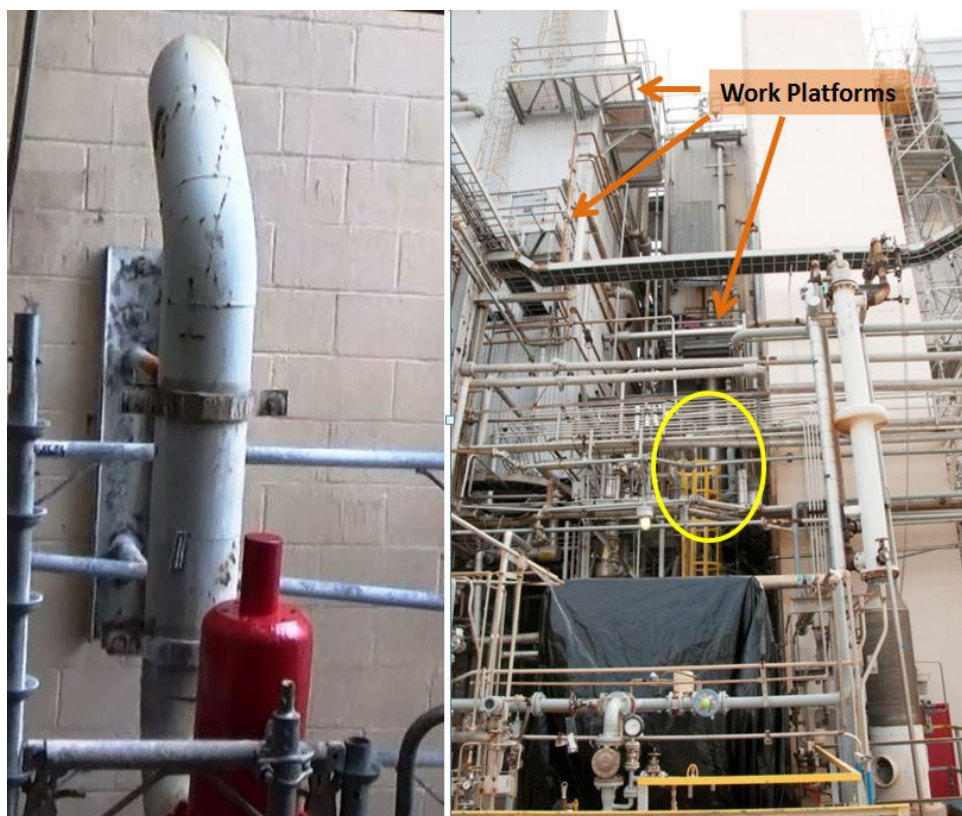
64. On December 16, 2014, highly toxic chlorine was released from a caustic scrubber relief valve (Figure 28 left photo) during an operation to vent and disconnect a chlorine railcar from the process. DuPont documentation indicates that the relief valve discharge piping is 10 feet above the work platform. This 10-foot value is used to help ensure relief valves discharge to a safe location.⁹⁰ However, an evaluation of the relief valve in the field indicates that while this 10-foot vertical safety margin exists for the immediate work platform, there are several other adjacent work platforms above the relief valve discharge piping as shown in Figure 28 (right photo). As a result, these adjacent work platforms are not safe locations for workers because highly toxic gas could be discharged towards them. The design of the relief valve discharge location should be thoroughly evaluated for safety.

Figure 28. Caustic scrubber pressure relief device location. The photo on the left shows the relief valve within the yellow circle in the photo on the right. This caustic scrubber relief valve is located in a congested area on the north side of the manufacturing building. Although DuPont documentation indicates the discharge piping of this relief valve is 10 feet above the work platform, the analysis failed to consider the other work platforms above this relief valve that can clearly be seen (orange arrows) in the photo on the right. On December 16, 2014, this relief valve was the source of a highly toxic chlorine release when a DuPont operations activity vented chlorine to the caustic scrubber in order to disconnect and relocate a chlorine railcar.

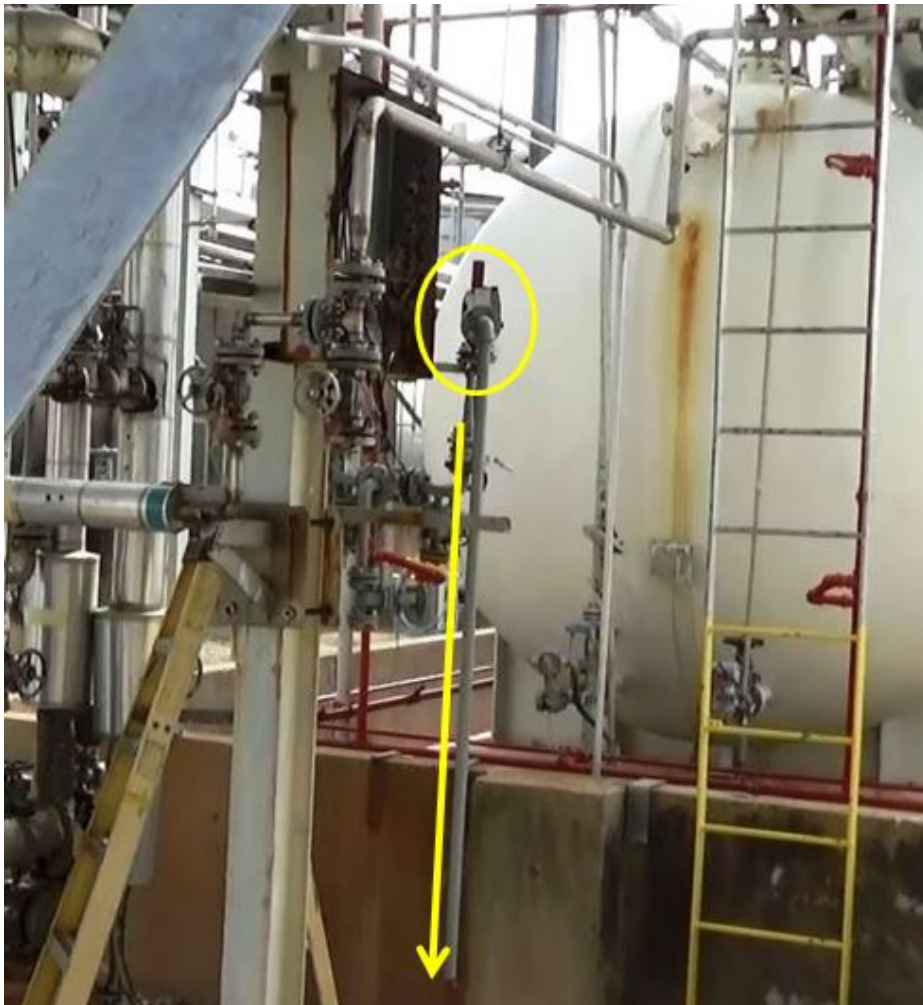
65. The methyl mercaptan pump that feeds the Lannate[®] process is equipped with relief valves designed such that they could discharge highly toxic, highly flammable liquid directly to the ground in the immediate vicinity of where an operator would be located when starting the pump (Figure 29). In the 1990s, DuPont eliminated a similar set of relief valves for the API process pump. Despite it being immediately adjacent and similarly designed, the Lannate[®] methyl mercaptan pump's relief valves remained. Furthermore, no PHA or engineering analysis has evaluated the Lannate[®] methyl mercaptan pump's relief valve discharge location to ensure worker safety.

Figure 29. Liquid methyl mercaptan relief valve on the discharge of the methyl mercaptan pumps is designed to discharge this highly toxic, highly flammable chemical to grade just north of the methyl mercaptan storage tank.

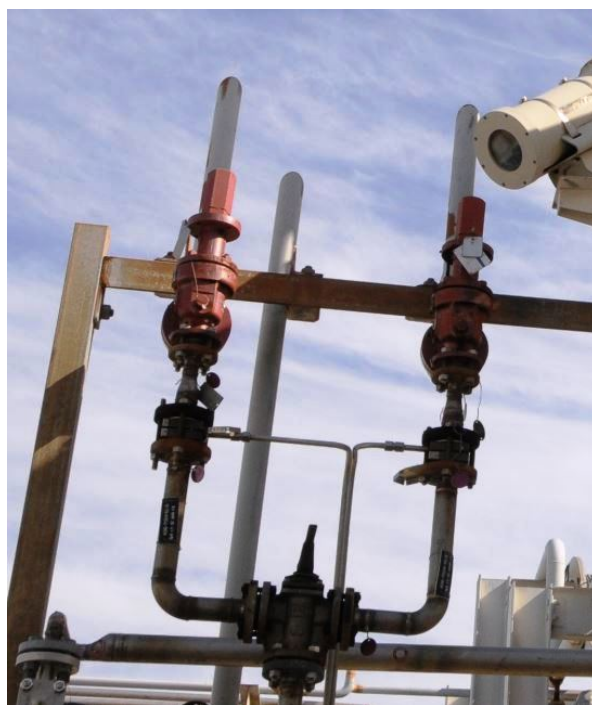
66. The design of the nitrogen relief valves at the railcar loading and unloading stations (Figure 30) did not consider a scenario where the relief valves could be lined up to the discharge of the methyl mercaptan pumps, as they were at the time of the incident. The methyl mercaptan pump discharge pressure (90 psig)⁹¹ is higher than the set pressure (80 psig) of these nitrogen relief valves. Therefore, the methyl mercaptan pump will cause the relief valve to open and release the highly toxic and highly flammable chemical to the atmosphere. When tested post-incident, three of the four nitrogen rupture discs were ruptured and all four of the nitrogen relief valves leaked.⁹² Because the rupture discs and relief valves would not hold pressure when tested, an atmospheric release of highly toxic and highly flammable liquid methyl mercaptan likely occurred during the incident through this relief system that was intended to release and disburse nitrogen vapor. This relief system is part of the 35% of systems that DuPont considers complete and in compliance with industry codes and standards. However, the alignment of block valves at the time of the incident revealed a highly toxic methyl mercaptan release scenario that DuPont's five-year relief system program never considered. Consequently, this program has not been fully effective.

Figure 30. This photograph shows the nitrogen relief valves at one of the two methyl mercaptan railcar unloading stations. The nitrogen relief systems for each of the two railcar unloading stations are nearly identical. DuPont PHAs and relief valve design documents never considered the possibility of the methyl mercaptan storage tank pumps being lined up to these relief valves – as it was at the time of the incident. As a result, liquid methyl mercaptan was discharged from a system designed for nitrogen vapor.
