# Investigation Report

Published: December 2022

On November 27, 2019, a series of explosions occurred at the TPC Group (TPC) Port Neches Operations (PNO) facility, located in Port Neches, Texas, after highly flammable butadiene released from the process unit. The explosions caused a process tower to propel through the air and land within the facility, other process towers to fall within the unit, extensive facility damage, and fires that burned for more than a month within the facility. The butadiene unit was destroyed, forcing the facility to cease butadiene production operations indefinitely. As of the date of this report, the butadiene production operations remain shut down. Two TPC PNO employees and a contractor reported minor injuries, and according to media reports, at least five local residents reported injuries. Officials in Jefferson County, Texas declared the county to be in a state of disaster and issued a mandatory four-mile radius evacuation order that affected people in the cities of Port Neches, Groves, Nederland, and a portion of Port Arthur. The explosion also led to reduced usage of the Sabine-Neches Waterway, the nation's third largest waterway by cargo volume

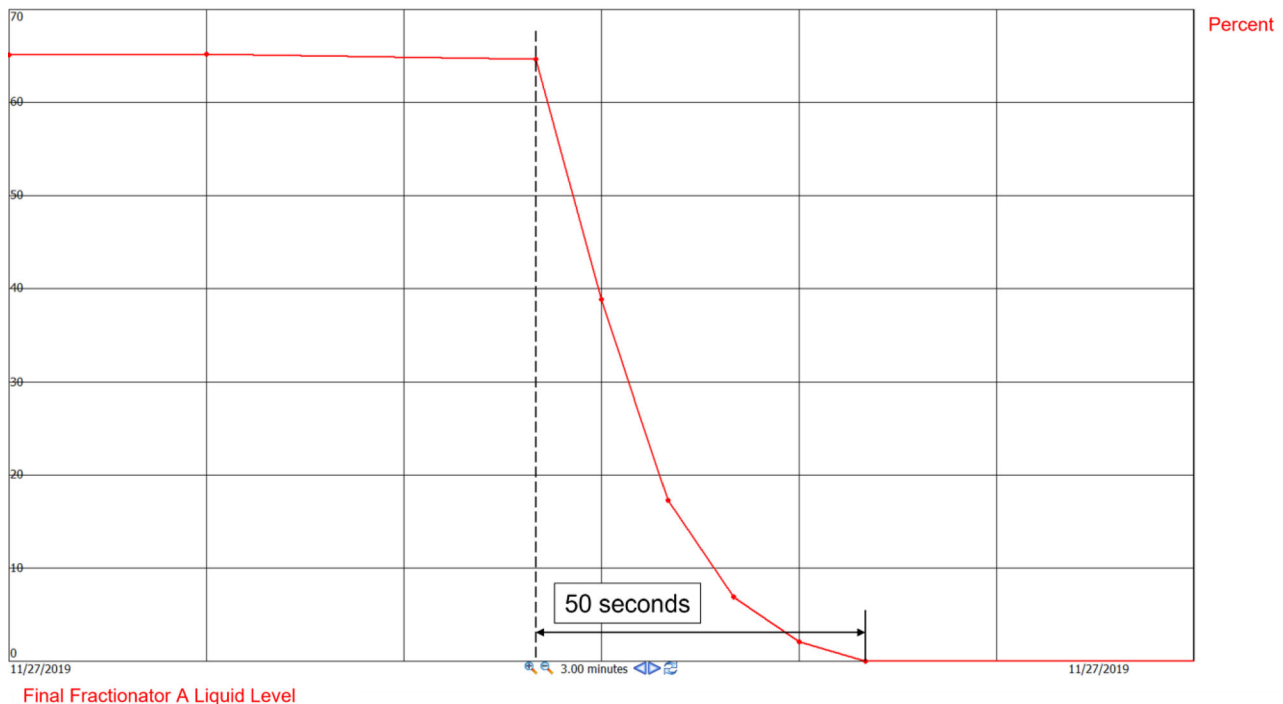
A loss of containment event then occurred as a result of the rupture, causing the liquid level in the Final Fractionator A to drop rapidly from its operating level. The CSB calculated the Final Fractionator A liquid volume at the time of the initial level drop to be approximately 6,000 gallons.<sup>d</sup> Process data indicate that the liquid, which was primarily butadiene, fully emptied from the Final Fractionator A in less than a minute (**Figure 10**). The liquid butadiene vaporized upon release<sup>e</sup> and formed a flammable vapor cloud.

**Figure 10.** Process data trend showing the liquid level (in percent) in the Final Fractionator A at the time of the incident. (Credit: CSB)

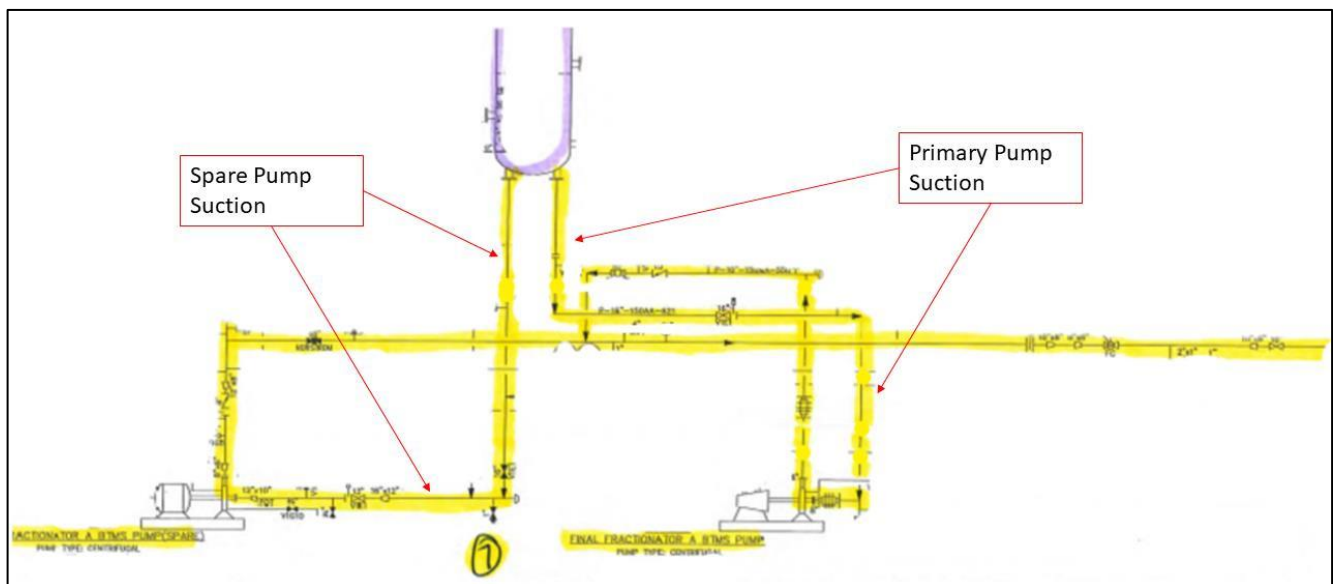
The CSB reviewed the two previous Process Hazard Analysis (PHA) revalidations for TPC PNO’s butadiene process (performed in 2011 and 2016), which included the final fractionation process. TPC PNO defined an analysis section, or node, that extended from the Final Fractionator A outlet to the Final Fractionator B inlet (see **Figure 22**). This node included both the Primary Pump and the Spare Pump. The PHA teams analyzed “no/low flow” as a potential deviation caused by Primary Pump failure. The consequence identified for this deviation was “possible unit upset causing off-test product resulting in economic impact,” and one of the claimed safeguards was the existence of a Spare Pump (see **Figure 23**). Neither PHA team identified the potential consequence of popcorn polymer accumulation, piping failure, and release to atmosphere for the no/low flow deviation for this node.

**Figure 22.** Excerpt from TPC PNO's 2016 PHA revalidation of the butadiene process depicting the node encompassing the Primary Pump and the Spare Pump. (Credit: TPC, annotated by CSB)

Despite not identifying the pipe rupture consequence for the node shown in **Figure 22**, in an earlier node analyzed during the PHA, the PHA team found that no/low flow could be caused by popcorn polymer formation, resulting in “possible line rupture with hydrocarbon release to atmosphere ... resulting in potential environmental/economic impact/personnel exposure and/or fire.” Based on this analysis, the PHA team made a recommendation that TPC PNO “assure that when equipment in high-purity [butadiene] service is [out of service] for maintenance, the lines are still flushed monthly” (see **Figure 24**). The PHA team felt this needed to be emphasized in the existing “Dead Legs in High Purity Butadiene Service” procedure. As the PHA acknowledges, this procedure was originally implemented in response to a popcorn polymer rupture incident that occurred at the site in 1999.<sup>a</sup> TPC PNO accepted this recommendation and assigned a targeted due date for implementation of December 7, 2016, almost three years before the incident. TPC PNO did not implement this recommendation, however.
