U.S. Chemical Safety and Hazard Investigation Board

Three Catastrophic Hydrogen Fluoride Incidents at Honeywell Geismar

Geismar, Louisiana | No. 2023-02-I-LA

Investigation Report

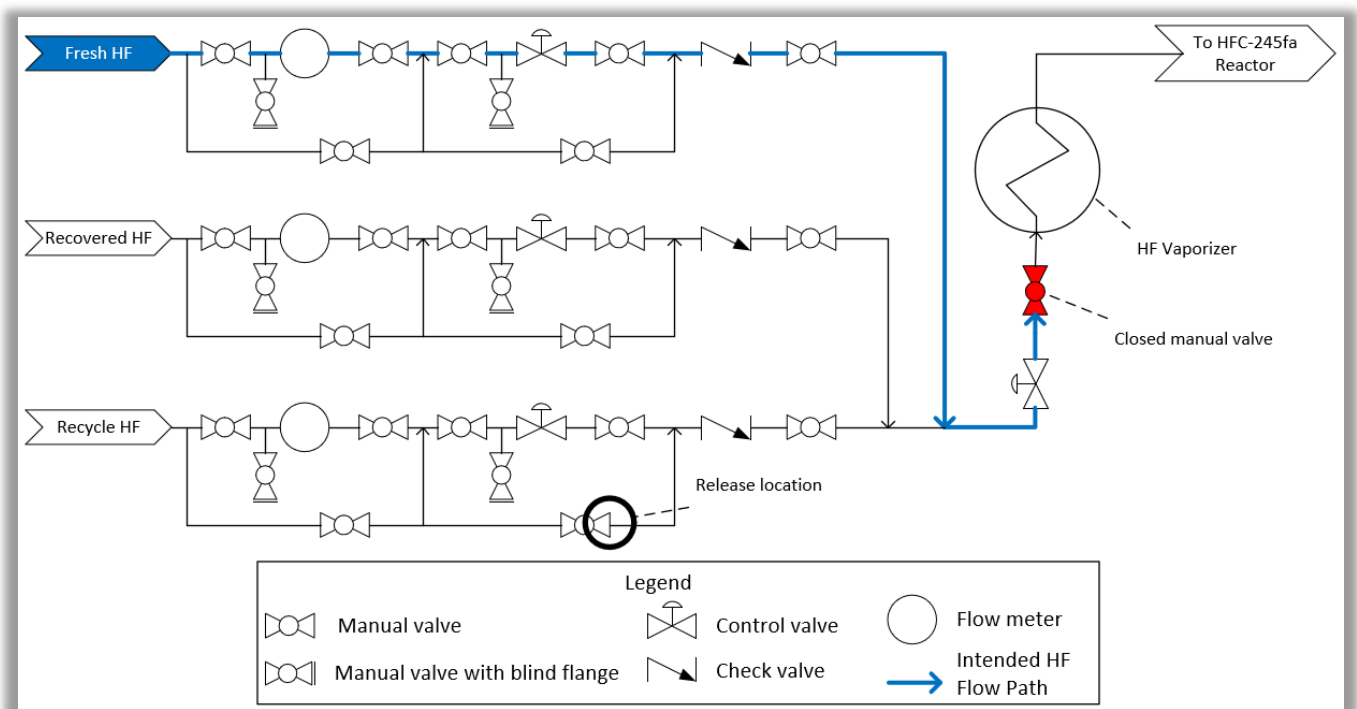
Figure 6. Intended flow path of HF during the attempted startup of HFC-245fa reactor D. (Credit: CSB)

After the Board Operator (from the control room) and Field Operator 1 made various unsuccessful operational moves at the fresh HF feed station to attempt to resolve the no-flow condition to the vaporizer, the Board Operator requested that Field Operator 1 check the alignment of the manual block valve on the combined HF feed to the vaporizer. Unbeknownst to either the Board Operator or Field Operator 1, the manual block valve immediately upstream of the vaporizer was closed because reactor D had not been made ready to return to service^a (**Figure 6**).

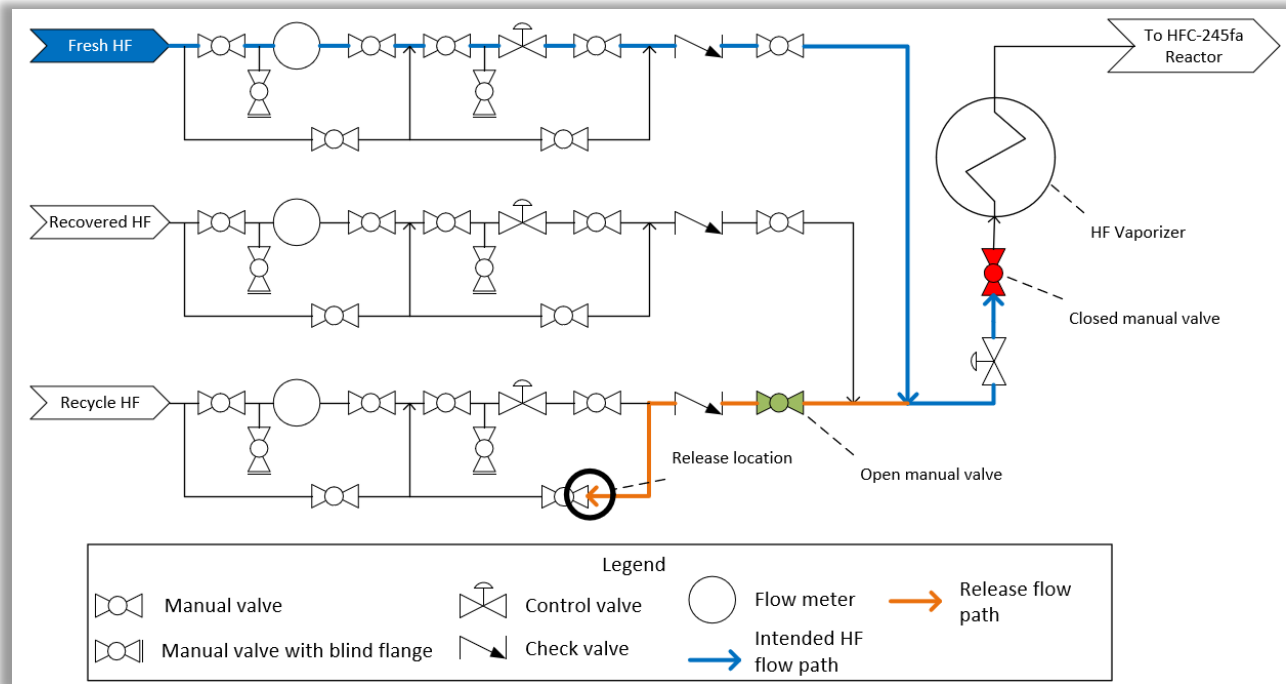
Figure 8. Simplified diagram showing the release flow path during the incident. (Credit: CSB)

At this point in the startup, the recycle HF feed station should not have been pressurized, and there should have been no HF flow to this feed station. Assuming that the HF was flowing from the upstream direction, Field Operator 1 went to check an upstream block valve to ensure that it was closed. The operators were unaware that HF was backflowing from the downstream direction because of the closed valve on the HF inlet to the vaporizer (**Figure 8**).

Honeywell investigated the incident and found that the cause of the no-flow condition to the D reactor vaporizer was a closed manual block valve immediately upstream of the vaporizer; the same valve that the Board Operator had asked Field Operator 1 to check before Field Operator 1 detected the HF leak from the recycle HF feed station. Honeywell isolated the vaporizer in preparation for the planned outage, but the vaporizer was never placed back into service prior to the startup. The valve was found locked closed. Honeywell determined that the closed manual valve caused the fresh HF to backflow into the recycle HF feed station through an open manual valve and a check valve^a to the release point (**Figure 8**).^b

On the morning of the incident, Honeywell attempted to start up reactor D after a planned unit maintenance outage. Leading up to the outage, reactor D and its associated equipment, including the vaporizer, were isolated and locked out. The D reactor vaporizer was not subsequently unlocked and valved back into service prior to the startup attempt. As a result, the manual valve on the HF inlet to the vaporizer remained locked closed during the startup attempt, which caused HF to backflow through an open manual valve on the downstream side of the recycle HF feed station, through a check valve that had failed, and to the incident flange (**Section 2.3; Figure 8**).

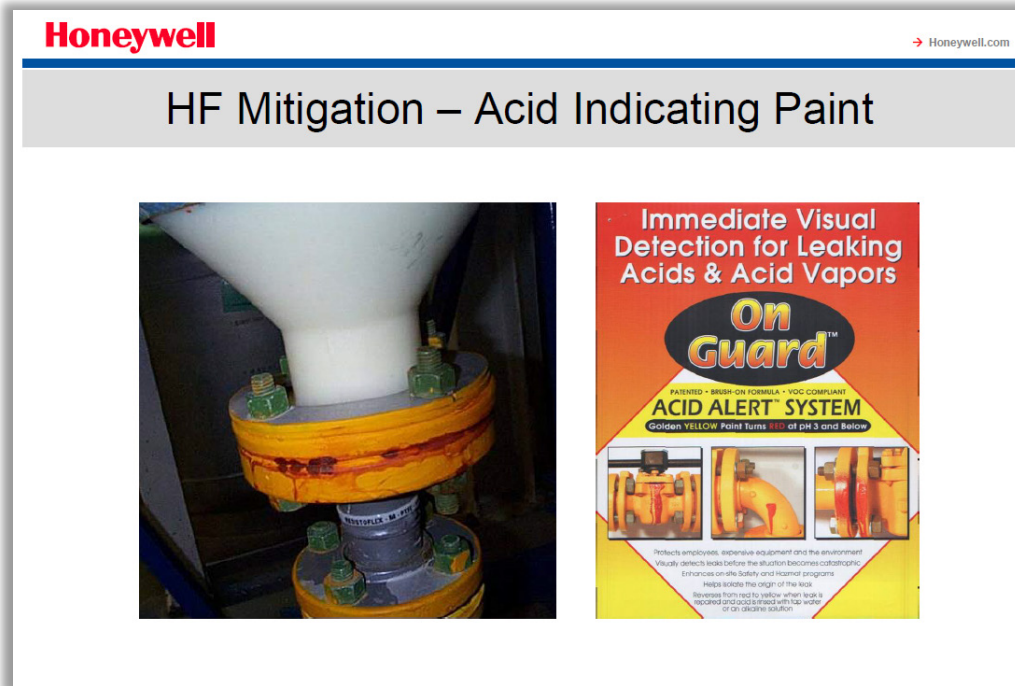
Figure 14. Slide from a 2009 presentation Honeywell made to the CSB, advocating for the use of acid indicating paint. (Credit: Honeywell)

Furthermore, in 2009, Honeywell representatives gave a presentation titled “Hydrofluoric Acid Overview” to CSB Board Members and investigative staff. The presentation contained a series of slides describing what Honeywell called “HF Safety Best Practices.” The following slide advocated for the use of acid indicating paint and was included in the presentation (**Figure 14**).

On its website, Honeywell purports to be “the leader in HF [...] safety and handling training” and offers various training and consulting services concerning the use of HF [19]. Despite marketing itself as a leader in the safe use of HF, and despite advocating for practices such as the use of acid indicating paint to its customers and to the CSB, Honeywell did not use acid indicating paint in its own 245 unit. Honeywell did not begin using the paint in the 245 unit until after a Honeywell operator was fatally injured by an HF leak in the October 2021 incident that could have been prevented by the use of the paint.

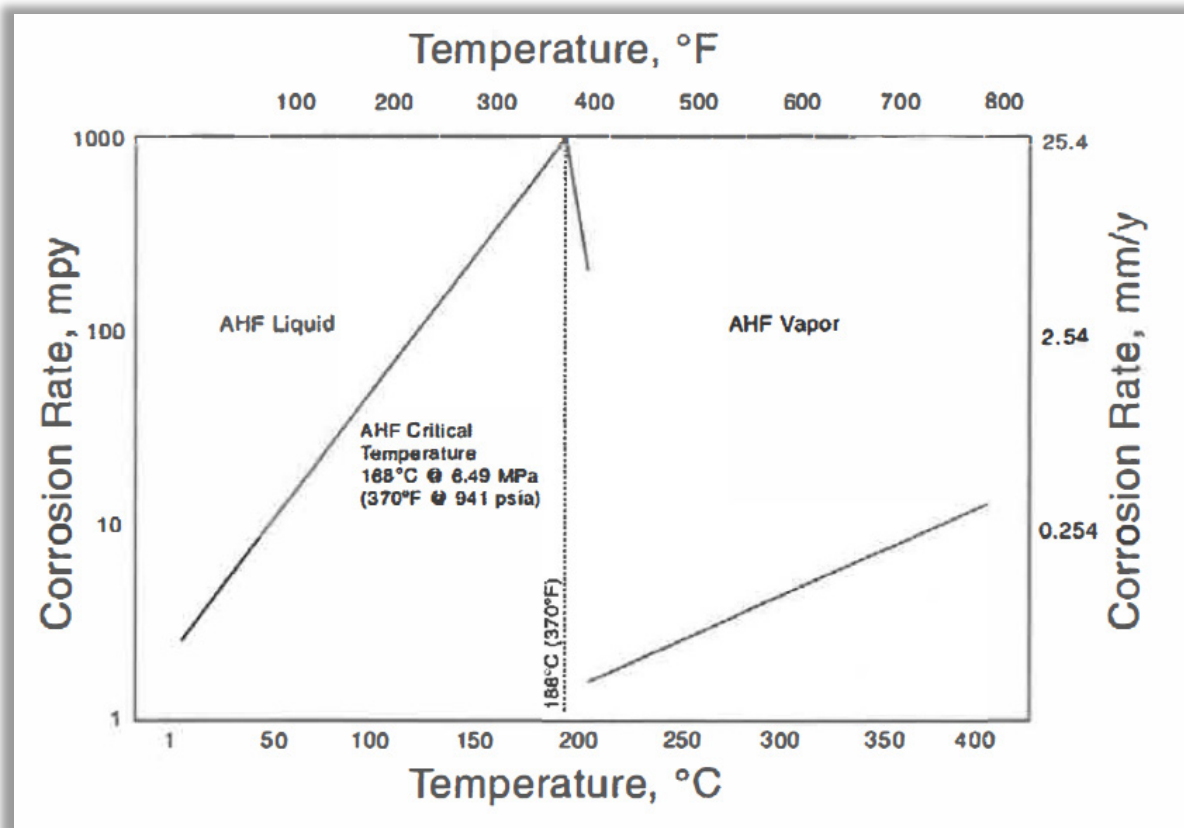
Figure 20. Corrosion rates^a of carbon steel in anhydrous HF (abbreviated as AHF in the figure) service over a range of temperatures. (Credit: AMPP [5, p. 12])

Figure 20 shows that at the temperatures at which Honeywell operated the reboiler, Honeywell could expect a corrosion rate of roughly 30-80 mils^b per year (mpy). Honeywell Geismar was generally aware of the data and

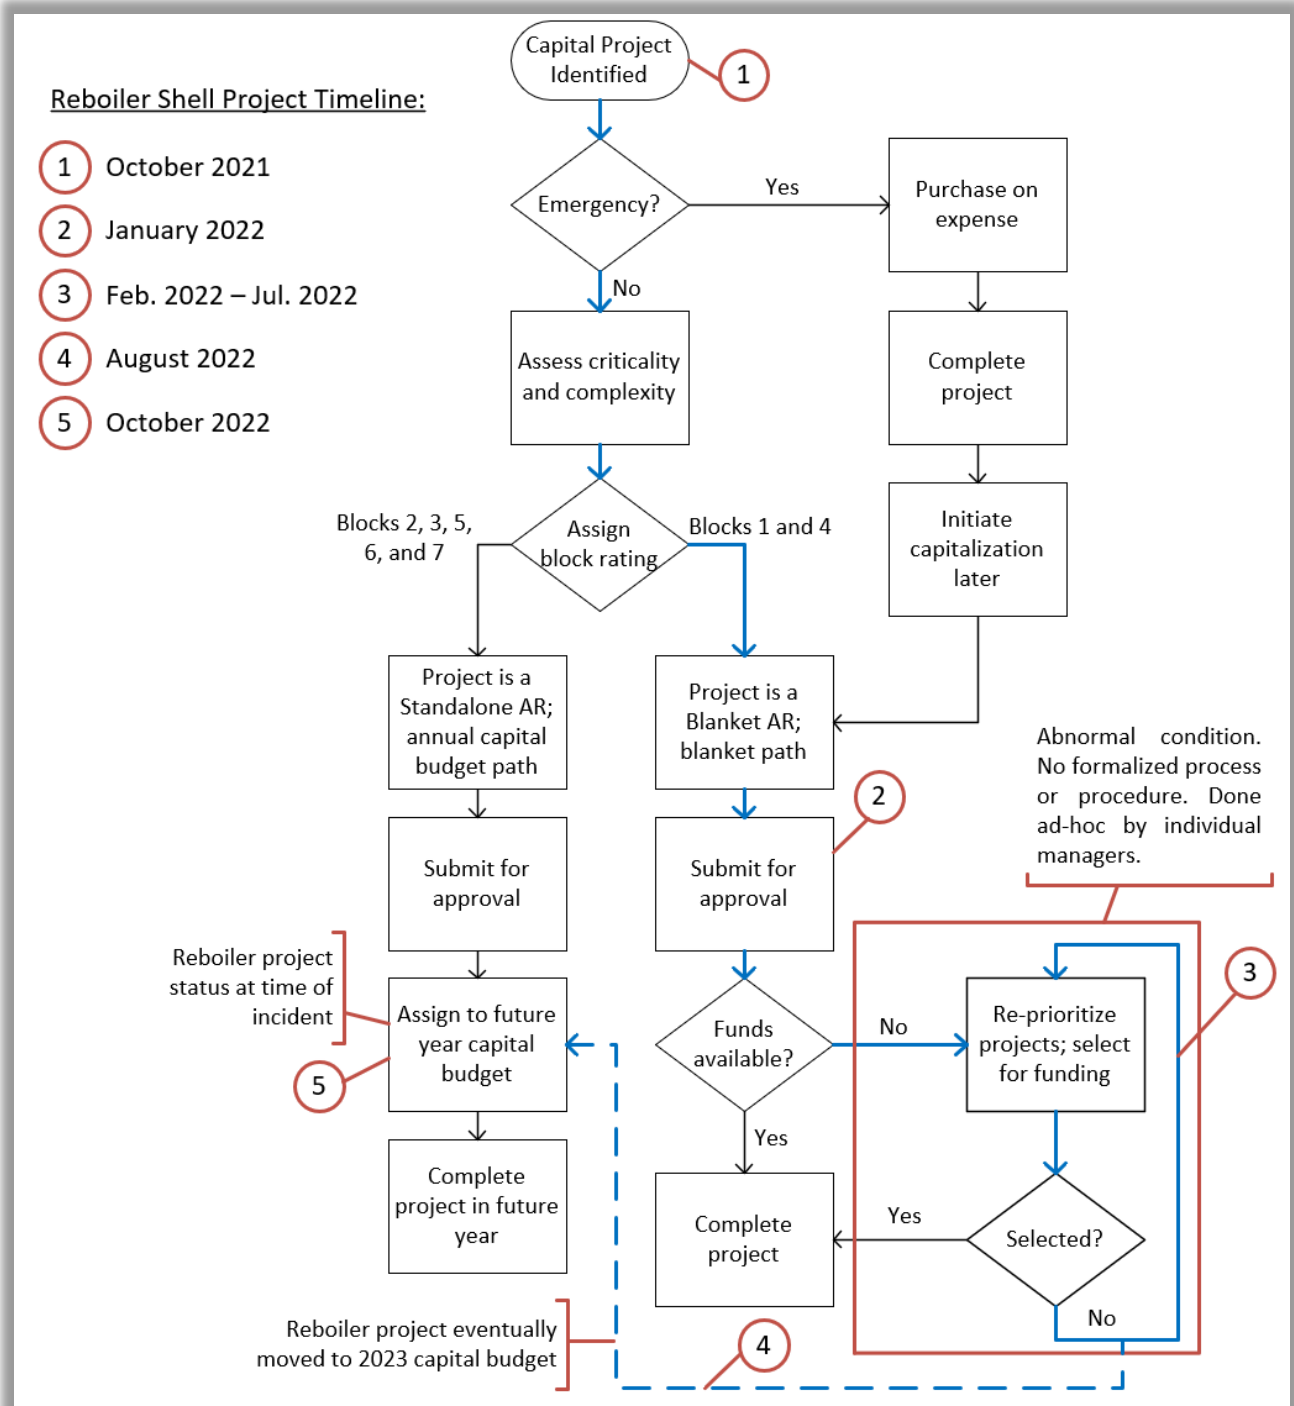
Figure 26. Flowchart showing how the reboiler project was managed. The steps through which the reboiler project progressed are highlighted with blue arrows. (Credit: CSB)

The site managers who were asked to re-prioritize the project list were the same managers who told the CSB that they were unaware of the reboiler project's urgency, despite some of them having approved the project themselves. Further, project re-prioritization was done on an ad-hoc basis via email, without any formalized policy, procedure, or guidance on how to do so or which factors should be considered. **Figure 26** below shows a graphical representation of how Honeywell Geismar's capital project management systems functioned with respect to the reboiler project.

Honeywell’s block rating methodology, which was applied before a project was assigned to either the annual capital budget process or to the blanket AR process, accounted for a project’s impact on safety. Projects with a high or urgent potential safety impact were more likely to be assigned to the blanket path. After a project was assigned to the blanket process, however, there was no further formalized and documented consideration of a

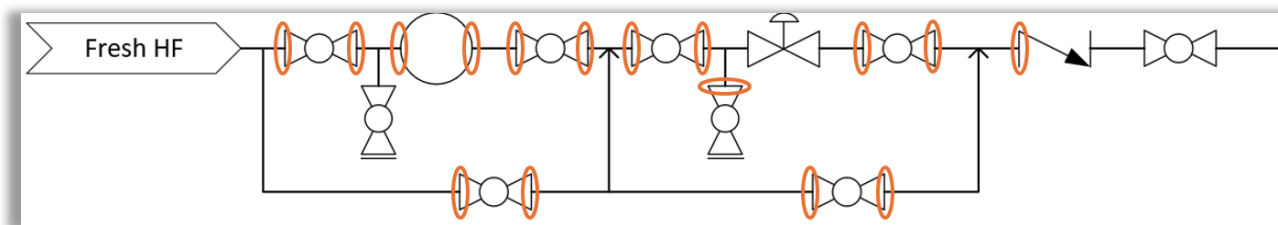
Figure 27. Excerpt of the incident job scope. In-scope flanges and gaskets are circled in orange. (Credit: CSB)

By June of 2024, the progress of the effort to replace spiral wound gaskets reached the D reactor fresh and recovered HF feed stations. At the time of the incident, two contract pipefitters were replacing gaskets in the D reactor fresh HF feed station. An excerpt of the scope of work involved in this incident is shown in **Figure 27**.

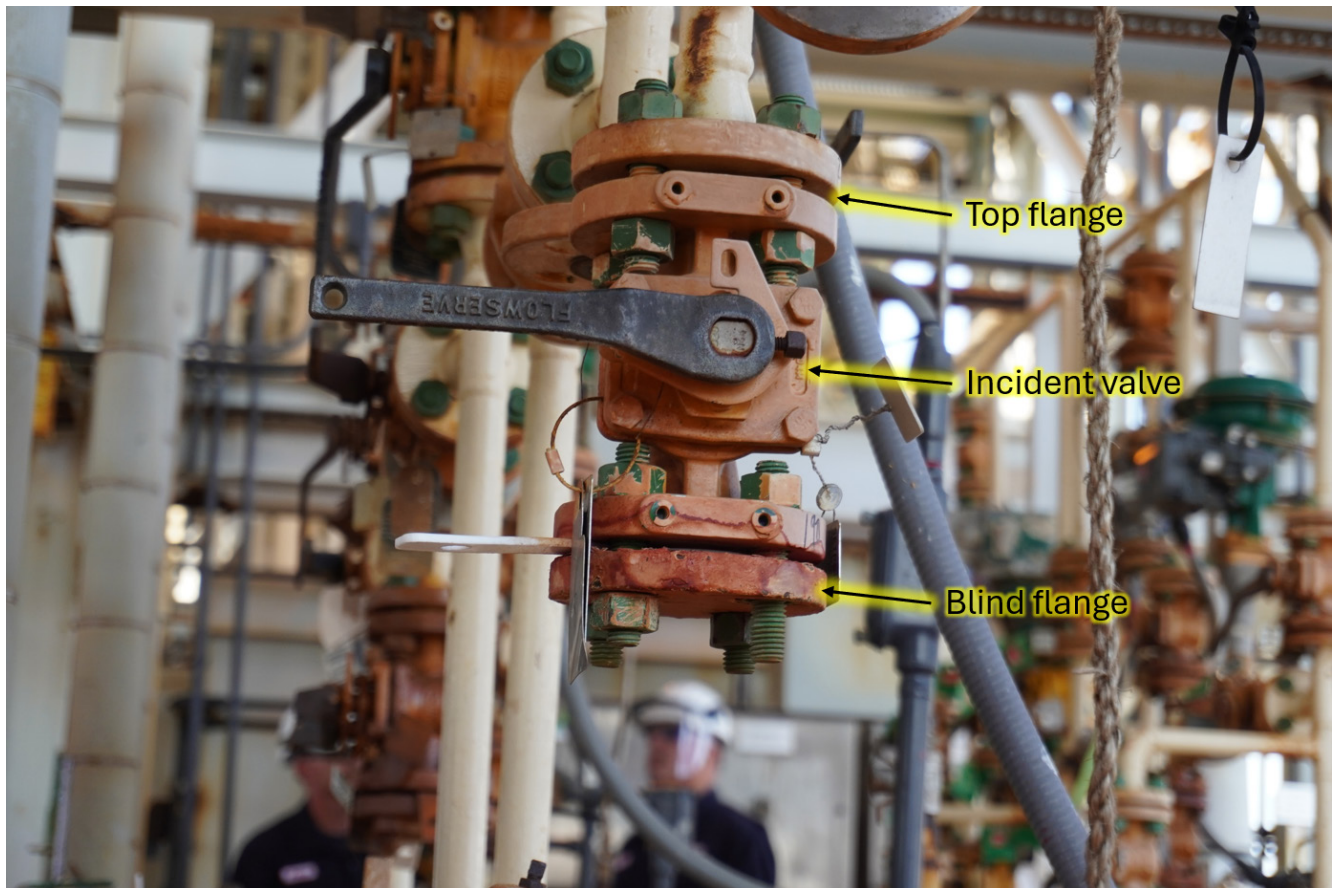
Notably, the incident valve and blind flange assembly meet all four of those descriptions, as it was a local low point on a horizontally oriented section of piping, it constituted a dead leg,^a it contained a closed valve, and it contained an installed blind. During Honeywell's preparation for maintenance, leaving the incident valve closed prevented it from being cleared during the nitrogen purge and vacuum steps of the clearing procedure. Had the valve been opened during this point of the preparation process, the valve likely would have been cleared of HF prior to the incident, and the worker would not have been exposed to HF when he mistakenly loosened the out-of-scope blind flange. A photo of the valve as found in the closed position is shown in **Figure 32**.^b

^b Note the orange-tinted acid indicating paint on the body of the valve and on the top and bottom flanges. On the bottom flange, the paint has turned red, indicating that it has been exposed to HF vapors. See **Section 2.4.2.1** for a discussion of acid indicating paint.

Figure 32: As-found condition of the incident valve showing that the valve was in the closed position at the time of the incident. (Credit: CSB)

The CSB concludes that Honeywell did not ensure that all piping within the bounds of the lockout was free of hazardous energy. The incident valve should have been cleared of HF as part of Honeywell's preparation for the maintenance work. Doing so would have prevented the HF release and the serious injury.
