U.S. Chemical Safety and  
Hazard Investigation Board

# Chemical Decomposition, Fires, and Toxic Gas Release at KIK Consumer Products / Bio-Lab Conyers Facility

Conyers, Georgia | Incident Date: September 29, 2024 | No. 2024-04-I-GA

## Investigation Report

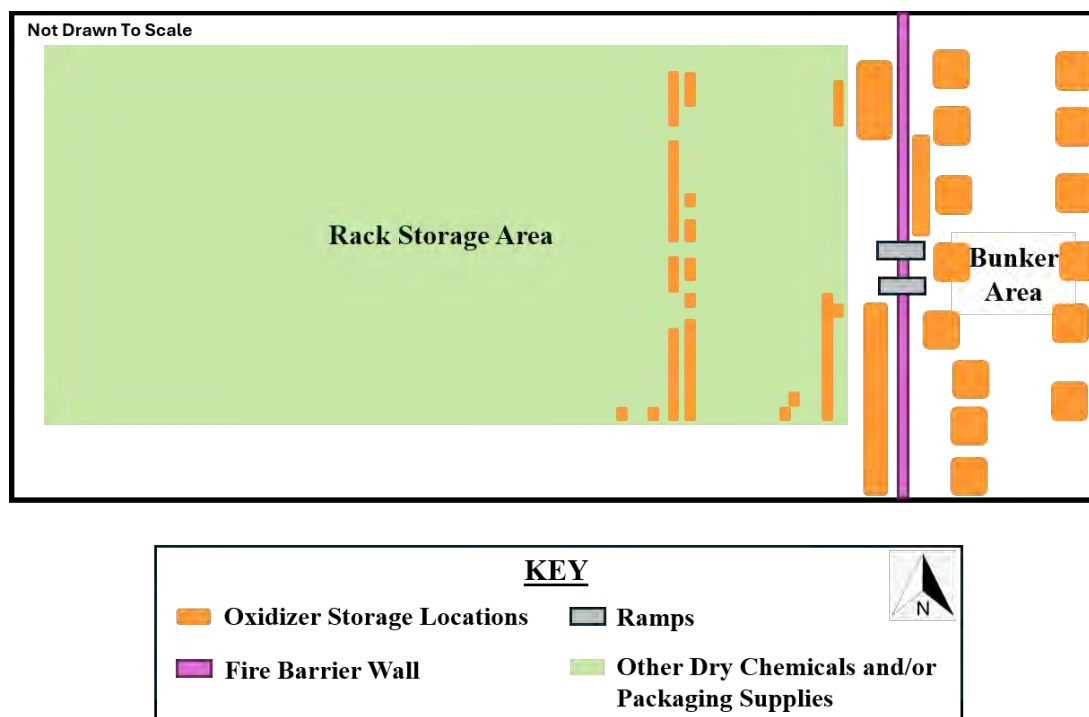
**Figure 10** is a representation of the approximate locations of the oxidizers stored inside and outside the bunker, in storage racks alongside other dry chemicals, and on the floor on wood pallets, stacked two high.

**Figure 10.** Sketch of the Plant 12 Storage Warehouse floor plan showing the fire barrier wall, rack storage, and the bunker. (Credit: CSB)

From the construction of the Bio-Lab Conyers Plant 12 Storage Warehouse in 2019 until sometime in 2023, it was standard practice for the facility to store Class 1 and Class 2 oxidizers only in the bunker (**Figure 10**),

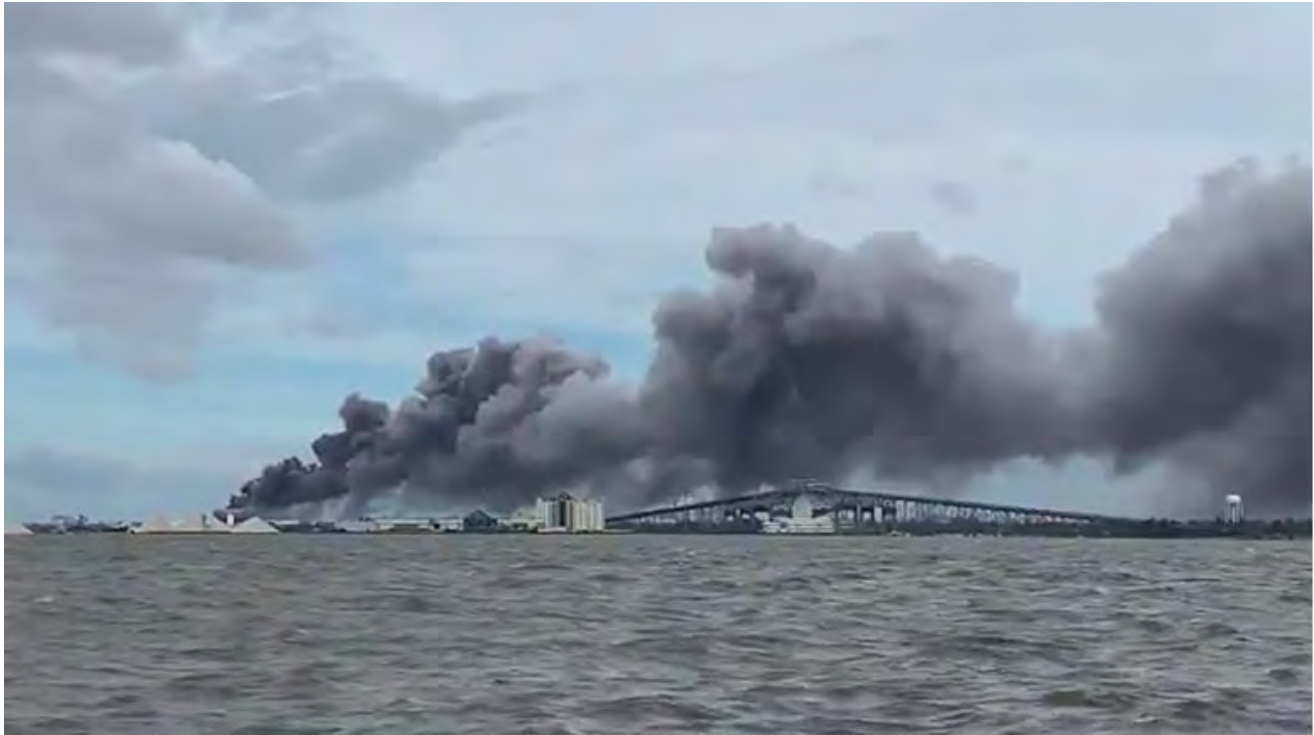
3. On the morning of August 27, 2020, at the Bio-Lab Lake Charles facility in Westlake, Louisiana, rainwater from Hurricane Laura, a Category 4 hurricane, came into contact with TCCA-based formulation materials stored inside a Production Building at the facility, initiating a chemical reaction and subsequent decomposition that led to a fire that destroyed the building.<sup>a</sup> Hurricane Laura produced heavy rainfall and winds of 101 miles per hour (mph), with a peak gust of 137 mph recorded in downtown Lake Charles. Later in the afternoon, a second decomposition reaction and release occurred in the Finished Goods Warehouse at the Bio-Lab Lake Charles facility, which had also been severely damaged by the hurricane's winds. At the time of the incident, the warehouse was storing TCCA-based formulation material. The decomposition reactions released large plumes of hazardous gases, including toxic chlorine, into the air, crossing the facility boundary. The plumes were visible over a substantial portion of the nearby community (**Figure 13**), resulting in the closure of part of a nearby interstate for over 28 hours and the issuance of a shelter-in-place order.

**Figure 13.** A large plume of hazardous gas from the decomposition at the Bio-Lab Lake Charles facility approaching the Calcasieu River Bridge in Louisiana, located between Westlake and Lake Charles. (Credit: 4WWL-TV [31])

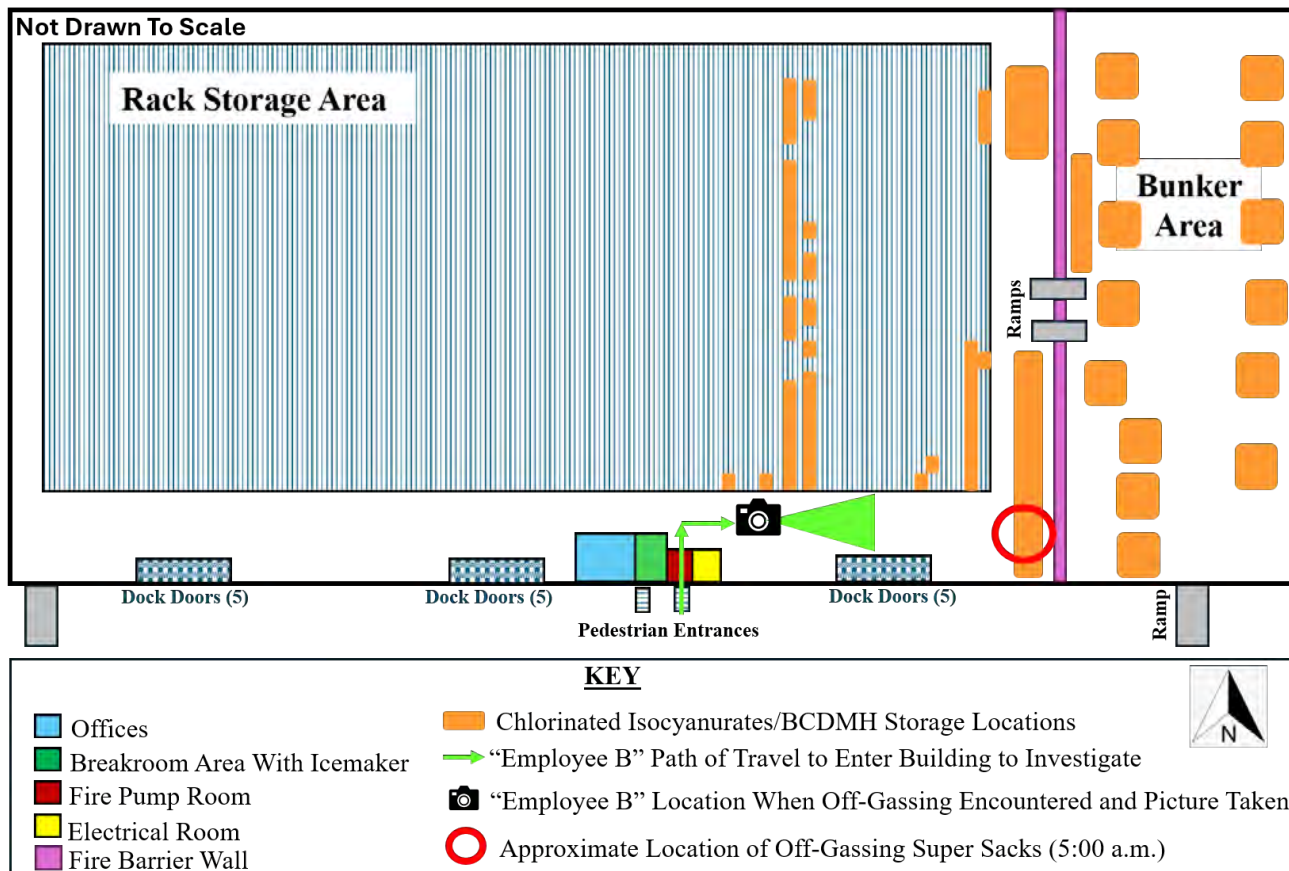
Employee B was able to remove only four super sacks of material from the area in front of the off-gassing super sacks before both employees had to leave the building due to the increasing fume density affecting visibility. Employee B also encountered difficulty moving the super sacks because there was "[n]o visibility and floors [were] too slick for forklift" due to the water from the sprinkler flow. Employee B took a picture and video of the dense white fumes before leaving the building (**Figure 17**).<sup>a</sup> **Figure 16** depicts the path of travel that Employee B took when entering the building to shut off the fire pump, the general location of the off-gassing material, and where Employee B was standing when they took the picture (**Figure 17**).

**Figure 16.** Depiction of the Plant 12 Storage Warehouse floor plan showing Employee B’s path of travel into the warehouse and the location where the off-gassing picture was taken. (Credit: CSB)

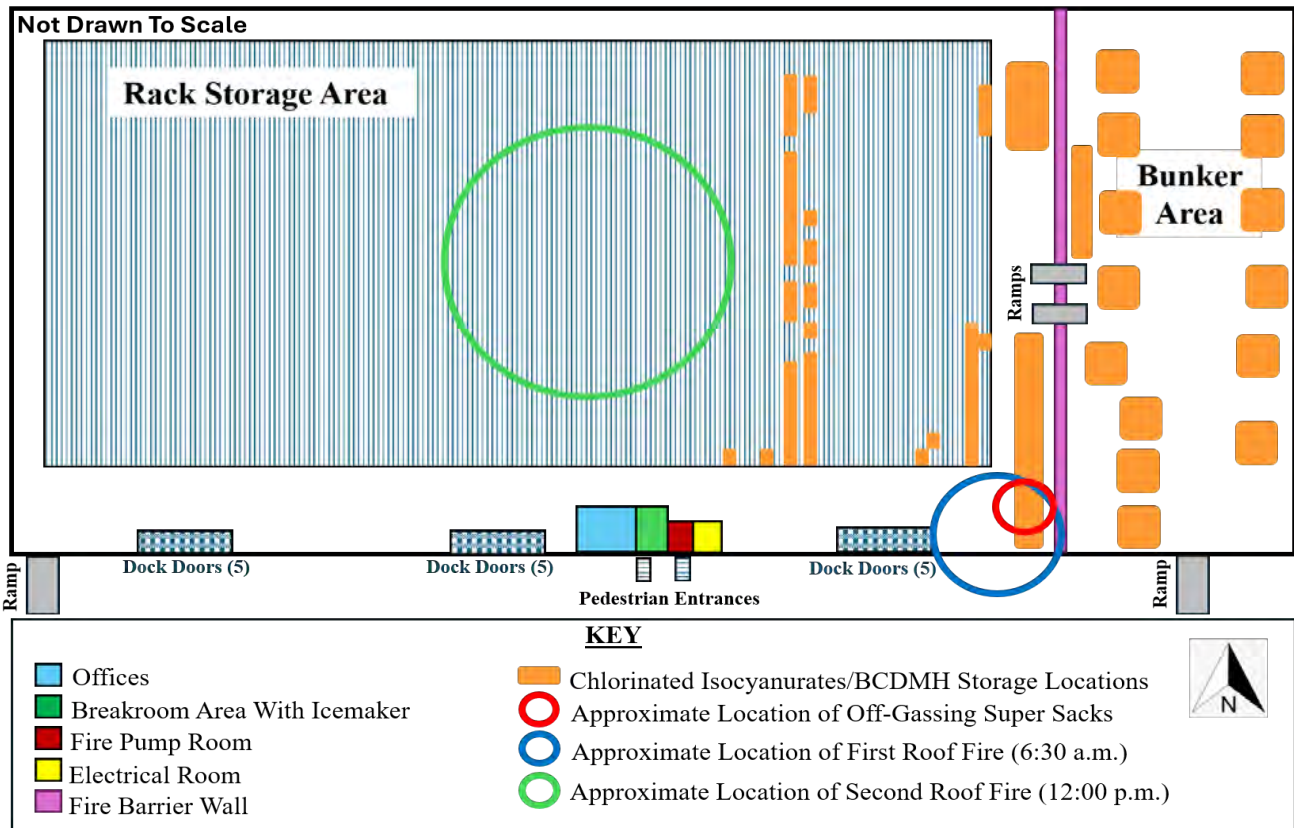
The second roof fire occurred at approximately 12:00 p.m., with black smoke initially observed rising from the center of the Plant 12 Storage Warehouse. When an RCFR responder went up in the aerial ladder of a firetruck to investigate the extent of the second fire, they described seeing:

Because the building was constructed from concrete slabs raised into place and supported by a roof and truss system, the walls lacked the support to remain standing once the roof began collapsing shortly after the second larger fire broke out. By 12:40 p.m., some of the warehouse's exterior had already collapsed from the loss of roof support. **Figure 21** shows the second fire and the large roof hole at the building center, taken with a drone approximately 10 minutes after the fire was first observed by witnesses on the ground. **Figure 22** shows the location of the second fire, relative to the first fire at 6:30 a.m., and the interior layout of the warehouse building.

**Figure 22.** Location of second roof fire relative to first fire and building interior layout. (Credit: CSB)

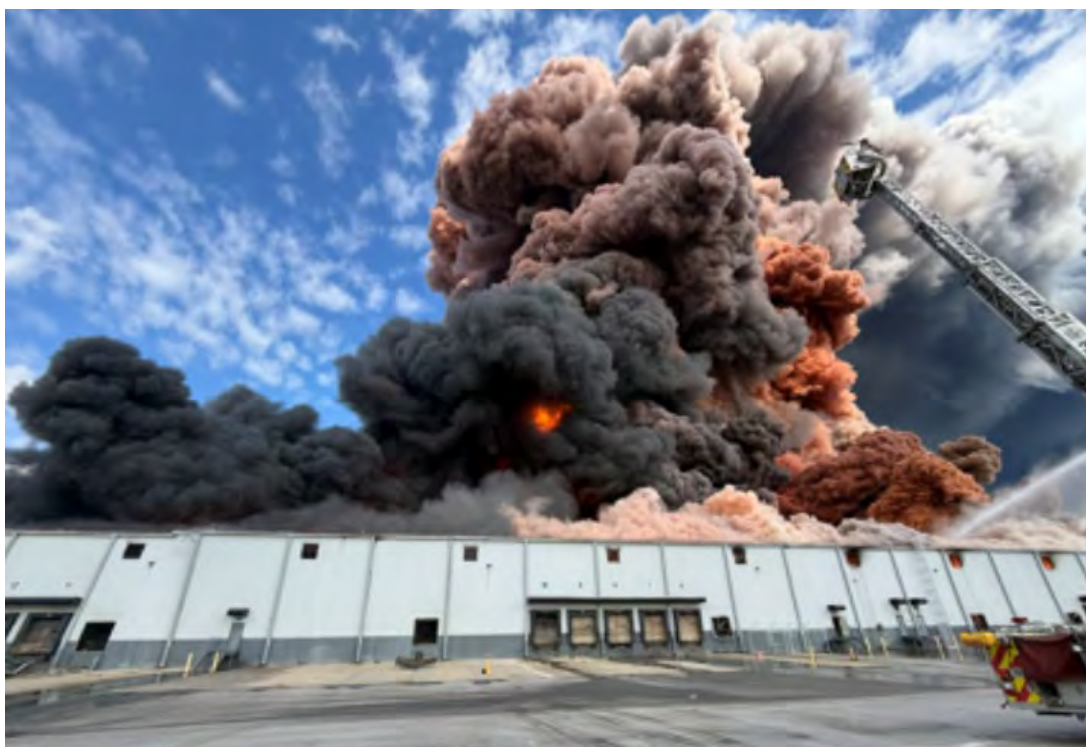
RCFR personnel described that the second fire as initially consisting of a large plume of black smoke, thick white fumes and large flames, before changing over to multicolored plumes of smoke, as shown in **Figure 23**.

**Figure 23.** Multicolor plumes of smoke observed during the second fire at Bio-Lab Conyers on September 29, 2024. (Credit: Ross/11Alive)

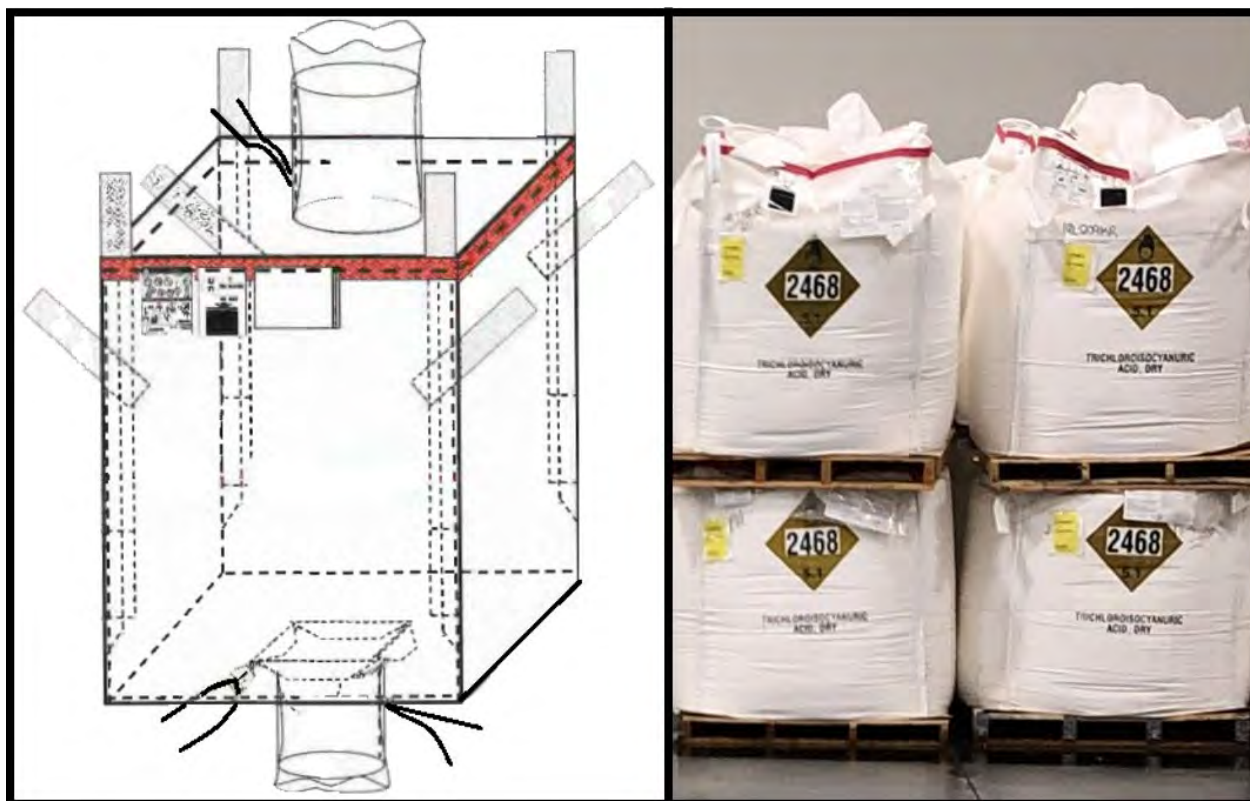
As discussed in **Section 1.3.4**, in the Plant 12 Storage Warehouse, oxidizers were stored in woven propylene super sacks with a top and bottom neck for filling and discharge and were equipped with a polyethylene liner (also known as a plastic insert) closed on top with a sewn cord (**Figure 40**).

**Figure 40.** Design of the super sacks used in Plant 12 Storage Warehouse (left), and exemplar super sack used at Plant 12 Storage Warehouse (right). (Credit: Bio-Lab and ARCO, modified by CSB)

However, the outer super sack fabric (woven polypropylene) is not waterproof. Because the bags are not sealed, there's an opportunity for moisture in the air to enter the bags, contact the chlorinated isocyanurates, and cause them to release corrosive vapors, such as HCl, as stated in **Section 1.2.3**. These corrosive vapors create a corrosive atmosphere that can corrode metals in the area, such as the sprinkler system. Corrosion of a sprinkler system can cause failures, resulting in water leaking onto bags stored below it. Once wetted, the material in the super sacks underwent a decomposition reaction, producing toxic vapors described by employees as “dense white clouds” coming from the “off-gassing bags” (see **Section 2.2**).

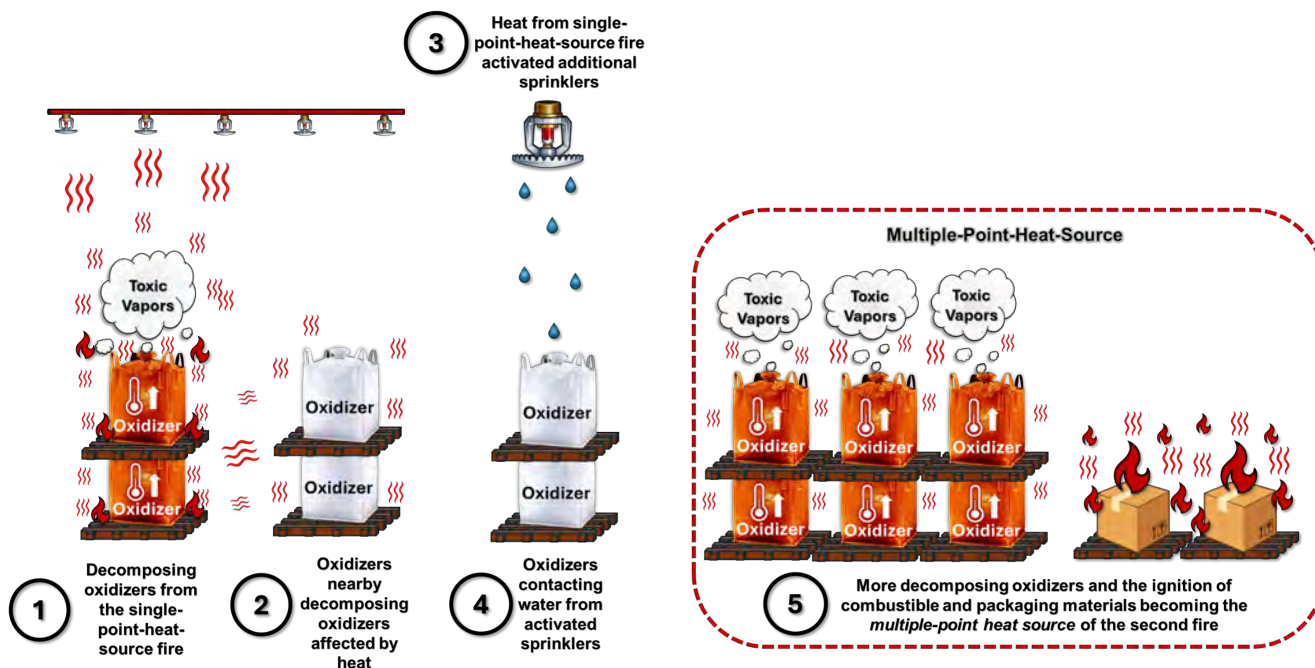
The heat generated by the decomposing materials and fire inside the building triggered additional sprinklers, wetting more super sacks and causing them to decompose and generate more heat. The resultant heat activated even more sprinklers, wetting additional super sacks throughout the building, and initiating the transition from a single-point to a multiple-point heat source (**Figure 42**).

Although the first building fire was extinguished at approximately 8:10 a.m., the elevated temperatures inside the building from additional decomposing super sacks of materials continued to affect other areas of the warehouse. As shown in steps 1 through 3 of **Figure 42**, the heat emitted by decomposing oxidizers also activated the sprinklers in additional zones of the warehouse (see **Section 2.2**).

**Figure 42.** Depiction of the progression of the second fire in Plant 12 Storage Warehouse caused by a multiple-point heat source. (Credit: CSB)

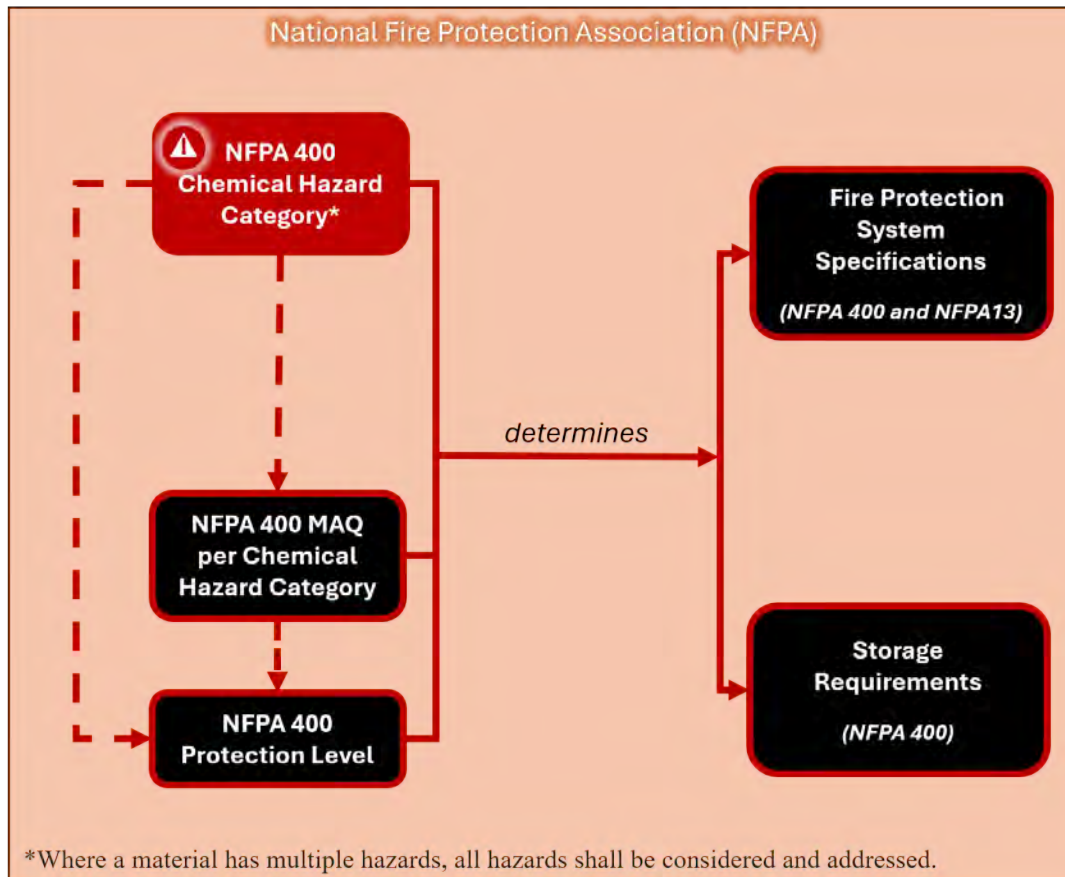
Primarily focusing on the oxidizing properties of these pool-treatment chemicals in NFPA 400 Annex G, without specifically noting their additional hazardous categories, could possibly lead a user to overlook their corrosivity and water reactivity. As illustrated in **Figure 50**, misclassification of the chemical hazard category or failure to properly assess each hazard category and appropriately address the most restrictive requirements directly affects MAQ determinations and Protection Level requirements, which, in turn, impact storage requirements and fire protection system design (black round rectangles).

**Figure 50.** Impact of incomplete hazard classification on NFPA 400 and NFPA 13 requirements. (Credit: CSB)

For example, a material classified and managed only as a Class 1 oxidizer has an MAQ that is “not limited,” with no Protection Level required. If the same material is also considered corrosive, an MAQ of 10,000 lbs. applies, and the corrosive environment must be addressed, causing additional code requirements. **Table 14** summarizes some significant differences between assigning a chemical to a single versus multiple hazard categories. These differences materially impact storage, handling, and fire protection system design.

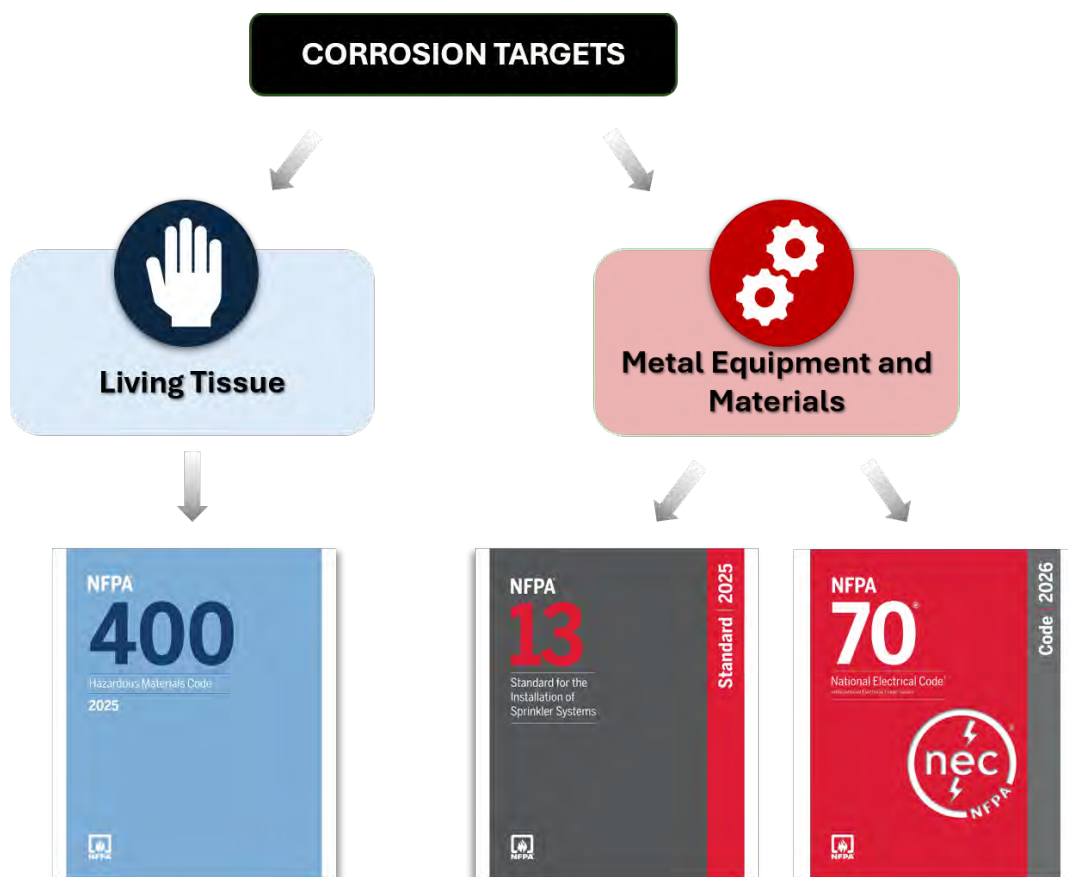
The resulting safety requirements are not harmonized across the standards, leading to differing interpretations of how corrosion should be addressed. **Figure 51** illustrates how each NFPA standard targets a distinct aspect of corrosion within its respective scope.

**Figure 51.** Corrosion targets for NFPA 400, NFPA 13, and NFPA 70 [94]. (Credit: CSB)

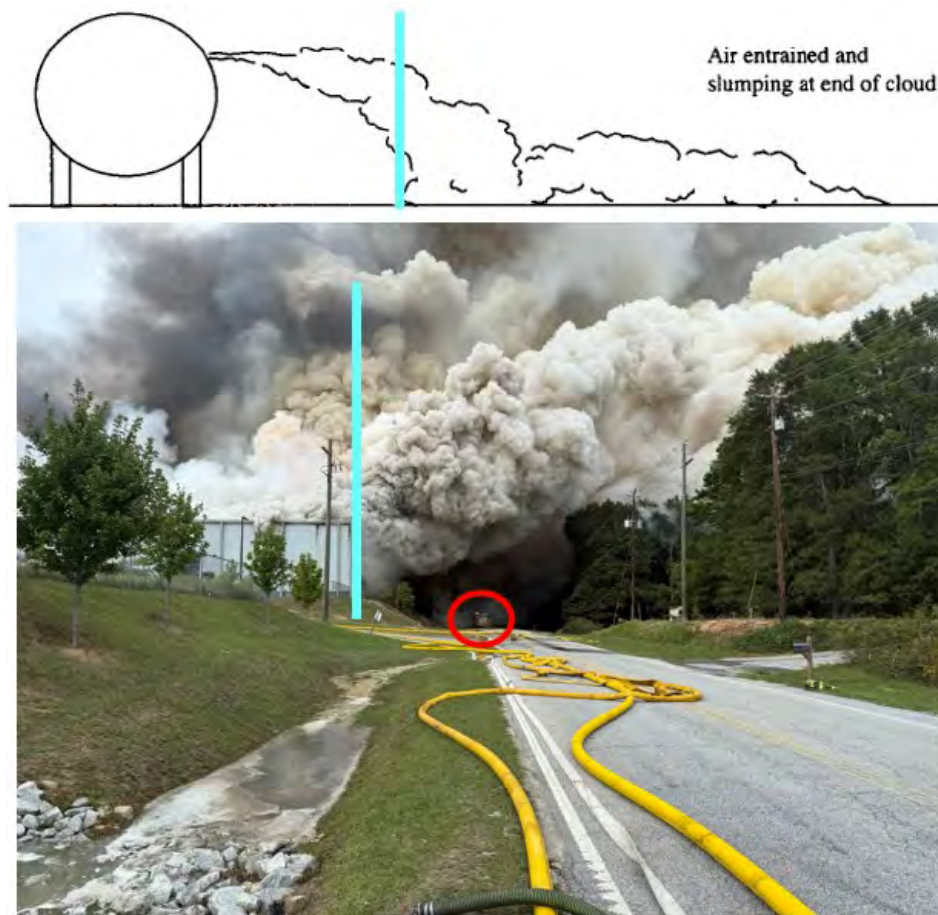
Air monitoring by EPA following the September 2024 Conyers incident indicated that the observed plume from the site contained bromine, chlorine, and hydrogen chloride.<sup>b</sup> Per EPA’s *Risk Management Program Guidance for Offsite Consequences Analysis*, bromine, chlorine, and hydrogen chloride are all classified as dense gases for EPA RMP off-site consequences modeling [100, pp. B-2 and B-4]. **Figure 52** shows the dense gas behavior of the plume during the incident, where a significant portion of the gas plume remained close to the ground, where it would have a greater impact at the ground level compared with a lighter buoyant plume. The light blue line in **Figure 52** shows the point at which the dense plume slumps to the ground, and the red circle shows the RCFR fire truck inundated by the thick ground-level plume.

**Figure 52.** Comparison of expected dense gas behavior to plume behavior observed during the Bio-Lab Conyers 2024 incident. (Credit: Wells [98, p. 40], at top; RCFR at bottom; annotated by CSB)

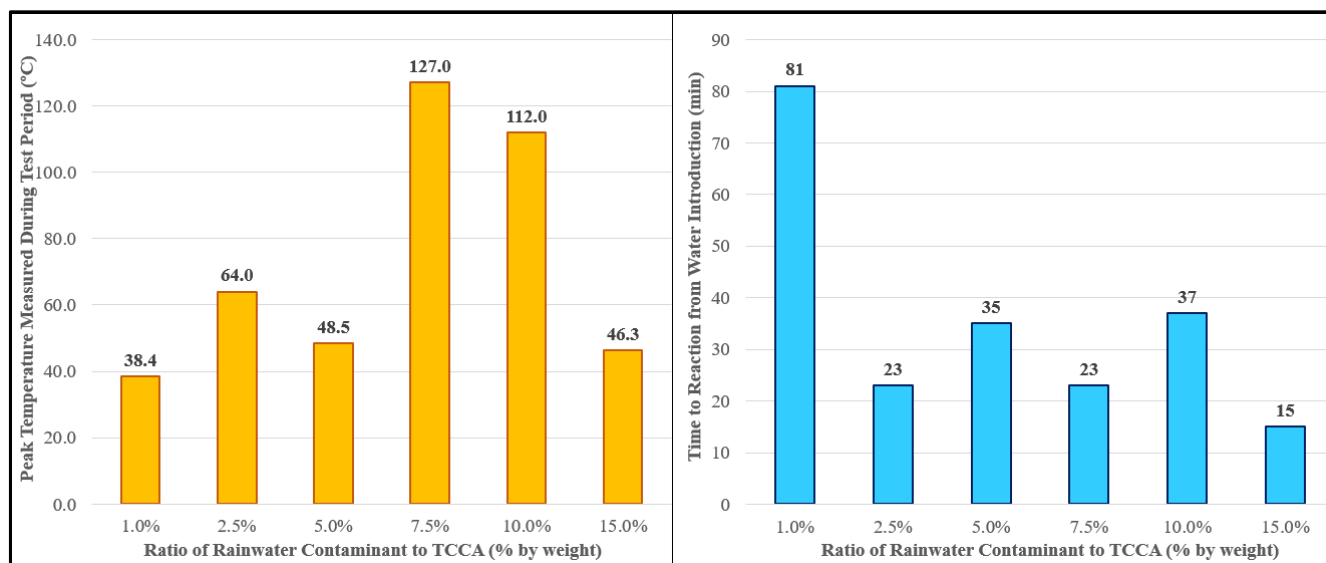
**Figure 54.** Summary of peak temperature (left) and time to reaction results (right) from TCCA and rainwater test series (2021). (Credit: Raw data from Bio-Lab, summary graphics developed by CSB)

Although all samples exhibited a temperature increase relative to ambient conditions (29°C), the highest peak temperatures measured were for the tests performed at concentrations of 7.5 percent and 10 percent water. For the samples in the concentration range of 2.5 percent to 10 percent water, the time between water exposure and onset of temperature rise was approximately 30 minutes. Upon initiation of reaction, active TCCA decomposition and elevated temperatures persisted for several hours for the samples tested at water concentrations of 2.5 percent, 5 percent, 7.5 percent, and 10 percent. For example, during the test for the 7.5 percent water concentration, although the time to reaction was 23 minutes, the peak temperature was not achieved until approximately 400 minutes, declining to approximately 40°C at 700 minutes. The 2021 testing results demonstrated that TCCA exhibits the strongest reaction concentration of approximately 7.5% to 10 percent water to total material.
