## Investigation Report

Published: June 12, 2019

On January 22, 2018, a blowout and rig fire occurred at Pryor Trust 0718 gas well number 1H-9, located in Pittsburg County, Oklahoma. The fire killed five workers, who were inside the driller's cabin on the rig floor. They died from thermal burn injuries and smoke and soot inhalation. The blowout occurred about three-and-a-half hours after removing drill pipe ("tripping") out of the well.

# Gas Well Blowout and Fire at Pryor Trust Well 1H-9

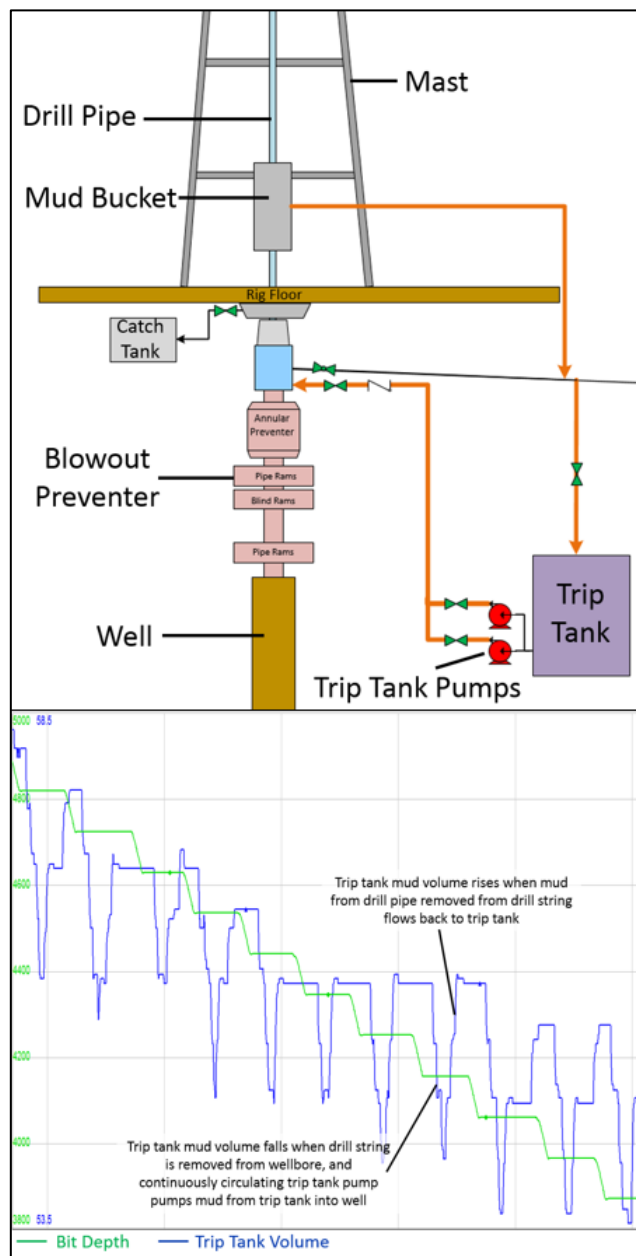
On Rig 219, the mud bucket discharge was routed to the trip tank. Level changes in the trip tank are a key indicator of mud gains or losses while tripping, and adding the mud into the trip tank from the mud bucket during the tripping operation confounded that information for the driller and company man. As the crew tripped out pipe, the trip tank volume fluctuated up and down from mud draining into the trip tank and from mud being pumped out of the trip tank (Figure 24). The driller communicated that he had never before tripped wet pipe out of the well with this lineup, and all of the volume fluctuations in the data made monitoring for the correct volume reduction in the trip tank difficult.

*Figure 24. Rig equipment alignment and data during tripping operation out of vertical portion of well. The crew was tripping wet pipe, and the mud from the pipe stands removed drained back to the trip tank, causing the trip tank volume to fluctuate.*

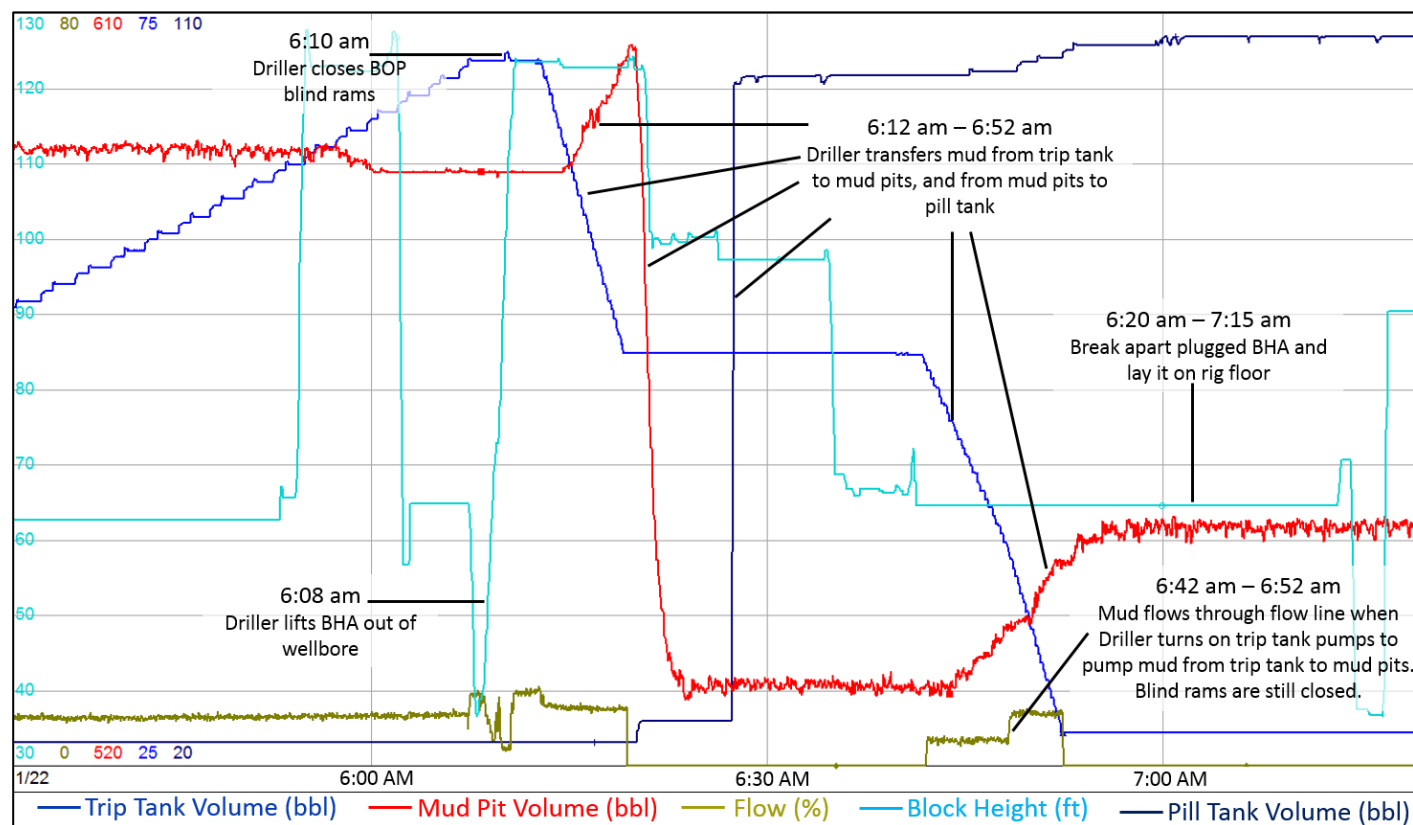
By 7:15 am, the day crew had broken apart the plugged BHA and laid it on the rig floor (Figure 27).

Figure 27. Rig Data between 5:32 am and 7:20 am on Monday, January 22, 2018 (day of incident).

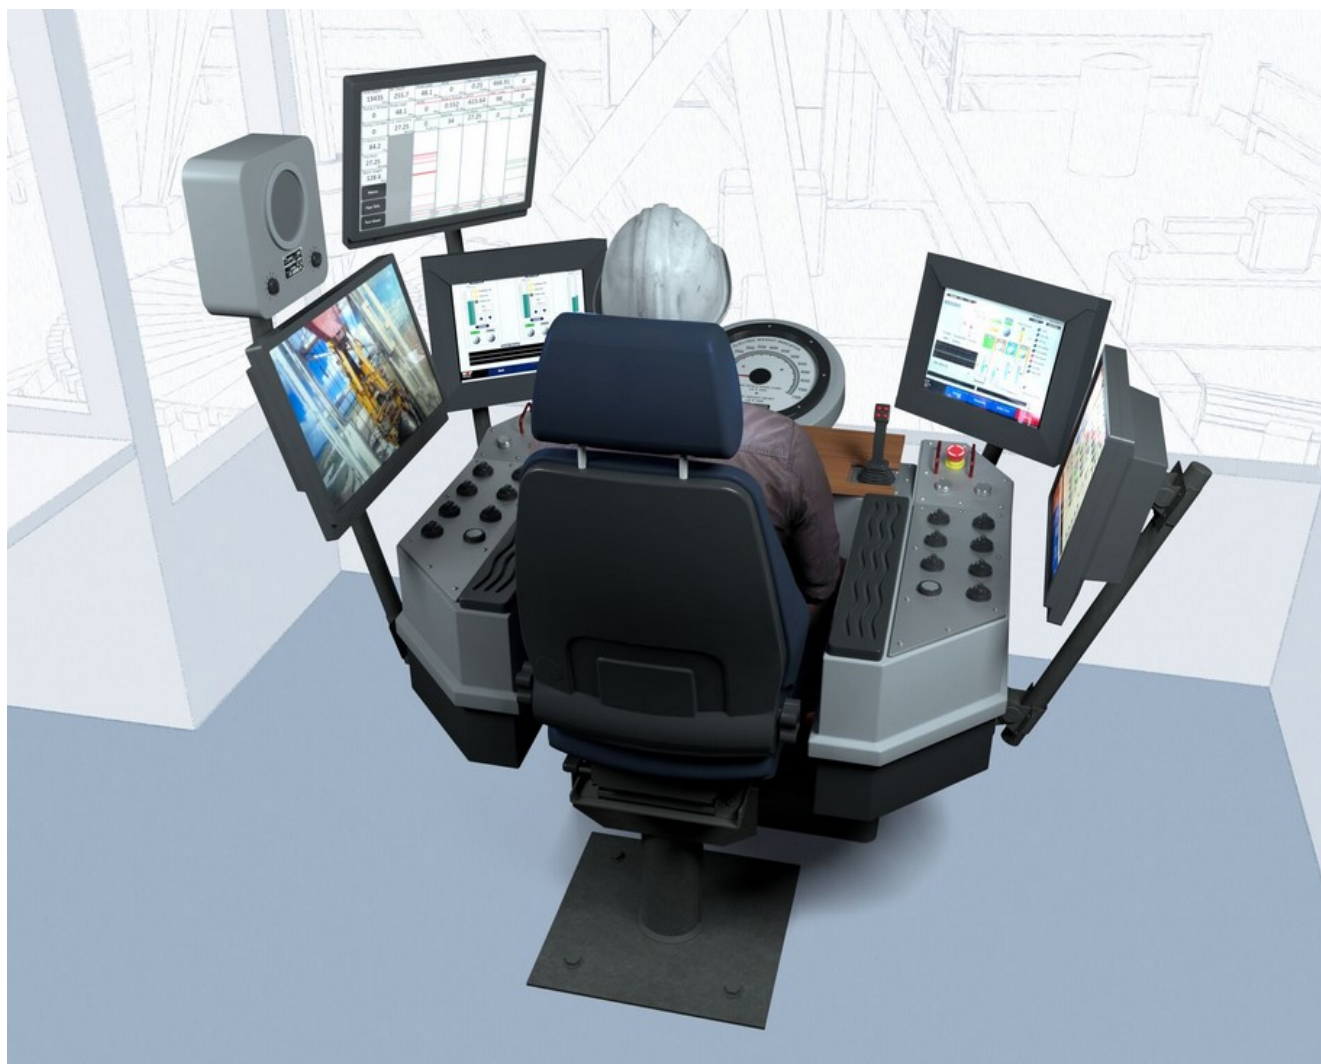
The driller's cabin was equipped with several monitors displaying data and camera footage essential to the drilling operation. A re-creation of the setup is shown in Figure 37. The top screen to the left of the driller displayed an aggregate of the drilling data, including drill bit depth, weight on bit, torque, stroke count, mud pit volumes, trip tank volume, gain/loss, mud return flow, and other parameters. The other monitors in front of the driller displayed data for the drawworks,<sup>a</sup> pump parameters, top drive parameters,<sup>b</sup> and camera feed to watch drill pipe latching operations.

*Figure 37. Depiction of driller console on Rig 219. The upper screen to the left of the driller displayed the aggregate of the drilling data.*

On the drilling data monitor (upper left monitor), the driller could adjust alarm set points, silence individual alarms, silence all alarms for all parameters by turning the alarm horn off, or completely deactivating the alarm system so that both the horn and visual indications of alarms would be disabled. The data system installed was provided by Pason,

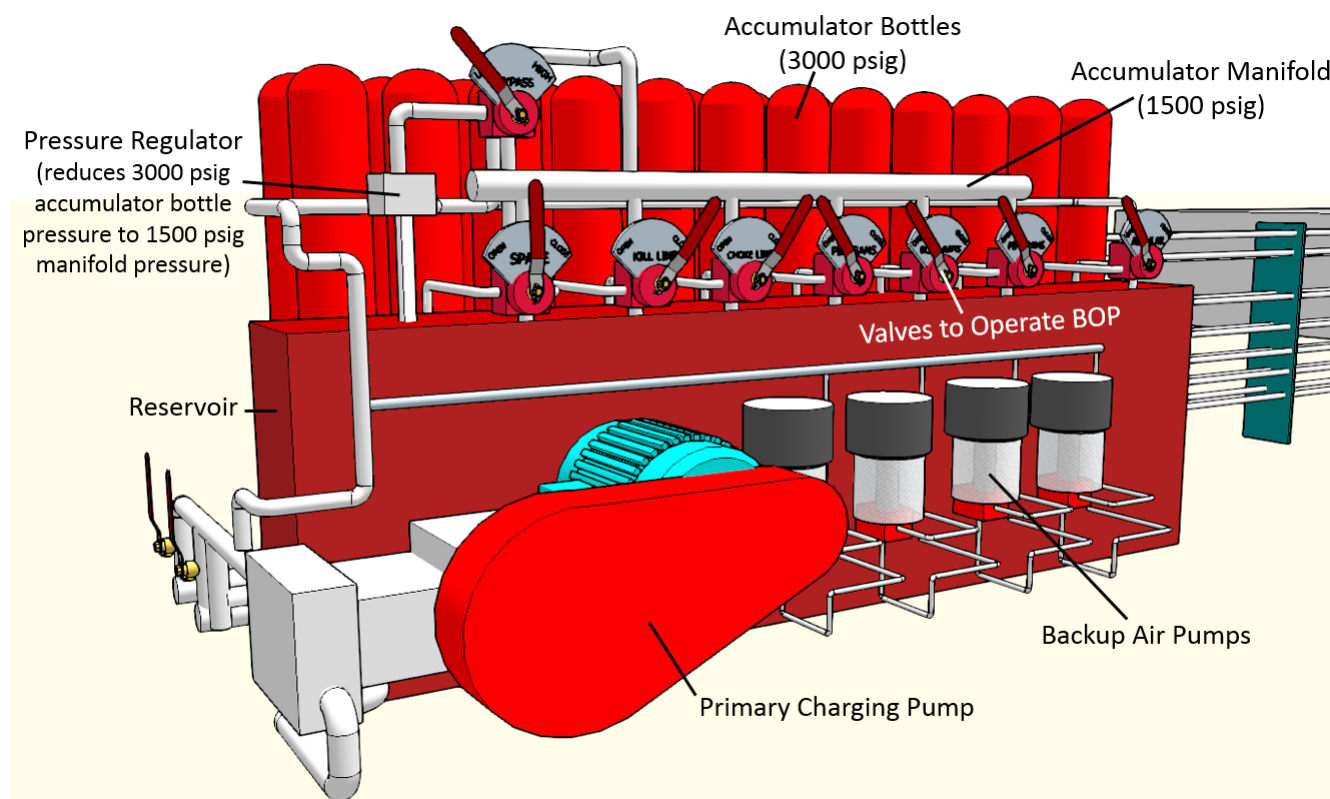
Blowout preventers are hydraulically operated equipment, using high-pressure hydraulic fluid stored in an accumulator.<sup>a</sup> A depiction of the Rig 219 accumulator is shown in Figure 48.<sup>b</sup> Hydraulic fluid at 3,000 psig is stored in the accumulator bottles. That pressure is reduced to 1,500 psig through a pressure regulator for the manifold. Hydraulic fluid in the accumulator manifold is used to function the blowout preventer.

<sup>b</sup> The accumulator handle labeled “Kill Line” was not in use on Patterson Rig 219. It was effectively a spare valve.

Figure 48. Depiction of the Patterson Rig 219 accumulator. The top valve on the accumulator is the Bypass valve. From left to right, the bottom valves are Spare, Kill Line, Choke Line, Bottom Pipe Rams, Blind Rams, Top Pipe Rams, and Annular Preventer.

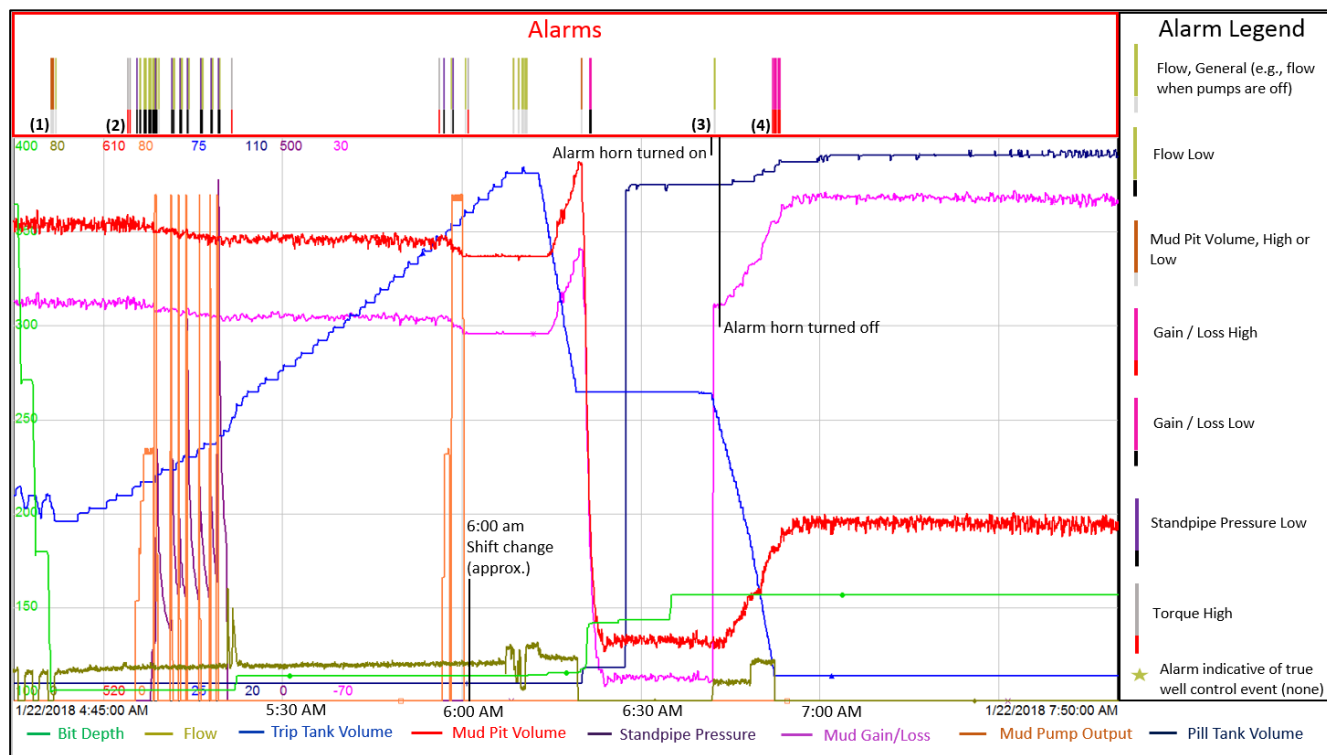
During this period a shift change occurred at around 6:00 am. At 6:42 am, the alarm system was reactivated, likely by the new driller on tour. Non-critical alarms would have been continuously sounding while the alarm system was on. Twenty seconds after the alarm system was turned on, it was turned off again. The alarm horn remained off through the blowout at 8:36 am.

Figure E- 4. Information from alarm system data, indicating what alarms would have activated between 4:50 am and 7:50 am during the rig floor operations, had the alarm system been turned on. None of the alarms would have alerted to the well control event. Information about the specific alarms is in Table E- 4 below. The numbers in parentheses correspond with the note numbers in Table E- 4.
