Improving Public and Worker Safety at Oil Refineries

Draft Report of the Interagency Working Group on Refinery Safety Governor Jerry Brown

July 2013

CHEVRON RICHMOND REFINERY FIRE

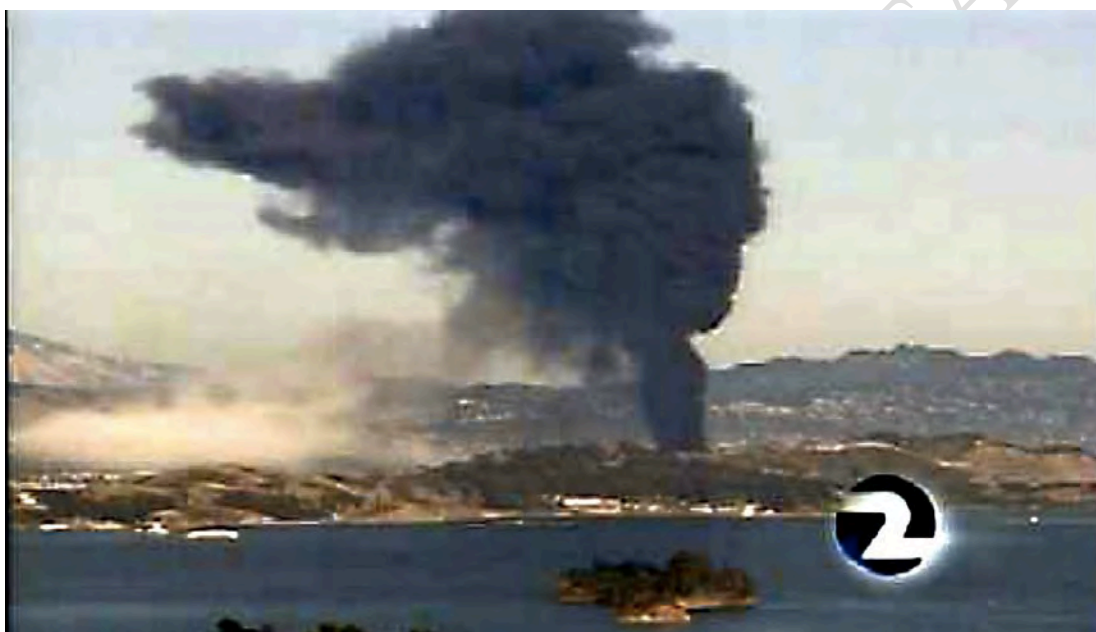
2. The ignition and subsequent continued burning of the hydrocarbon process fluid resulted in a large plume of unknown and unquantified particulates and vapor traveling across the Richmond, California, area (Figure 2 and Figure 3). This resulted in a Community Warning System (CWS) Level 3 alertⁱ and a shelter-in-placeⁱⁱ was issued at 6:38 pm¹ for the cities of Richmond, San Pablo, and North Richmond. It was lifted later that night at 11:12 pm after the fire was fully under control. In the weeks following the incident, nearby medical facilities received over 15,000 members of the public seeking treatment for ailments including breathing problems, chest pain, shortness of breath, sore throat, and headaches. Approximately 20 people were admitted to local hospitals as inpatients for treatment.

Figure 2. Vapor cloud (white) over Richmond area and smoke (black) from Chevron Richmond Refinery fire as seen from San Rafael in Marin County.²

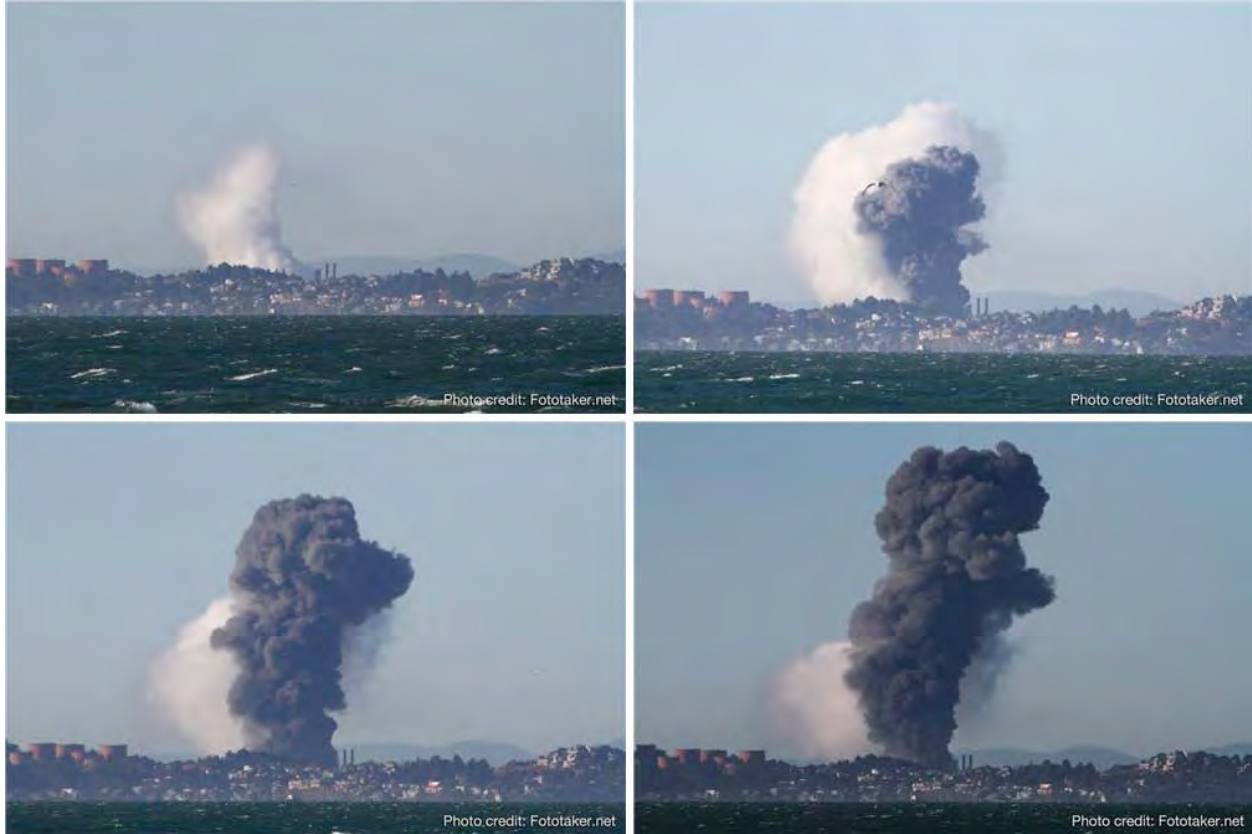
Figure 3. Initial vapor cloud formation (white cloud) and subsequent ignition (black smoke) as seen from a pier in San Francisco, California.

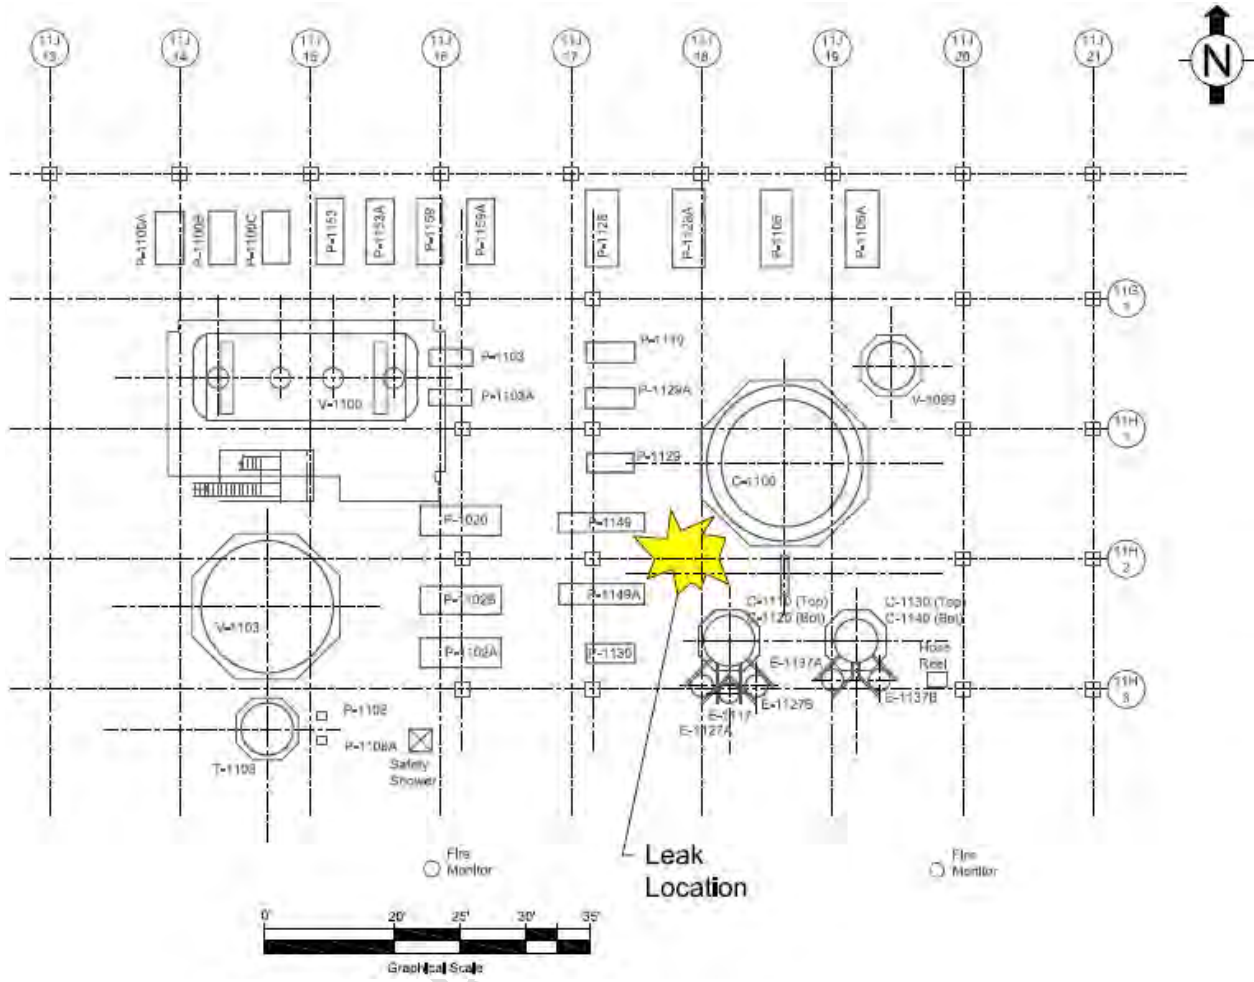
3. The incident occurred from the piping referred to as the “4-sidecut” stream, one of several process streams exiting the C-1100 Crude Unit Atmospheric Column (Figure 4).ⁱ A plot plan of the crude unit shows the leak location relative to C-1100 (Figure 5). As shown in Figure 6, light gas oil (the crude unit 4-sidecut process fluid) exits the atmospheric column via a 20-inch nozzle and is split into a 12-inch line and an 8-inch line. The August 6, 2012, pipe rupture (Figure 7) occurred on a 52-inch long componentⁱⁱ of the 4-sidecut 8-inch line (the 52-inch component). The line operated at a temperature of 640 degrees Fahrenheit (°F)ⁱⁱⁱ and had an operating pressure of approximately 55 pounds per square inch gauge (psig) at the rupture location. At the

Figure 5. Overhead view of the equipment in the #4 Crude Unit showing the leak location, commonly referred to as a plot plan.

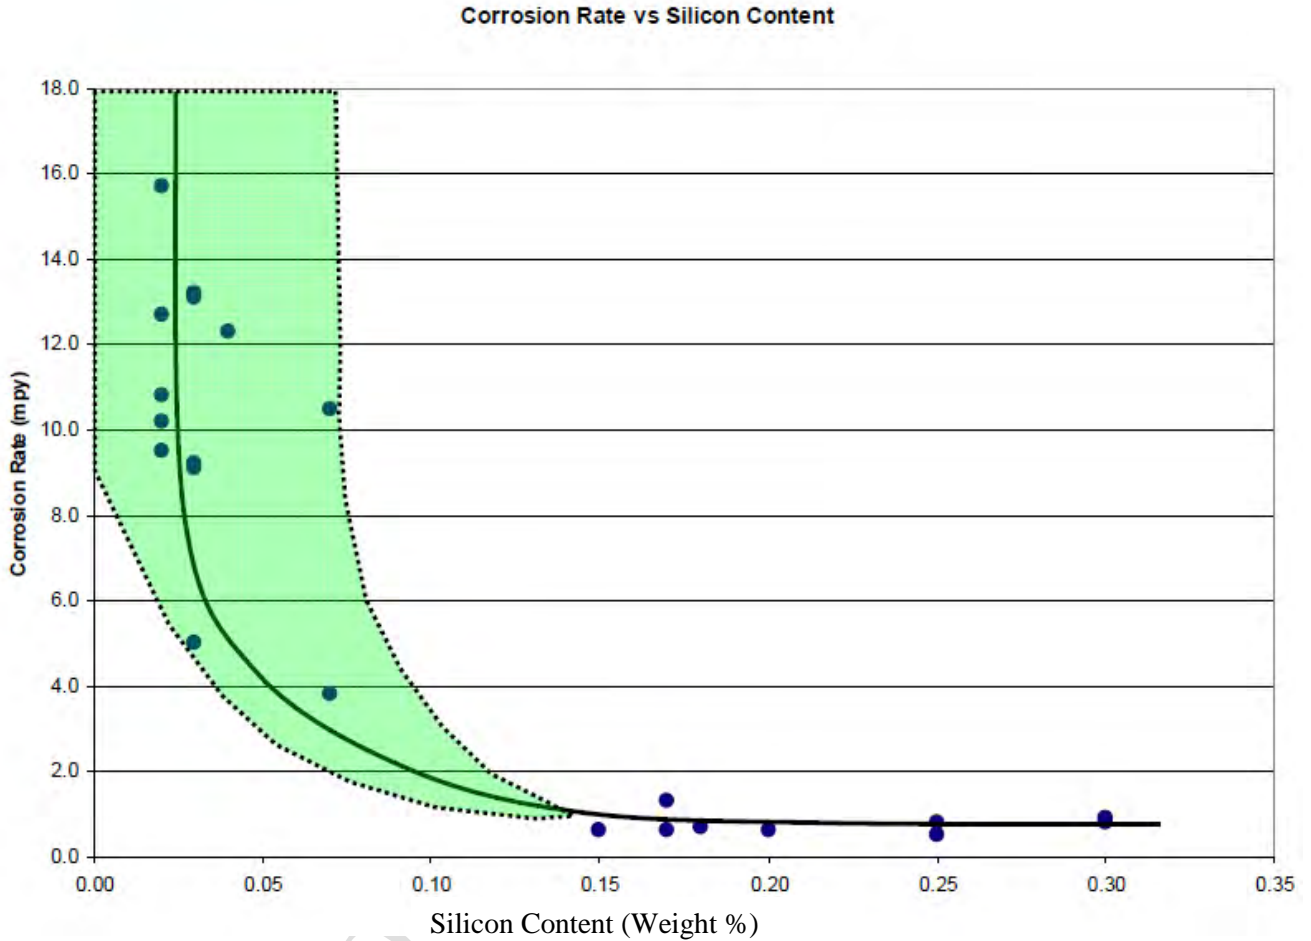
Figure 8. This graph shows how corrosion rates increase in carbon steel containing decreasing percentages of silicon. This information can be found in Annex C of API RP 939-C.ⁱ

10. The refining industry has been aware of increased rates of sulfidation corrosion in low-silicon carbon steel piping since as early as 1974,¹³ nearly 40 years before the August 6, 2012, incident and two years before the Chevron crude unit was constructed. Prior to the incident, Chevron documented its understanding of the significant consequences of sulfidation corrosion. This is reflected in Chevron’s *Corrosion Prevention and Metallurgy Manual*, which states:

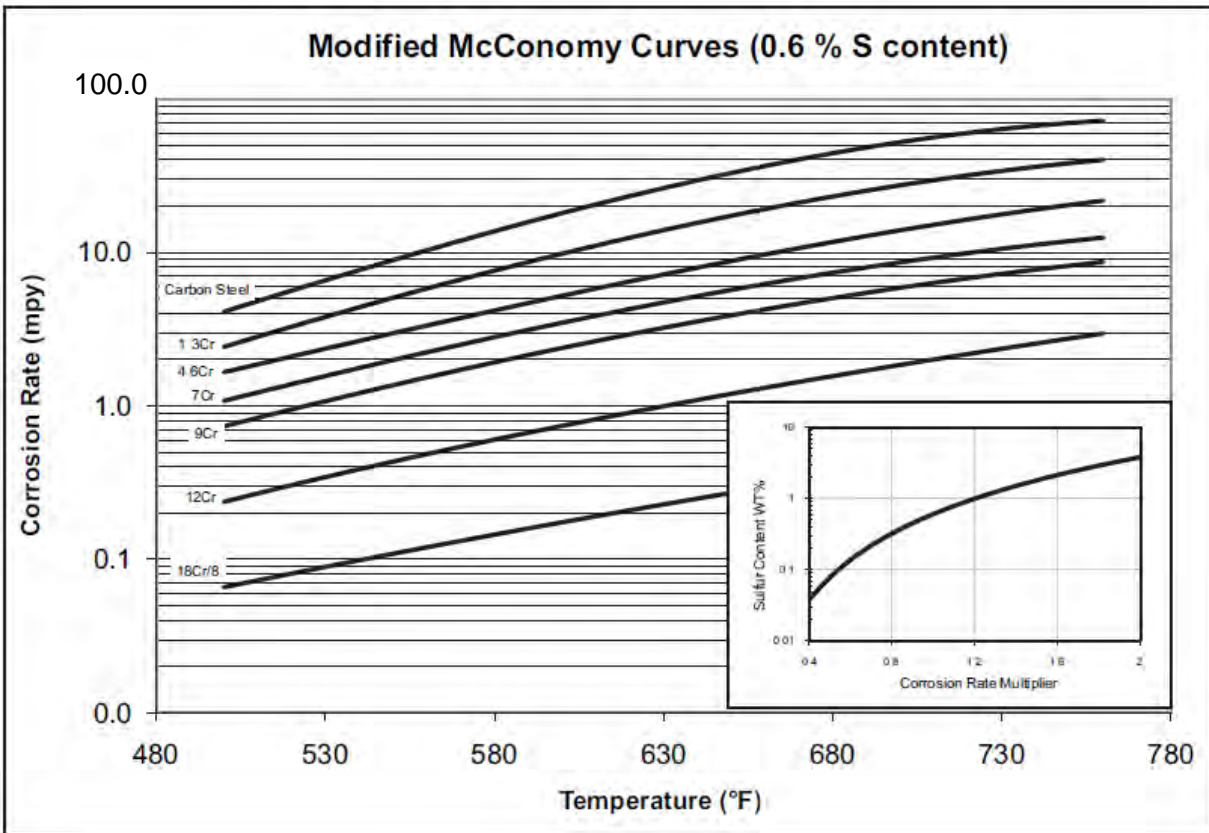
This makes alloys with higher chromium content an inherently safer choice in high temperature sulfidation corrosion environments.ⁱ As shown in the Modified McCconomy Curvesⁱⁱ (Figure 10) from API RP 939-C, 9-Chromeⁱⁱⁱ corrodes 15 times faster than stainless steel,^{iv} and carbon steel^v corrodes 125 times faster than stainless steel.²⁷

Figure 10. Modified McCconomy Curves from API RP 939-C.

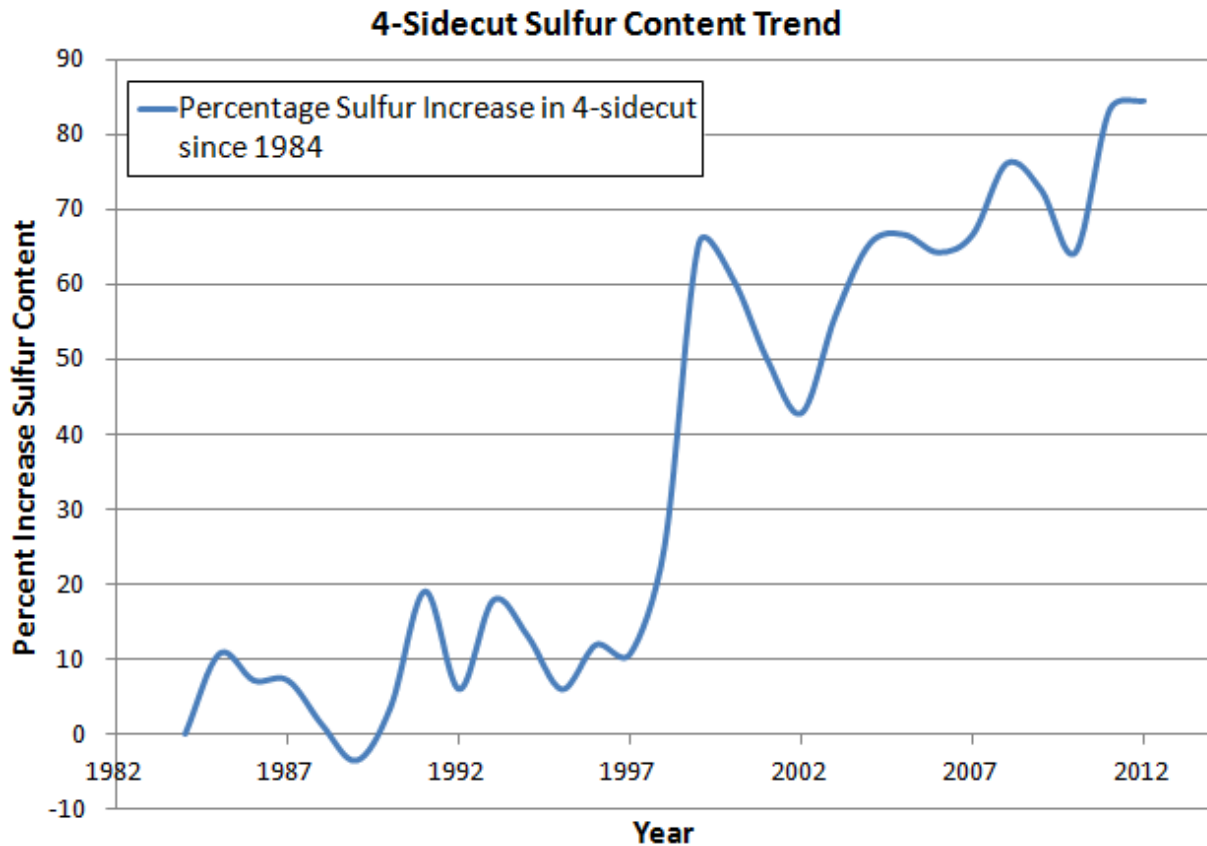
running more high-sulfur content crudes, the sulfur content in the 4-sidecut line steadily increased (Figure 14), as discussed below.

Figure 14. Graph shows the percentage increase from 1984 values of the sulfur content in the 4-sidecut.

40. When Chevron introduces a new crude, an MOC is generated to evaluate the potential impact on the refinery.ⁱ While Chevron stayed under its established crude unit design basis for total wt. % sulfur of the blended feed to the crude unit, the sulfur composition significantly increased over time. This increase in sulfur composition likely increased corrosion rates in the 4-sidecut line. Chevron did not conduct an MOC analyzing the impact that increases in sulfur composition would have on corrosion in the crude unit. Chevron also did not change its corrosion monitoring programs in response to the increased sulfur content.

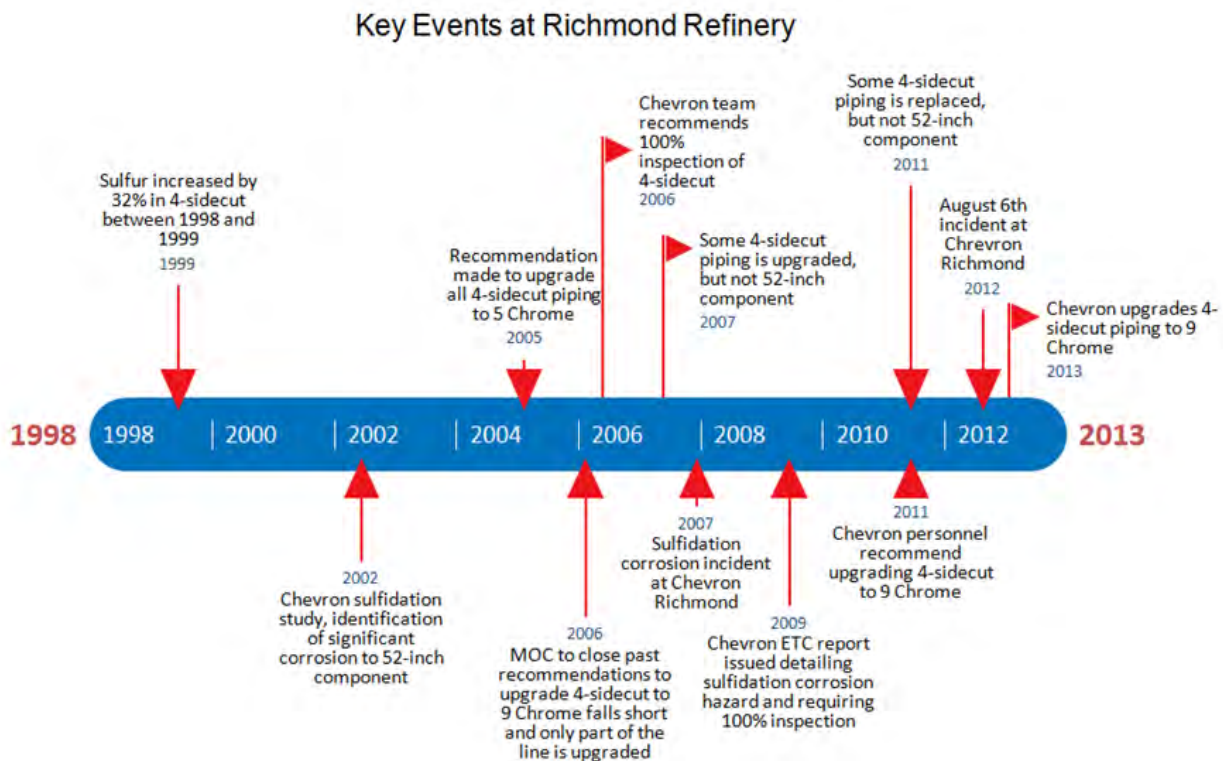
44. In the ten years prior to the incident, a small number of Chevron personnel with knowledge and understanding of sulfidation corrosion made at least six recommendations (listed in the following six paragraphs and included in Figure 15) to increase inspection or upgrade the metallurgy in the 4-sidecut piping. The recommendations made by these personnel were not implemented by Chevron management.

Figure 15. Key events at the Richmond refinery between 1998 and 2013.

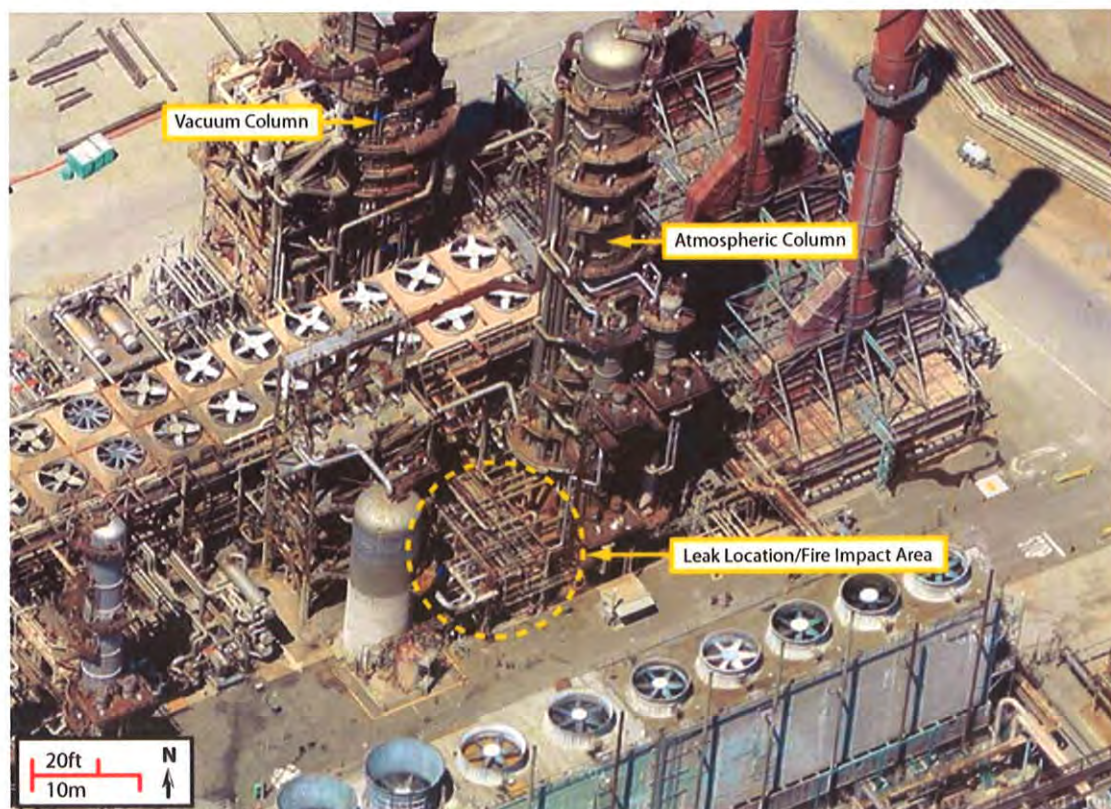
On August 6, 2012 at approximately 1548 hours, a leak was discovered by an operator in an 8-inch diameter pipe carrying light gas oil (LGO) in the 4 Crude Unit (4CU) at the Chevron U.S.A. Inc. (CUSA) Refinery in Richmond, California (Refinery). At approximately 1830 hours, the hydrocarbon release from the pipe resulted in the formation of a white cloud, a subsequent fire, and a black smoke plume (collectively, the Incident). A shelter-in-place order was issued for the cities of Richmond, San Pablo, and North Richmond, which advised residents to remain indoors until the fire was controlled. The CUSA Fire Department (CFD), with assistance from Petrochemical Mutual Aid Organization and Municipal Mutual Aid, brought the fire under control and the shelter-in-place was lifted at 2312 hours on the same day. Six responders were treated for first-aid injuries (Appendix 1). The 4CU and a cooling tower sustained damage. The general location of the Incident is shown in Figure 1.

Figure 1. Overhead view of the 4CU prior to the Incident with the location of the rupture circled in yellow (image from Google Maps®).

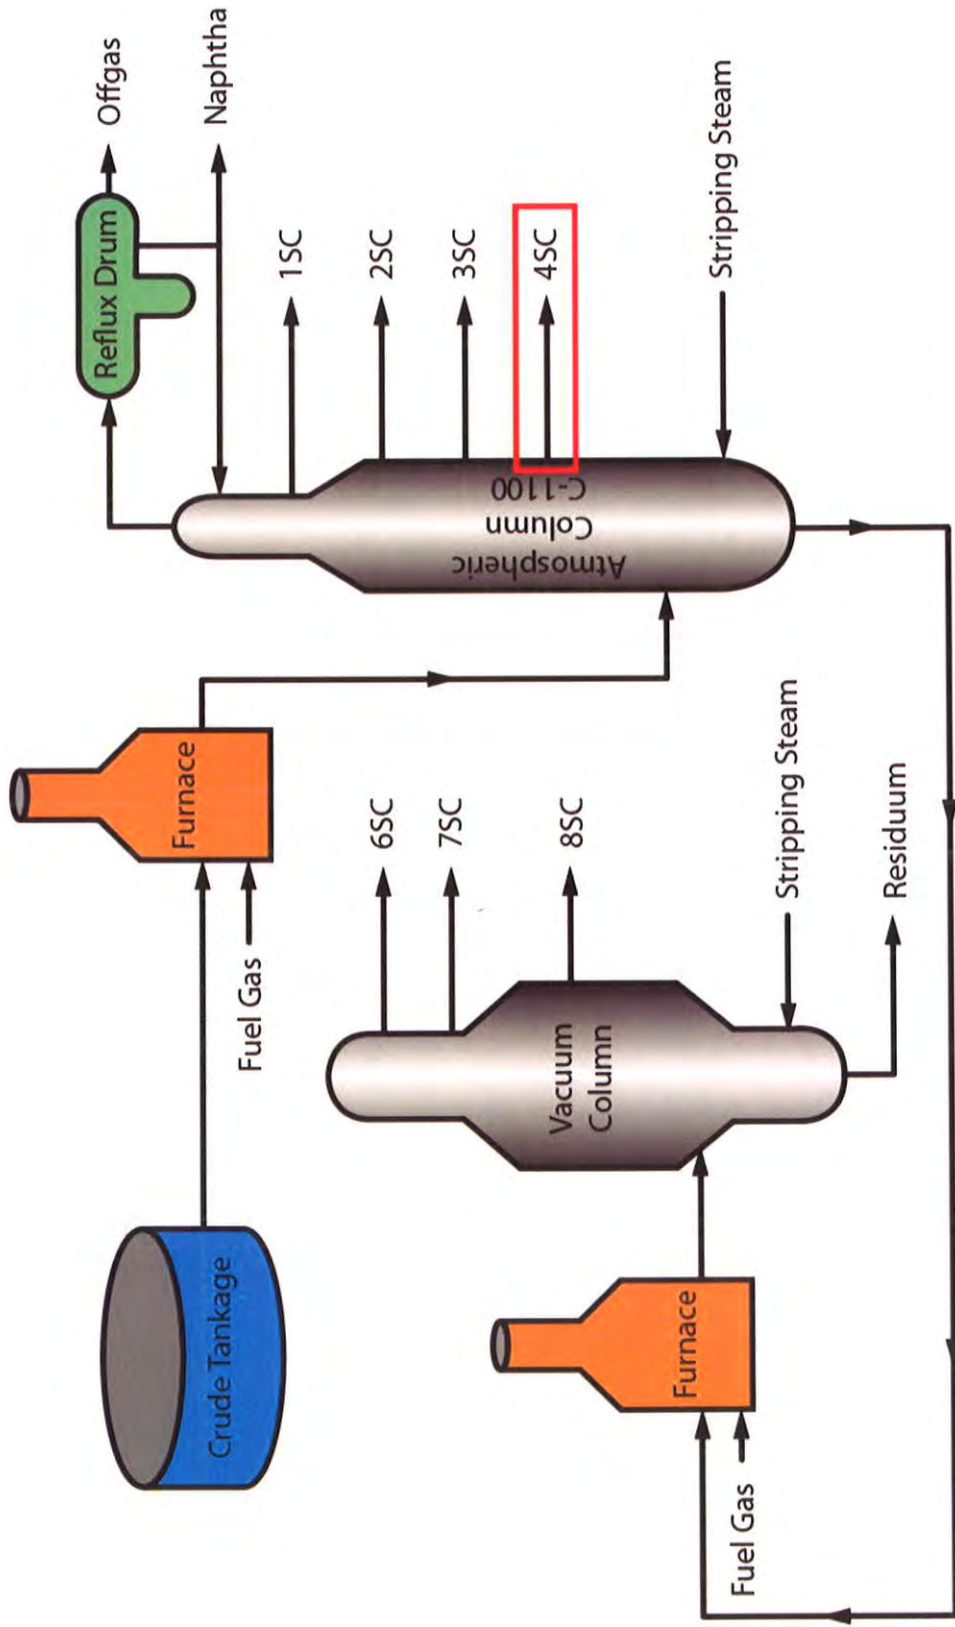
Figure 2. Simplified 4CU flow diagram. The failure occurred in the 4SC piping of the C-1100 (marked in red).

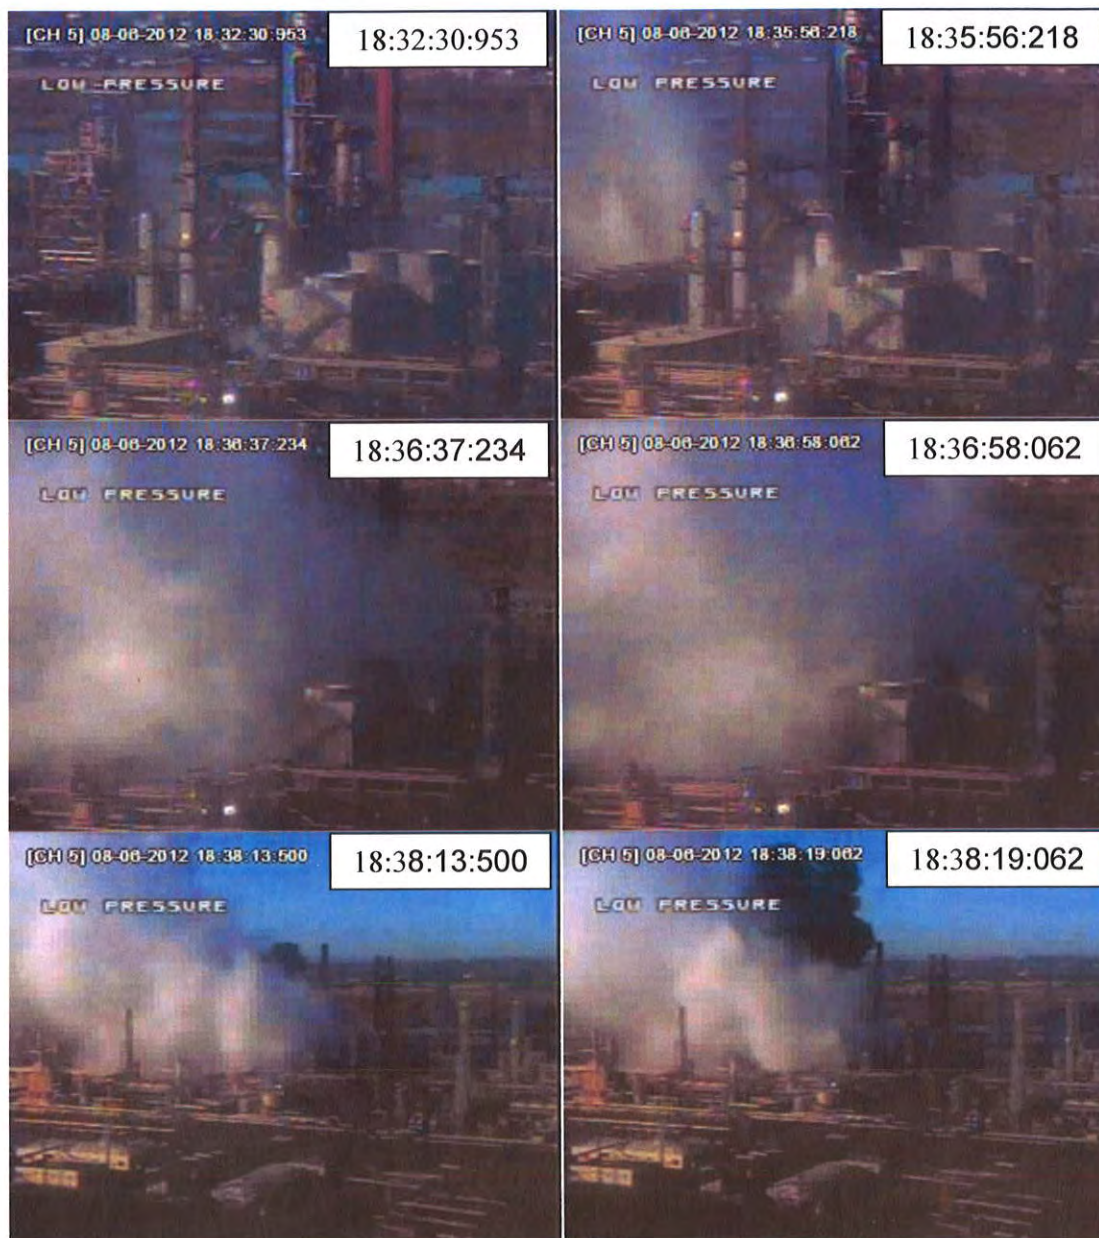
Figure 6. CUSA surveillance camera showing the 4CU (top left). A white cloud is shown forming (top-right and middle-right/left) for approximately 2 minutes and 30 seconds after the leak escalated and before the fire ignited (bottom, camera had been zoomed out). (The clock in these images is approximately 5-7 minutes ahead of actual time.)

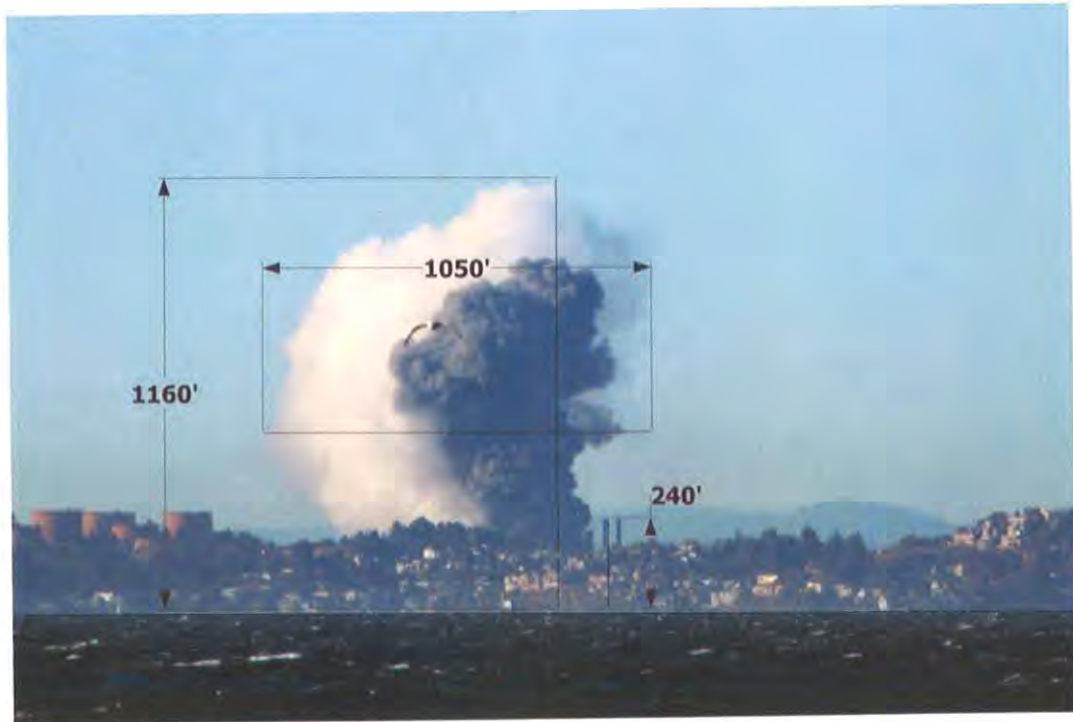
Just after ignition, a freelance photographer at Pier 39 in San Francisco and video footage shot from Marine View Avenue in Point Richmond captured the white cloud. Analysis was performed to estimate the size of the white cloud at the time witnesses reported the fire started. The largest dimensions of the white cloud were approximately 1,100 feet wide (in the east-west direction) and approximately 1,200 feet high, as shown in Figure 13.

Figure 13. Estimated size of the white cloud utilizing a photograph taken at Pier 39 in San Francisco. The 240 foot dimension shows the height of the 4CU furnace stacks.
