## **FINAL INVESTIGATION REPORT**

### **CARIBBEAN PETROLEUM TANK TERMINAL EXPLOSION AND MULTIPLE TANK FIRES**

#### **CARIBBEAN PETROLEUM CORPORATION (CAPECO)**

REPORT NO. 2010.02.I.PR

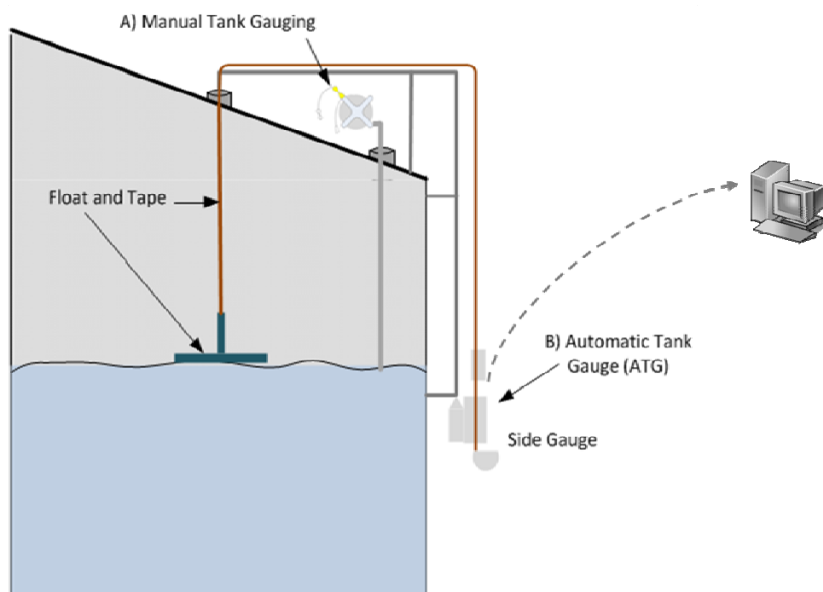
Figure 3: Manual and Automatic Tank Gauging. (A) Manual Gauging requires an operator to use a tape and measure to determine the liquid levels inside the tank. (B) Automatic Tank Gauging (ATG) requires an operator to read a level measurement from a tank gauge mounted to the side of the tank.

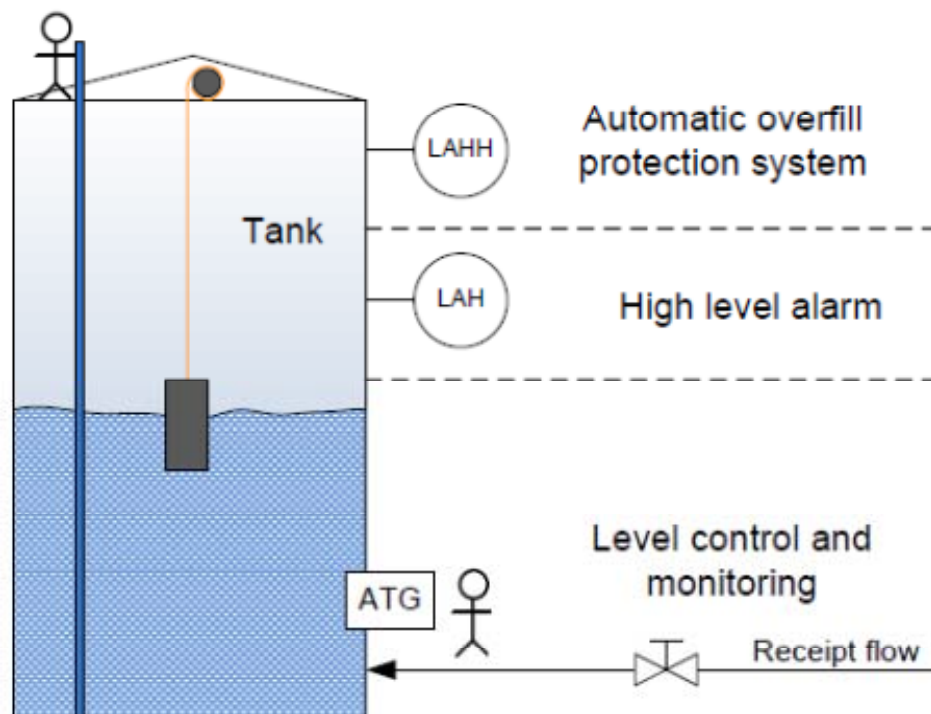
Figure 13: A comprehensive overfill prevention system includes the ATG, high level alarm (LAH), and automatic overfill prevention system (LAHH), in addition to the operator and facility procedures that govern, monitor, and control the flow of fuel into a tank.

CAPECO lacked a reliable automatic level control and monitoring system for measuring tank levels. (See Figure 12 and Figure 13.) The automatic gauging system at CAPECO, described in Section 3.6.3, had a history of repeated failures and prolonged out-of-service periods. On the night of the incident, the float and tape device inside Tank 504 became stuck and the transmitters for Tanks 107 and 409 were not receiving data from the side gauge on Tank 409; therefore, data on the tank liquid level and a calculated fill rate into 409 were not available in real time on the computer. The computer monitoring system was often compromised by outages from lightning strikes and accidental breakage of the computer cables after maintenance activities in the tank

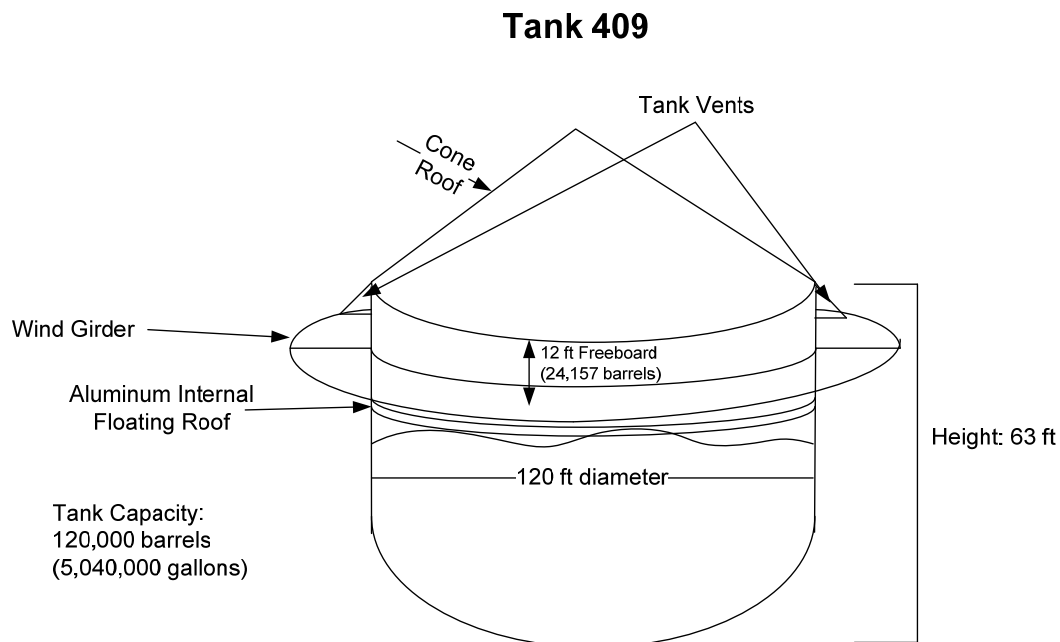
Figure 14: Tank 409 Specifications

to numerous operational limitations. Tank 409 had a fixed cone roof with an aluminum internal floating roof (IFR), and a freeboard<sup>72</sup> of 12 feet (24,157 bbls). (See Figure 14 for Tank 409 specifications.) Aluminum IFRs are prone to corrosion when exposed to caustic liquids but sufficient for petroleum and organic materials. An internal floating roof can fail by means of turbulence,<sup>73</sup> roof submersion,<sup>74</sup> seal issues, and fatigue.<sup>75</sup>
