DuPont La Porte, Texas Chemical Facility Toxic Chemical Release

Interim Recommendations

Investigation: 2015-01-I-TX
Incident Date: November 15, 2014
Issue Date: September 30, 2015

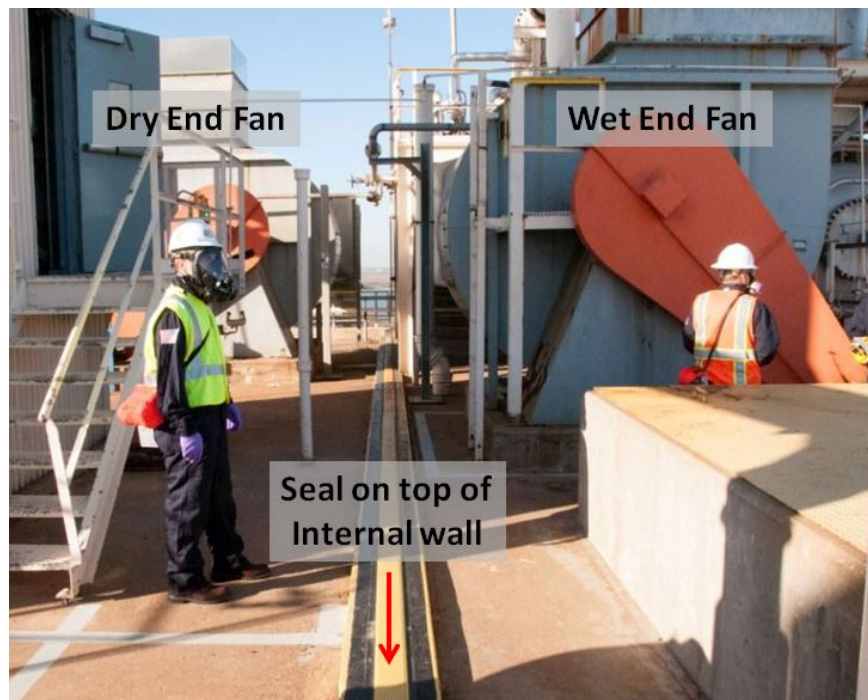
Figure 4. Roof of the manufacturing building showing the dry end fan (left), wet end fan (right), and location of the internal wall (middle) that separates each side within the building.

9. The two sides of the building are separately ventilated by fans located on the roof of the building as shown above in Figure 4. The manufacturing building is designed to make use of these roof-mounted fans via a dilution air ventilation system that operates as shown in Figure 5 through Figure 8. Fresh air is drawn into each floor on each side of the building, entering at floor level through a mechanical louver system.³⁷ Air is designed to flow from the fresh air louvers, across

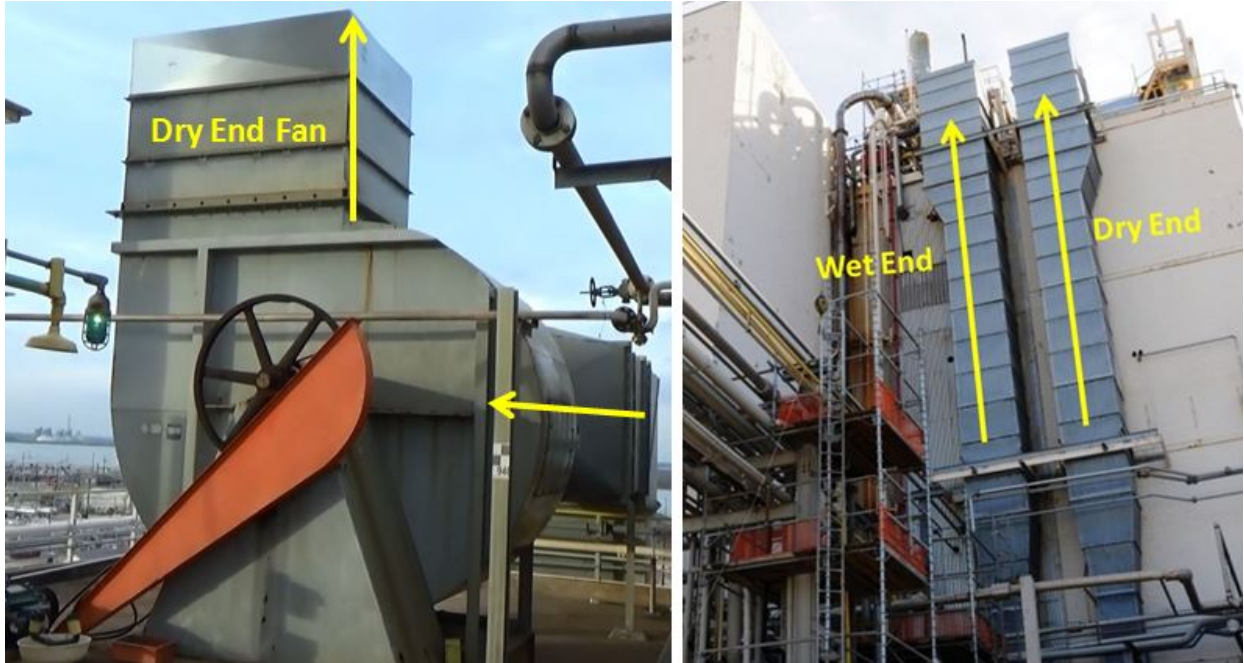
Figure 8. The dry end fan (left photo) and the exhaust air duct work (right photo). The exhaust air ducts from each floor are connected on the north side of the manufacturing building and air is pulled up through the fans and exhausted to atmosphere. Note – the dry end fan was not operational at the time this photo was taken.

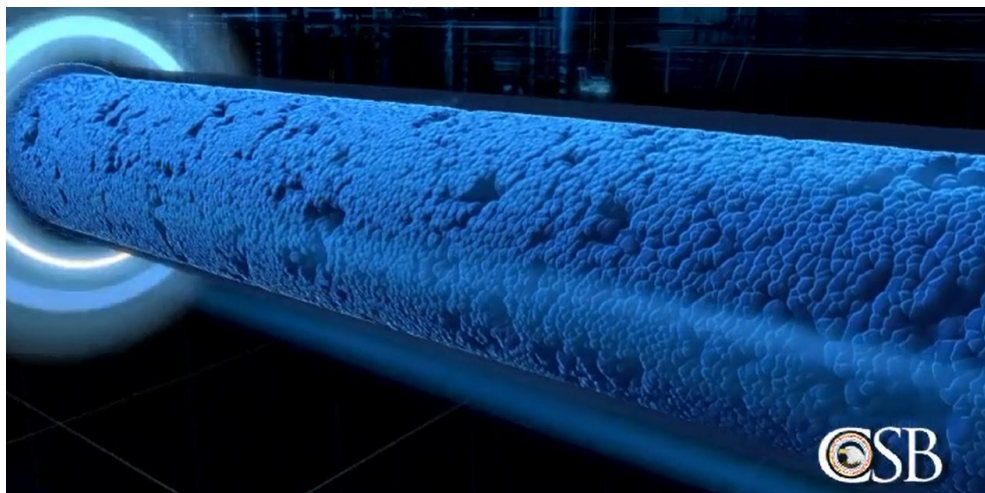
15. Modifications to the AAO concentration control system were made to address the diluted AAO. On Wednesday, November 12, 2014, DuPont operators attempted to restart the Lannate[®] process. However, during the shutdown, the methyl mercaptan reaction section, which generates a salt-slurry material, had plugged (Figure 12), and flow could not be established to accomplish the restart.

Figure 12. Snippet from CSB animation depicting the salt-slurry plugging within the methyl mercaptan reaction system.

16. Plugging of the equipment by the salt-slurry material following a shutdown is common. However, even though routine practices existed there were no written procedures for how to clear the reaction system. To clear the system, operators put hot water both outside and inside of the equipment, a historical site practice that typically clears the plug. Eventually, the salt-slurry

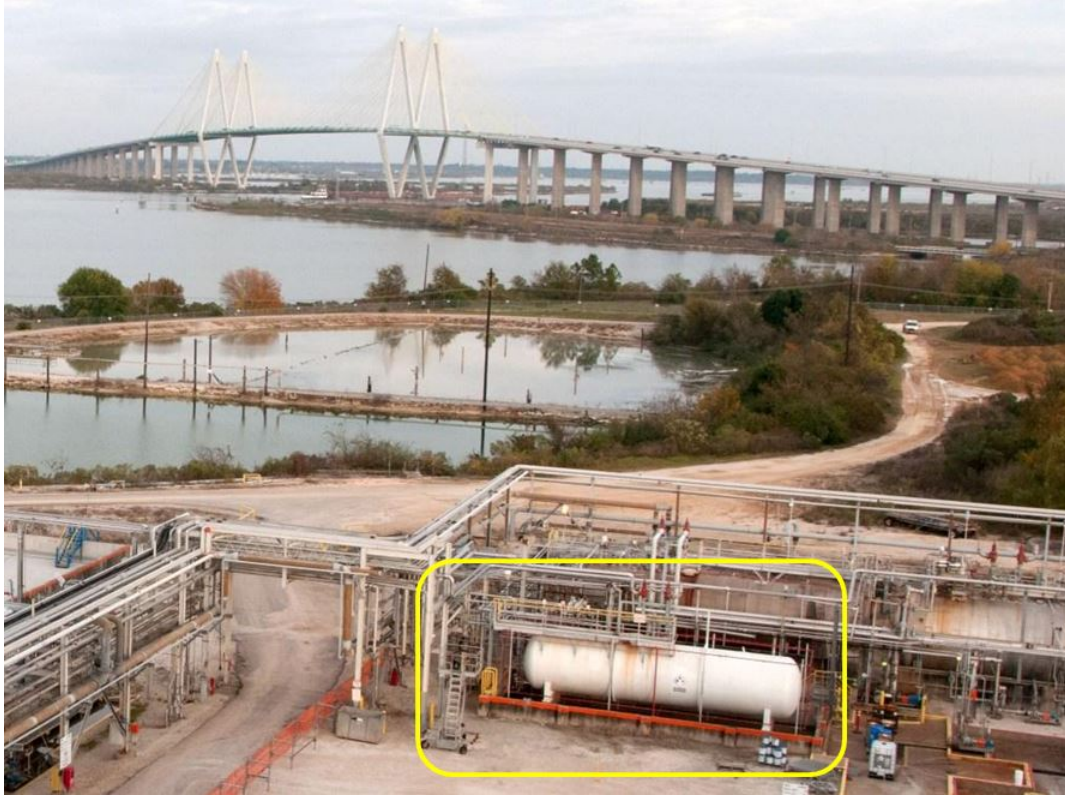
17. A review of process data revealed that on Wednesday night (November 12, 2014), the level in the methyl mercaptan storage tank (Figure 13) rose approximately 2%. Approximately 2,000 pounds of water had likely been inadvertently sent to the methyl mercaptan storage tank as a result of the operational activities that took place during attempts to clear process equipment plugging in the reactor system fed from the upstream methyl mercaptan storage tank.⁴⁹ This tank level rise was not noticed at the time.⁵⁰ The methyl mercaptan storage tank and the feed line to the reaction system now contained a mixture of methyl mercaptan and water.

⁵² Although the methyl mercaptan hydrate with water had been identified in DuPont’s methyl mercaptan technical standard and in PHAs years earlier, DuPont never implemented safeguards, such as heat tracing, or developed a procedure to safely dissociate the hydrate.

Figure 13. The yellow box outlines the 18,000 gallon methyl mercaptan storage tank at the DuPont facility in La Porte, Texas. Both the Lannate[®] and Vydate[®] insecticide processes use methyl mercaptan as a key raw material.

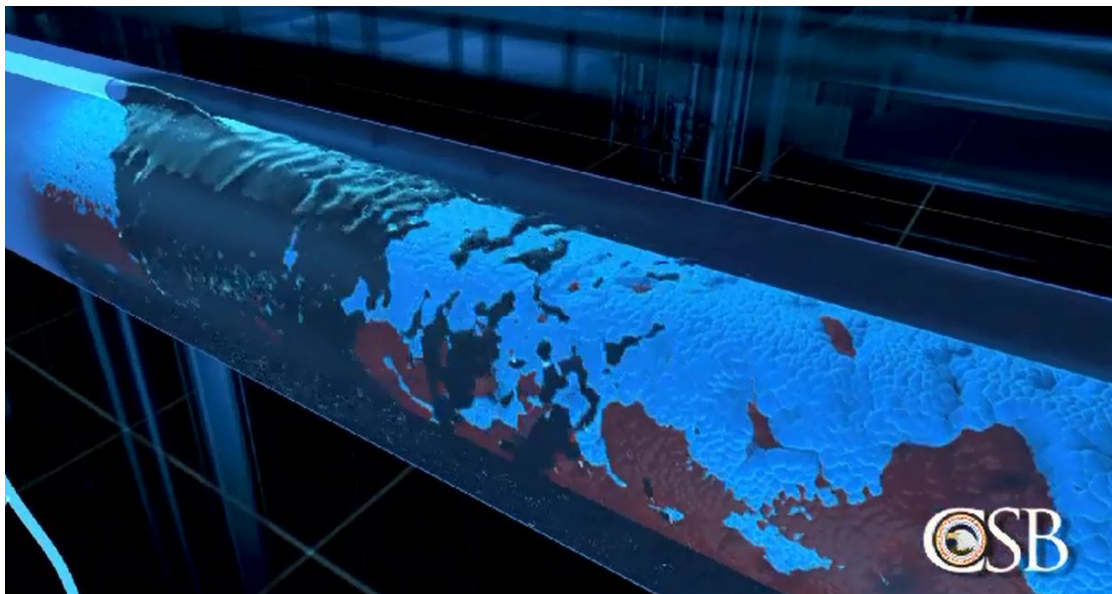
requested that operators put hot water on the outside of the methyl mercaptan feed piping, under the insulation, to warm the piping and its contents to dissociate the hydrate back to liquid methyl mercaptan and water (Figure 14).

Figure 15. Snippet from CSB animation depicting DuPont's use of hot water hoses placed under the insulation to provide heat to dissociate the hydrate back to methyl mercaptan and water.

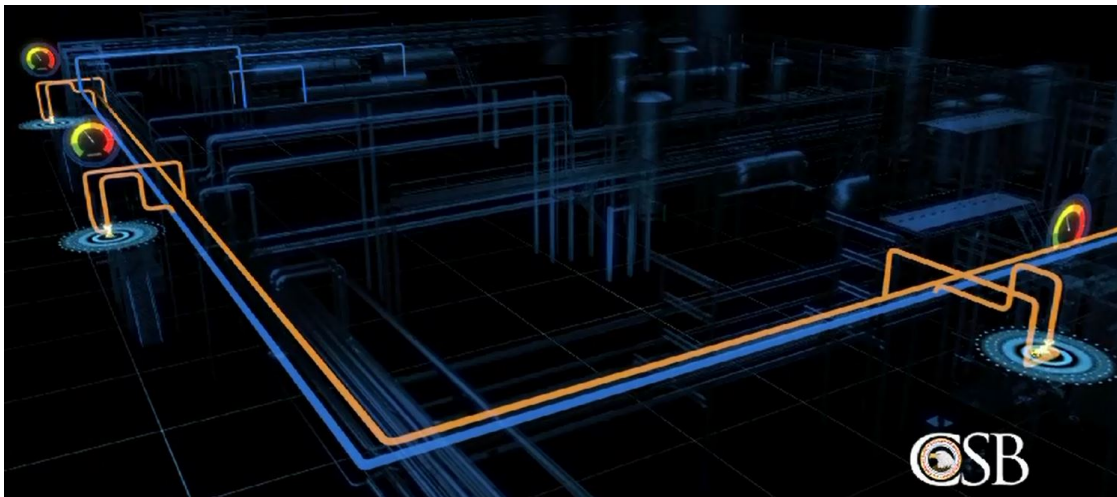
unwanted vapor from the process and route it to the NRS incinerator for thermal destruction. DuPont personnel used pressure gauges at those three valves (Figure 16) to determine where the blockage was, and what progress they were making to clear it. At the time of the incident, one of these three valves between the methyl mercaptan feed system and the waste gas vent header was fully open. A second valve was slightly open.

Figure 16. Snippet from CSB animation depicting the three locations where valves connected the methyl mercaptan feed line (blue) to the waste gas vent header (orange) piping. Pressure gauges shown at these locations were used to monitor the progress of clearing the hydrate blockage inside the methyl mercaptan feed line.

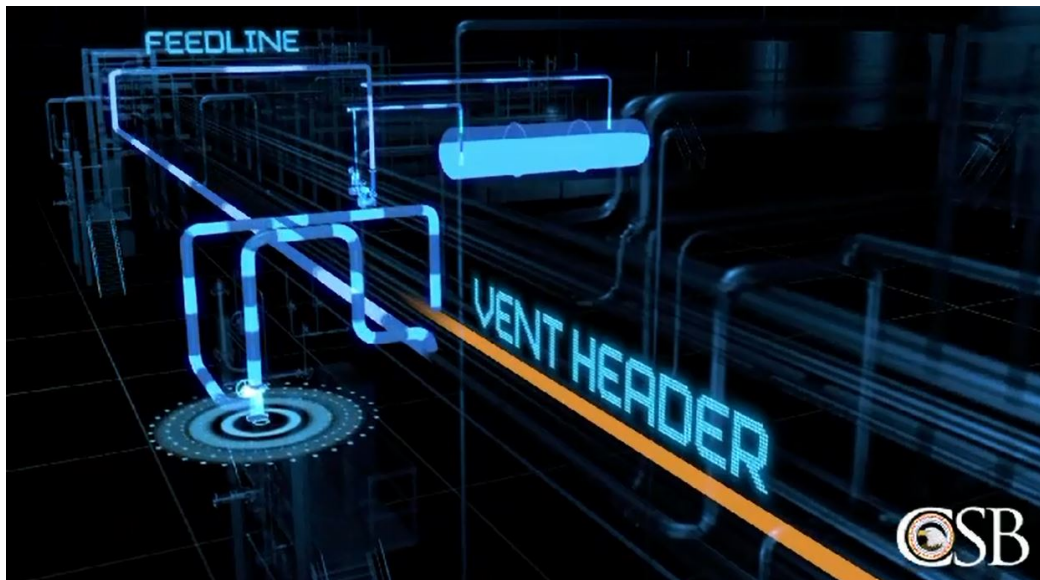
26. A post-incident evaluation of process data identified that the level in the methyl mercaptan storage tank began to drop at approximately 2:45 am. Liquid methyl mercaptan had started to flow into the waste gas vent header piping (Figure 18). This was likely caused by the hydrate being dissociated sufficiently to allow liquid to flow forward and through the connections opened between the liquid methyl mercaptan piping and the waste gas vent header piping. However, the drop in methyl mercaptan storage tank level was not detected, because the level was still within normal operating limits.

Figure 18. Snippet from CSB animation depicting the piping arrangement that allowed liquid methyl mercaptan from the feed line (blue) to flow into the waste gas vent header piping (orange).

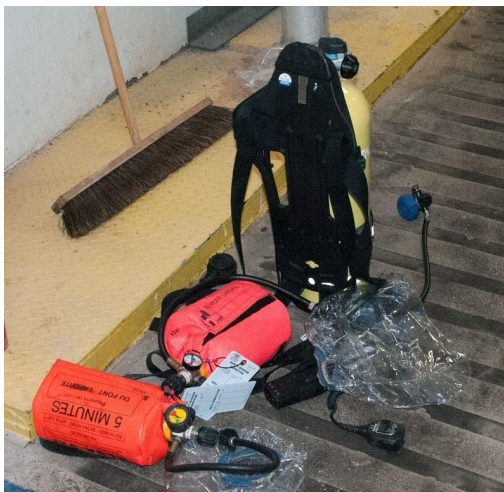
Figure 20. Photo of the 5-minute escape air bottles and 30-minute self-contained breathing apparatus (SCBA) on the third floor, dry end (west) side of the manufacturing building following the incident. The third 5-minute escape air bottle was put on Operator 4 and was left at the control room entrance. The 30-minute SCBA was originally just outside the door to the third floor entrance at the south stairway. It is presumed that Operator 6 grabbed this SCBA prior to entering the third floor.
